**VERIDIAN ON-SITE KNEE BOLSTER AIR BAG DEPLOYMENT INVESTIGATION
VERIDIAN CASE NO. CA 98-025
VEHICLE - 1997 KIA SPORTAGE
LOCATION - NEW JERSEY
CRASH DATE - APRIL 1998**

1. <i>Report No.</i> CA98-025	2. <i>Government Accession No.</i>	3. <i>Recipient's Catalog No.</i>	
4. <i>Title and Subtitle</i> Veridian On-Site Knee Bolster Air Bag Deployment Investigation Vehicle - 1997 Kia Sportage Location - New Jersey		5. <i>Report Date:</i> March 2001

14. <i>Sponsoring Agency Code</i>	
15. <i>Supplementary Notes</i> On-site investigation of the deployment of a knee bolster air bag in a 1997 Kia Sportage.

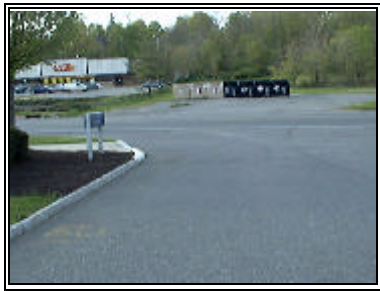
Figure 1
The Kia's travel path while departing the parking lot and attempting a left turn

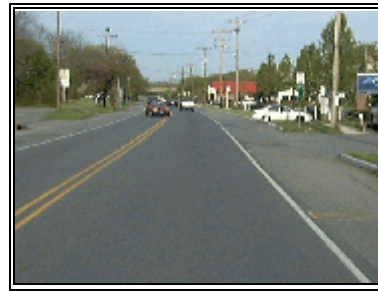
Figure 2
The Caprice's eastbound trajectory 15 m (50') prior to the point of impact

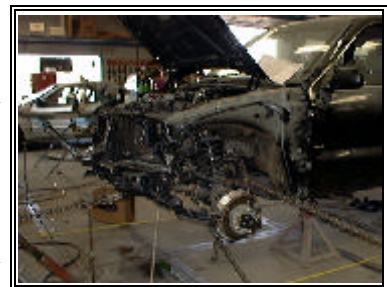
Figure 3

The Kia Sportage was under repair at the time of the SCI inspection with the front bumper, grille, left front fender, and front wheels removed (**Figure 3**). The collision shop had the vehicle positioned on jack stands in the frame straightening area of the shop. The structure of the vehicle was realigned prior to SCI arrival. The direct contact damage began 55.9 cm (22.0") left of center and extended 10.2 cm (4.0") to the front left bumper corner. Engagement continued onto the left front fender, terminating 35.6 cm (14.0") rearward of the corner area. Maximum crush was estimated at 5.1 cm (2.0") at the front left corner of the bumper with approximately 10.2 cm (4") of sheet metal crush occurring at the leading edge of the left front fender. The Collision Deformation Classification (CDC) for this impact was 11FYEW-1. The vehicle was towed from the scene.

Exterior view of the Kia Sportage that was under repair at time of the SCI inspection

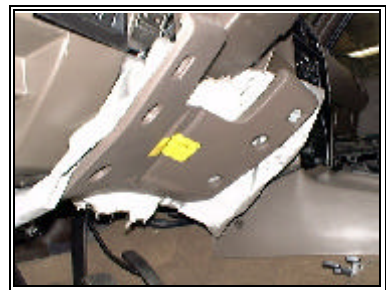
The driver knee bolster was constructed of a pliable vinyl cover which was backed by 12.7 mm (0.5") thick high density foam padding and reinforced by a 15.9 mm (1/16") thick sheet metal backing plate. The bolster panel was rectangular in shape with a U-shaped cutout for the steering column. The dimensions of the bolster are as follows: bottom edge 30.5 cm (12.0"); left and right edge 30.5 cm (12.0"); left top edge adjacent to the steering column 9.5 cm (3.75"); right top edge adjacent to the steering column 7.6 cm (3.0"); vertical distance from the bottom of the bolster to the base of the steering column 20.3 cm (8.0"). The adjacent lower instrument panel had a rake angle of 45 degrees. **Figure 4** is a view of the deployed knee bolster air bag.

Figure 4
View of the knee bolster and knee air bag

The knee bolster sustained deformation as the result of being displaced by the deploying knee air bag. The knee air bag was attached to the center of the knee bolster which restricted its rearward excursion to a measured distance of 8.3 cm (3.25"). As the center of the knee bolster reached the maximum extent of travel, the knee air bag continued to exert pressure along the rear outboard aspects of the bolster where the left and right sides continued to move rearward resulting in a “V” shaped deformation pattern. The extent of deformation measured from a reference line across the face of the knee bolster to the center of the bolster measured 5.1 cm (2.0").

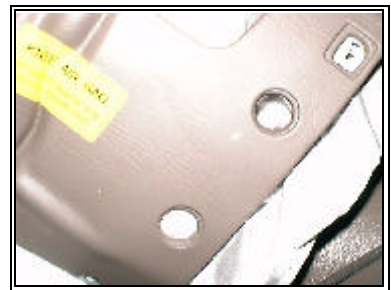
The knee bolster utilized six quick release points with three points along the left vertical edge and three on the right vertical edge (**Figure 5**). The two lower 2.5 cm (1.0") diameter release points along the left edge were located 3.8 cm (1.5") inboard from the edge and 10.2 cm (4.0") and 19.7 cm (7.75") from the bottom of the bolster. The left top release attachment point measured 1.9 cm (0.75") in diameter and was recessed in a 2.5 cm (1.0") square. It was located 26.0 cm (10.25") from the bottom of the knee bolster and 3.8 cm (1.5") inboard from the edge. The two lower 2.5 cm (1.0") diameter releases along the right edge were located 3.8 cm (1.5") and 3.2 cm (1.25") inboard from the edge and 10.2 cm (4.0") and 19.7 cm (7.75") from the bottom of the bolster. The top release attachment point was located 26.0 cm (10.25") from the bottom of the knee bolster and 1.9 cm (0.75") inboard from the edge measured 1.9 cm (0.75") in diameter and recessed in a 2.5 cm (1.0") square.

Figure 5
View of the knee bolster break away attachment points and warning label

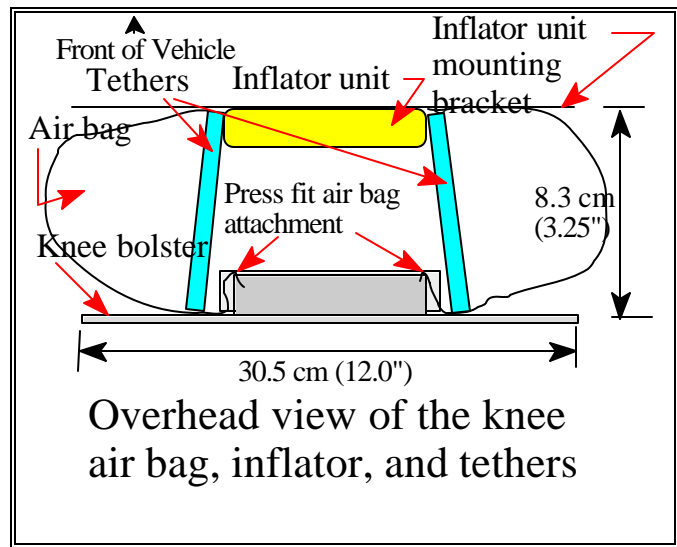
The front left driver knee bolster air bag was mounted behind the driver knee bolster panel. During the deployment sequence, the knee air bag displaced the knee bolster from the six attachment points and traveled a measured distance of 8.3 cm (3.25") toward the driver. The knee air bag had two tethers which limited the excursion of the bag and bolster panel. The tethers were located at the 10 o'clock and 2 o'clock position adjacent to the inflator unit and at 4 o'clock and 8 o'clock on the rear surface of the knee bolster. **Figure 6** is a schematic of the knee bolster air bag.

Figure 6. Schematic of the knee bolster air bag

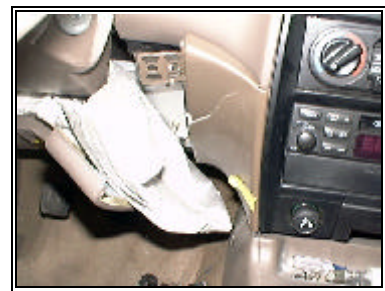
Figure 7

The lower instrument panel adjacent to the right side of the knee bolster was abraded and exhibited fabric transfers that were attributed to contact by the driver's right knee and lower leg. The contact pattern measured 12.7 cm (5.0") vertically and 8.9 cm (3.5") laterally and began 10.2 cm (4.0") left of the vehicle's centerline. Additionally, the vinyl surface of the instrument panel adjacent to the top of the contact point was fractured and was attributed to the same contact. The 14.0 cm x 6.7 cm (5.5" x 2.625") headlight switch panel located 58.4 cm (23.0") left of the vehicle centerline was dislodged from the lower instrument panel and the adjacent vinyl instrument panel cracked. This was attributed to contact by the driver's left knee during the crash sequence.

At impact, the driver's frontal air bag and knee bolster air bag deployed. The driver responded to the presumed 11 o'clock impact force by initiating a trajectory that was forward and to his left. Due to his forward position, his right knee contacted the instrument panel adjacent to the knee bolster as noted by the abrasion to the vinyl surface and a heavy fabric transfer pattern (**Figure 7**). The location of the contact was consistent with the description by the driver of his right knee orientation prior to the crash. The driver's left knee contacted the headlight control panel that was subsequently dislodged. Although there was no conclusive evidence, the knee air bag may have contacted the

View of the contact area located adjacent to the knee bolster and knee air bag

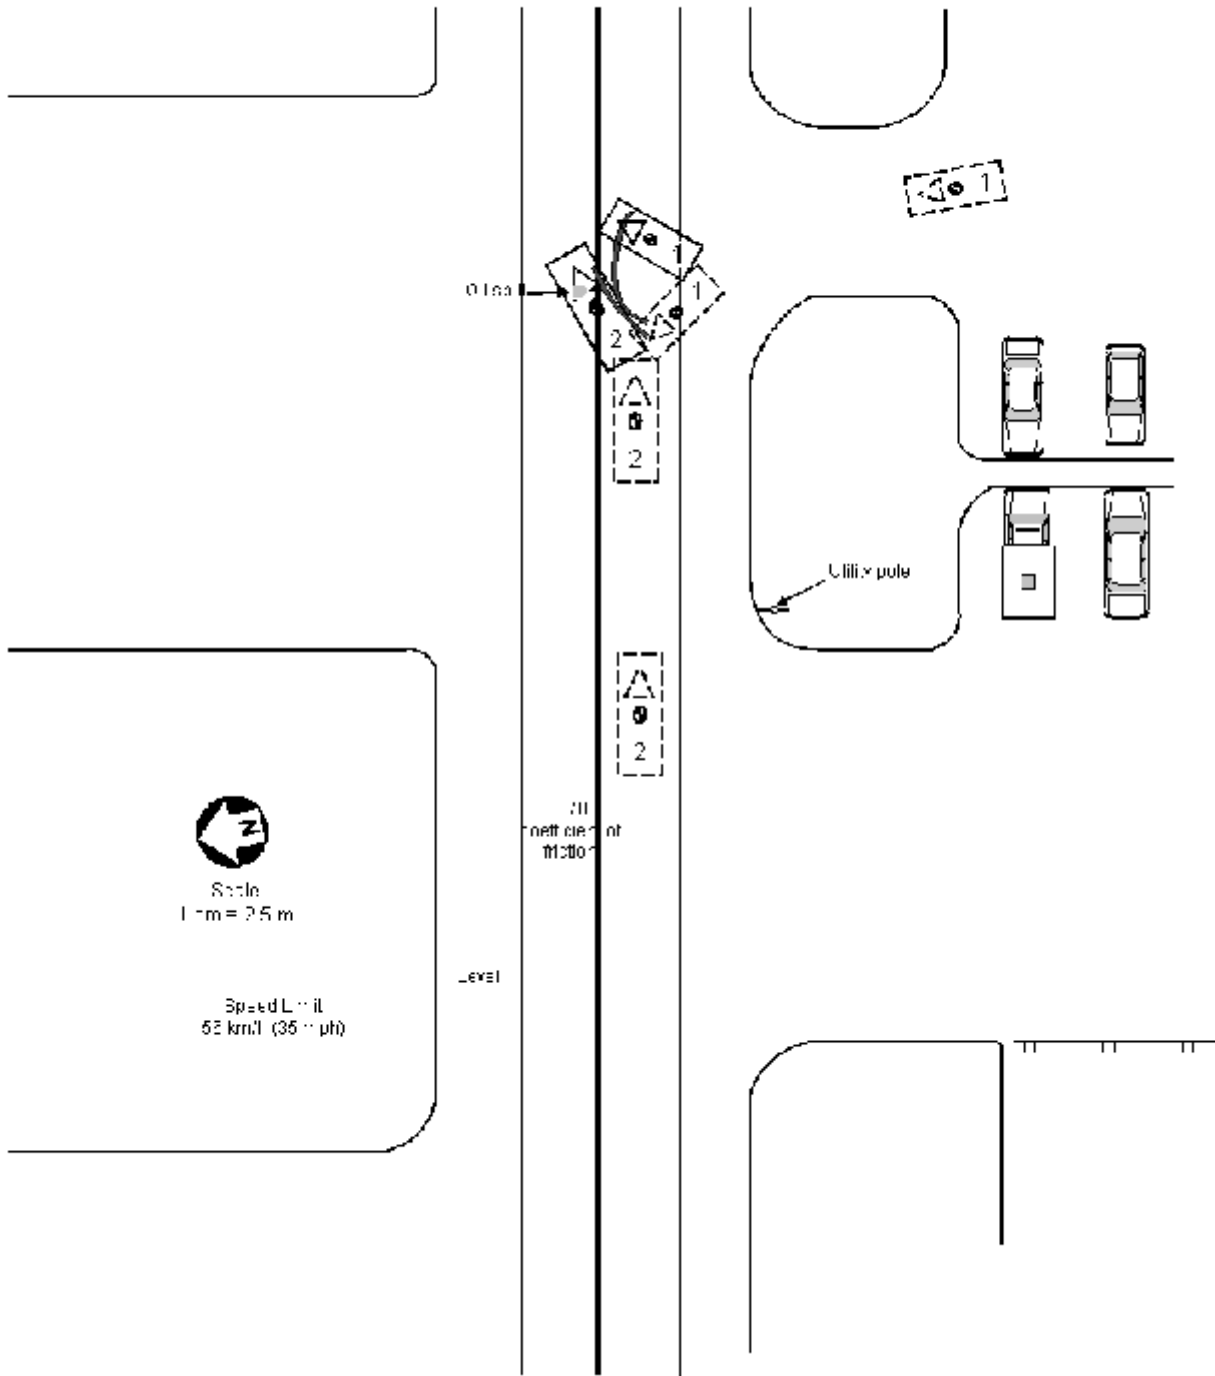
the vehicle was far enough away that it did not pose a threat to his turning action. The driver of the Kia then checked the westbound travel lane and noted the absence of approaching vehicles. He proceeded to turn left, across the eastbound travel lane to proceed in a westbound direction. As he initiated the left turn, the driver of the Kia noted the presence of Chevrolet Impala, which he estimated at approximately 6 m (20') from the impending point of impact (POI). He subsequently attempted to avoid the crash by accelerating and shifting the manual transmission from first to second gear. The crash schematic is attached as **Figure 8**, page 9.
