**ONSITE DEPOWERED DRIVER AIR BAG DEPLOYMENT INVESTIGATION**

**VERIDIAN CASE NO. CA98-029**

**VEHICLE: 1998 TOYOTA AVALON**

**CRASH DATE - APRIL 1998**

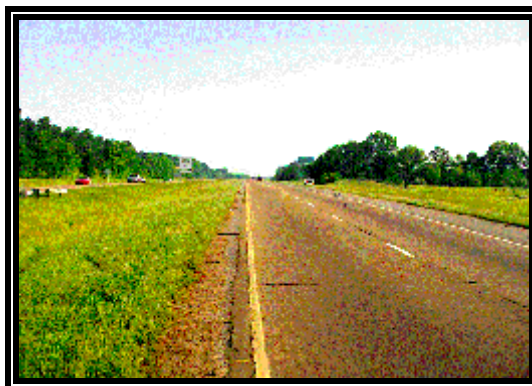
**Figure 1:** Northbound trajectory view of the interstate.

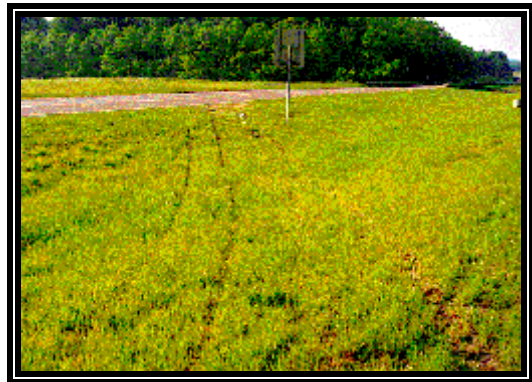
A witness traveling behind the southbound Subaru reported that prior to the crash the vehicle was in the outboard lane at a speed of approximately 113 km/h (70 mph). The Subaru then moved to the inboard lane to pass slower traffic and drifted off the left side of the road. The vehicle's left wheels dropped off the pavement. The Subaru driver corrected the vehicle's trajectory by steering back to the right, over-corrected and then steered back to the left. The Subaru departed the left side of the southbound interstate in a counterclockwise yaw and traveled through the median to the southeast, **Figure 2**. As the Subaru approached the northbound lanes of the interstate, analysis of the tire marks indicated the vehicle had ceased rotation and had returned to a more tracking trajectory.

**Figure 2:** Southeast trajectory view of the Subaru.

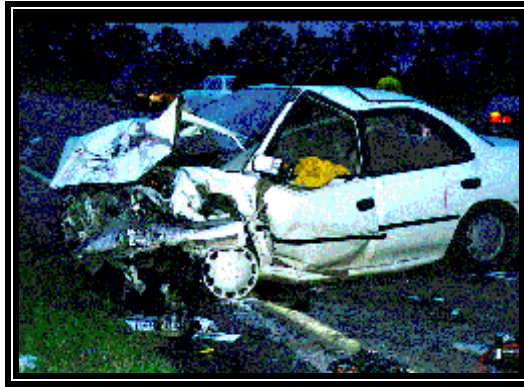
The front of the Subaru slid along the left side of the Toyota in a protracted engagement, as the northward momentum of the Toyota caused the Subaru to reverse direction. The left side damage on the Toyota extended rearward to the area of the left C-pillar. Both vehicles began to rotate counterclockwise. An area of gouge marks in the in-board lane identified the point of impact. The Subaru rotated counterclockwise approximately 210 degrees and came to rest in the in-board northbound lane approximately 5 m (15 ft) north of the point of impact, facing west. **Figure 3** is an on-scene police photograph of the Subaru at final rest.

**Figure 3:** Final rest position of the Subaru.

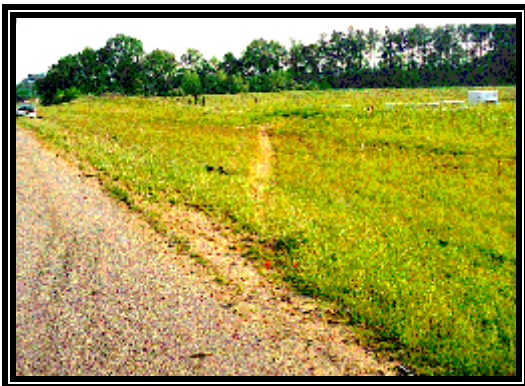
The force of this impact caused the SRS of the BMW to deploy. The Toyota and BMW remained in contact and slid off the right side of the interstate, approximately 49 m (160 ft) to the northeast. **Figure 4** is a post-impact trajectory view of the Toyota and BMW. The Toyota came to rest facing southwest, approximately 20 m (65 ft) east of the edge of the shoulder and the BMW came to rest facing northeast approximately 18 m (60 ft) east of the shoulder edge. The police report indicated that the Toyota and BMW were in contact at final rest and were then separated during the extrication process. **Figure 5** is an on-scene police photograph of the Toyota and BMW at final rest (note, the BMW has already been moved.)

**Figure 4:** Post-impact trajectory view of the Toyota and BMW.

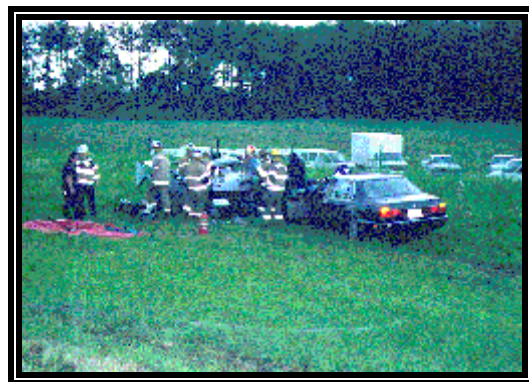
**Figure 5:** Final rest positions of the Toyota and BMW.

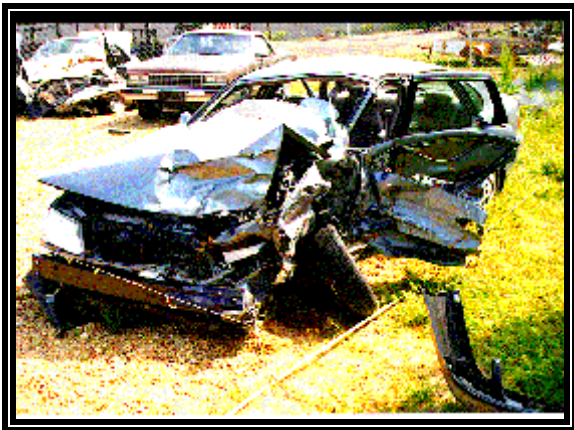
The front plane of the Toyota Avalon sustained 80.0 cm (31.5 in) of direct contact damage that began 3.8 cm (1.5 in) left of center and extended to the front bumper's left corner as a result of the combined frontal impacts. The crush profile measured along the face of the bumper rebar was as follows: C1=54.6 cm (21.5 in), C2=50.8 cm (20.0 in), C3=21.6 cm (8.5 in), C4=12.7 cm (5.0 in), C5=0, C6=0. **Figures 6 and 7** are the left front and left lateral views of the Toyota respectively. The Subaru's direct contact with the Toyota continued approximately 333 cm (131 in) along the left side of the vehicle to the left rear door. The impact displaced the bumper fascia from the vehicle. The left side wheelbase was foreshortened approximately 36 cm (14 in). There was no measurable change in the right side wheelbase dimension. The lower aspect of the left A-pillar deformed rearward approximately 20 cm (8 in) and 18 cm (7 in) laterally right. The roof was buckled adjacent to the left A-pillar and left B-pillar. The left front window glazing was shattered in the impact. The windshield was removed and the steering column and instrument panel were pulled up in the extrication process. The combined Collision Deformation Classification (CDC) of the Toyota Avalon resultant to the two overlapping impacts was 11-FYEW-3. The barrier equivalent delta V of the Toyota based on the frontal damage as calculated by the barrier model of the WINSMASH program was approximately 33.3 km/h (20.7 mph). The longitudinal and lateral components were 28.8 km/h (-17.9 mph) and 16.7 km/h (10.4 mph), respectively..

**Figure 6:** Left front view of the Toyota Avalon.

The passenger air bag was configured as a top-mount design located in the right instrument panel. The air bag module cover flap was a single vinyl flap that hinged on the aft aspect of the top of the instrument panel (refer to Figure 6). The flap was trapezoidal in shape and measured 21.6 cm (8.5 in) in width. The inboard and outboard heights of the flap were 8.6 cm (3.4 in) and 5.8 cm (2.3 in) respectively. The passenger air bag was tethered by a single wide strap sewn to the face of the bag. The bag vented internally back through the air bag module. The air bag extended approximately 61 cm (24 in) from the instrument panel in its deflated state. The face of the deflated bag measured 51 cm (20 in) by 51 cm (20 in) width by height. There was no contact evidence on the air bag.

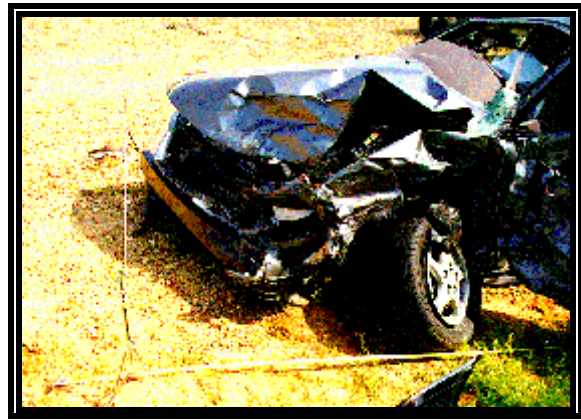
**Figure 7:** left lateral view of the Toyota.

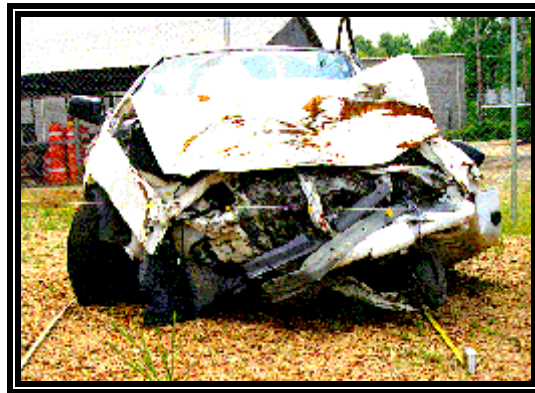
The 1995 Subaru Impreza sustained direct contact damage across the full frontal width of the vehicle. The measured crush profile (less assumed free space) at the elevation of the front bumper was as follows: C1=69.9 cm (27.5 in), C2=66.0 cm (26.0 in), C3=57.8 cm (22.8 in), C4=55.2 cm (21.8 in), C5=59.7 cm (23.5 in), C6=50.2 cm (19.8 in). **Figure 8** is the front view of the Subaru. The left front suspension deformed rearward into the lower aspect of the A-pillar. The left side wheelbase was foreshortened approximately 29.7 cm (11.7 in). The right side wheelbase dimensions was unchanged. The left A-pillar

deformed rearward approximately 14.0 cm (5.5 in) causing the roof above the driver to buckle. The left front door buckled and was jammed shut due to deformation. (The left front door was opened in the extrication process.) The left rear door was jammed at the C-pillar latch. The right front door was buckled and jammed at the right B-pillar due to deformation. The right rear door was operational. The steering wheel rim was deformed and the steering column was totally separated from the instrument panel at the shear plate (**Figures 9 and 10**). The CDC of the Subaru was 01-FDEW-3. The barrier equivalent delta V calculated by barrier model the WINSMASH program was approximately 66.1 km/h (41.1 mph).

**Figure 8:** Front view of the Subaru Impreza.

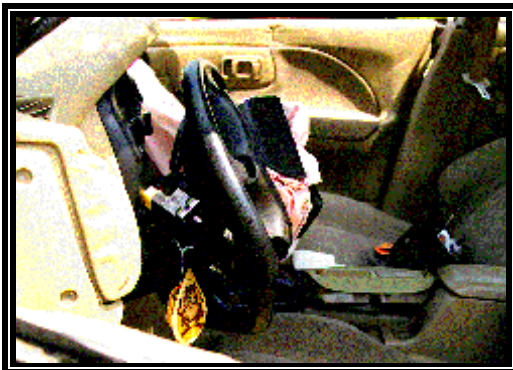
**Figure 9:** Lateral view of the steering wheel.

The driver air bag module was located in the typical manner in the center hub of the tilt steering wheel. There was no steering wheel rim deformation. The H-configuration air bag module opened as designed at the designated tear points during the deployment sequence. The width of the horizontal seam measured 17.3 cm (6.8 in). The height of the upper and lower flaps measured 7.6 cm (3.0 in) and 7.1 cm (2.8 in) respectively. The following nomenclature was embossed on the interior surface of the upper flap: 45112-07020 and the date code was 3/10/98.

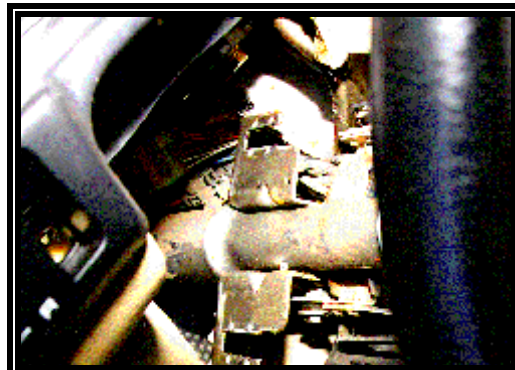
**Figure 10:** View of the steering column and shear plate.

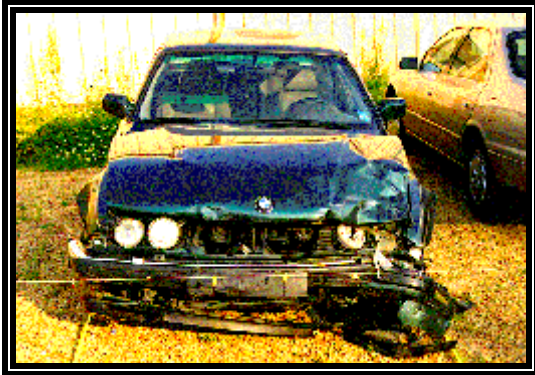
**Figures 11 and 12** are front and left lateral views of the 1991 BMW 750iL, respectively. The BMW sustained direct contact damage across the full frontal width of the vehicle as a result of its impact with the Toyota. The measured crush profile of the front bumper (less assumed free space) was: C1=17.8 cm (7.0 in), C2=14.0 cm (5.5 in), C3=12.7 cm (5.0 in), C4=11.4 cm (4.5 in), C5=11.4 cm (4.5 in), C6=12.7 cm (5.0 in). The damaged components of the BMW included the front bumper and bumper mounting structures, center grille, head lamp assemblies, left front and right front fenders and the hood. There did not appear to be any damage aft of the radiator support. There was no measurable change in the

respective wheelbase dimensions. The windshield and the glazing of all windows were intact. All the doors opened and closed properly. The CDC of the BMW was 12-FDEW-1. The barrier equivalent delta V calculated by the WINSMASH program was approximately 19.3 km/h (12.0 mph).

**Figure 11:** Front view of the BMW 750iL

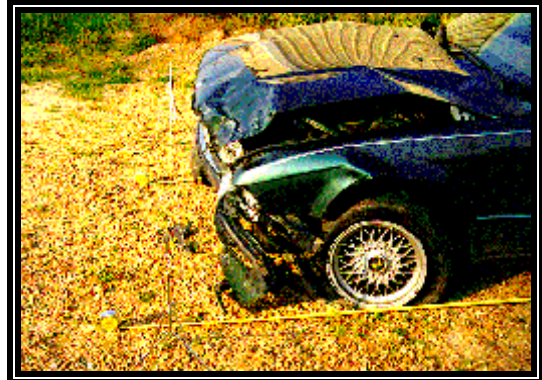
**Figure 12:** Left lateral view of the BMW.

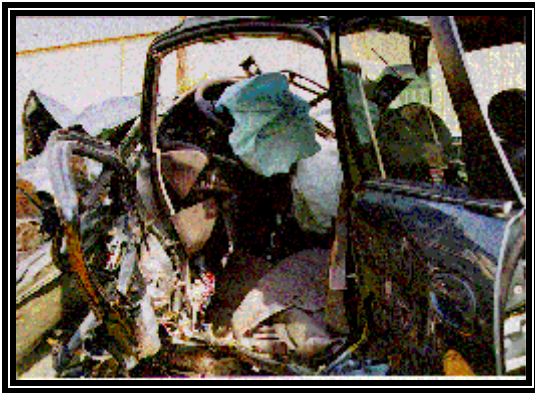
Passenger compartment integrity was lost through the left front and left rear side windows which disintegrated in the impact. Two specific areas of contact were identified on the left knee bolster as a result of the driver contact. The scuffs measured approximately 5 cm x 5 cm (2 in x 2 in). The left scuff was located 2.5 cm (1.0 in) left of the steering column centerline and vertically 5 cm (2 in) below the steering column. The right scuff was located laterally on the right edge of the bolster panel and was vertically located 16.5 cm(6.5 in) below the top edge of the panel.

**Figure 13** is a left interior view of the Toyota. The intrusion of the left A-pillar and left corner of the instrument panel measured approximately 20 cm (8 in) longitudinally rearward and 18 cm (7 in) laterally right. There was approximately 23 cm (9 in) of lateral intrusion at the left B-pillar. **Figure 14** is a view depicting the lateral deformation of the left front seat. The left front, left rear and right rear doors were opened by extrication. The steering column and left side of the instrument panel were pulled up vertically in the extrication process. Identification of interior contacts to the left door were hampered by the post crash extrication.

**Figure 13:** Left interior view of the Toyota.

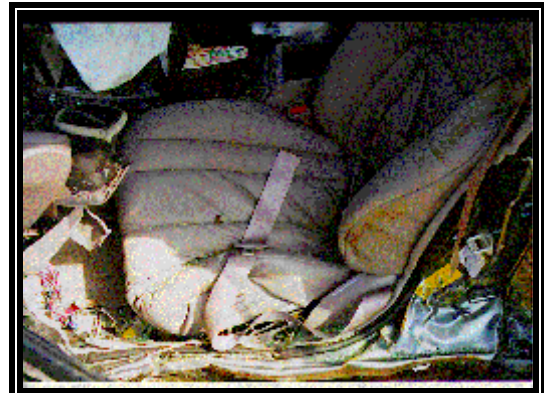
The vehicle's interior was a high grade vinyl and was tan in color. The 6-way power left front seat was jammed due the lateral deformation. The seat deformation measured 14.0 cm (5.5 in) at mid-cushion. The seat was adjusted to a mid-track position. The adjustable head restraint was in the full down position. There were no seat performance failures.

**Figure 14:** View of the Toyota's left front seat.

The Toyota was equipped with a Supplemental Restraint System (SRS) that consisted of depowered frontal air bags for the driver and front right passenger. There were no exterior identifiers on the vehicle that indicated the SRS was a depowered system. There also were side impact air bags located in the outboard aspects of the Toyota's front seat backs, refer to **Figure 14**.
