**CALSPAN ON-SITE DRIVER AIR BAG DEPLOYMENT/  
FATALITY INVESTIGATION**

**CALSPAN CASE NO. CA98-44**

**VEHICLE - 1991 DODGE SPIRIT**

**CRASH DATE - JULY, 1998**

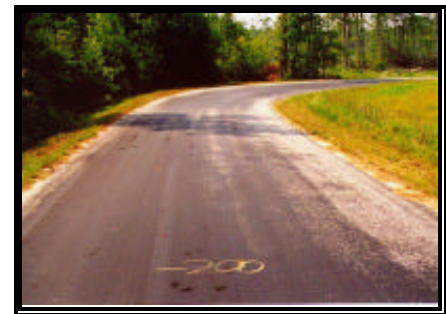
**Figure 1:** Northward trajectory view of the Dodge Spirit 61 m (200 ft) from the POI.

The shoulders of the road were gravel and grass. Parallel to and 4.6 m (15 ft) beyond the west road edge was a 0.6 m (2 ft) deep ditch and a line of trees and brush. The speed limit in the area of the crash was not posted and by state law defaulted to 89 km/h (55 mph). **Figure 1** is a northward view of the crash scene 61 m (200 feet) from the point of impact.

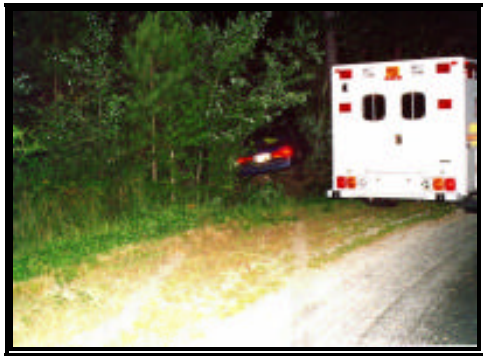
**Figure 2:** On-scene police photograph of the Dodge at final rest.

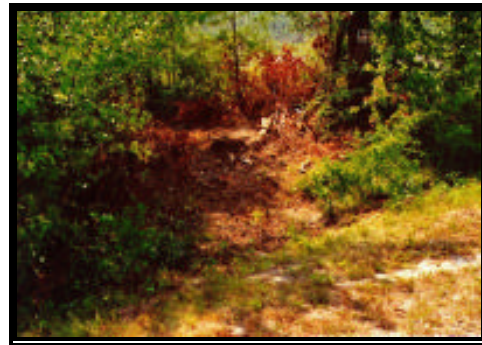
**Figure 3:** View of the embankment and tree at the POI.

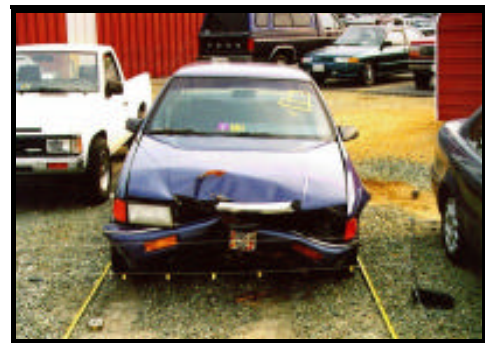
**Figure 4** is a front view of the Dodge Spirit. The Dodge sustained 130 cm (51 in) of direct contact damage that extended across the full frontal width of the vehicle from the embankment impact. The width of the direct contact damage from the tree impact measured 15 cm (6 in) and was located on the vehicle’s centerline. The crush profile of the combined

**Figure 4:** Front view of the Dodge Spirit.

damage measured across the width of the bumper was:  $C_1=10.2$  cm (4.0 in),  $C_2=24.1$  cm (9.5 in),  $C_3=29.7$  cm (11.7 in),  $C_4=37.3$  cm (14.7 in),  $C_5=15.7$  cm (6.2 in),  $C_6=0$ . The maximum crush of 37.3 cm (14.7 in) was located at  $C_4$ , 5.1 cm (2.0 in) right of vehicle centerline. The front center section of the hood buckled as designed. The left front fender was buckled and shifted rearward, slightly restricting the left front door. All of the vehicle's doors were operational and all glass was intact. There was no measurable change in the wheelbase dimensions. The Collision Deformation Classification's (CDC's) of the Dodge were 12-FDLW-1 and 12-FNEC-2 for the embankment and tree impacts, respectively. The barrier equivalent delta V calculated by the barrier model of the WINSMASH program was 29.3 km/h (18.2 mph).

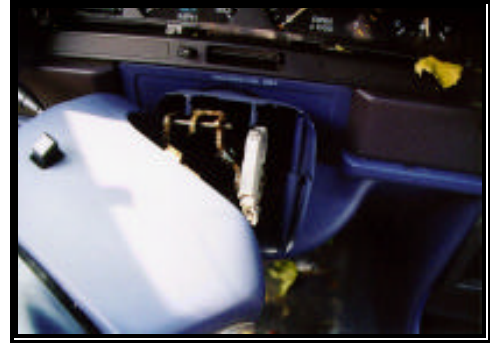
The only damage to the interior of the Dodge were those associated to the deployment of the SRS and interaction with the occupant. There was no interior damage or intrusion directly associated to the external forces of the crash. Inspection of the steering column revealed the complete displacement of the shear plate from the shear capsules. In addition, the steering wheel's tilt adjustment was fractured. The fracture occurred at the inboard cast adjustment knuckle, **Figure 5**, and allowed the outboard aspect of the rim to pivot upward and left. The damage and deformation to the steering column was a direct result of the driver's forward kinematic pattern and contact.

**Figure 5:** Fractured tilt mechanism of the steering wheel.

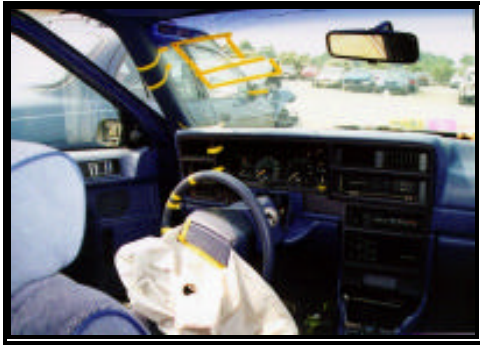
**Figure 6** is a view of the left interior contacts as viewed from the rear seat. The left aspect of the instrument panel (near the vent louver) was scuffed by contact from the back side (10 o'clock) of the steering wheel rim. The steering wheel rim was abraded in this area and fibers from that abrasion were identified on the instrument panel. This contact occurred as the driver loaded and displaced the fractured steering wheel.

The trim panel of the left A-pillar was scuffed by a probable contact with the driver's left forearm. The scuff was located 17.3 cm (6.8 in) below the header and measured 2.5 cm x 6.3 mm (1.0 in x 0.3 in). The left aspect of the windshield was fractured from probable contact with the knuckles of the driver's left hand. The elevation of the windshield fracture was consistent with the location of the scuffed A-pillar and was located 17.8 cm (7.0 in) right of the pillar.

**Figure 6:** Interior contacts.

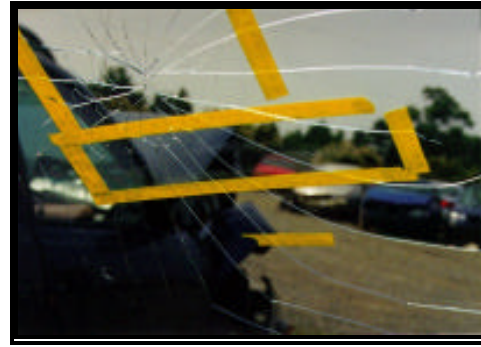
Directly below the fracture site was an area of air bag fabric transfer on the interior surface of the windshield, **Figure 7**. The area measured 18 cm x 5 cm (7 in x 2 in) and occurred due to the altered deployment path of the air bag.. This transfer was linked to a scuff located in the 10 o'clock sector on the face of the bag.

**Figure 7:** Air bag transfers to windshield.

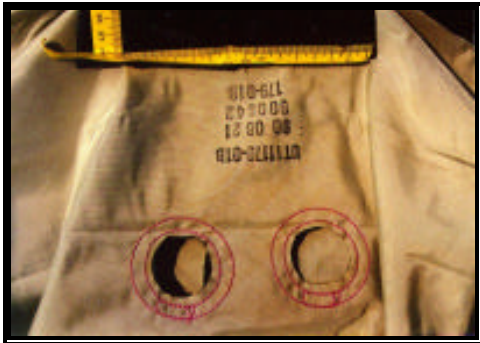
The driver air bag measured 71 cm (28 in) in its deflated state. The air bag was tethered by two 7.6 cm (3.0 in) wide straps sewn to the face of the bag in 3/9 o'clock positions. The bag was vented by two 3.3 cm (1.3 in) diameter ports located in the 11/1 o'clock sectors on the back side of the bag. A large melanin transfer was noted on the back side of the air bag from 10 to 2 o'clock sectors. There also was a region of tissue transfer, located in the 2 o'clock sector on the back side of the bag, that measured approximately 13 cm (5 in). **Figure 8** is a close-up view of the transfers on the back side of the air bag. **Figure 9** is a

**Figure 8:** Close-up view of melanim transfers on the back side of the air bag.

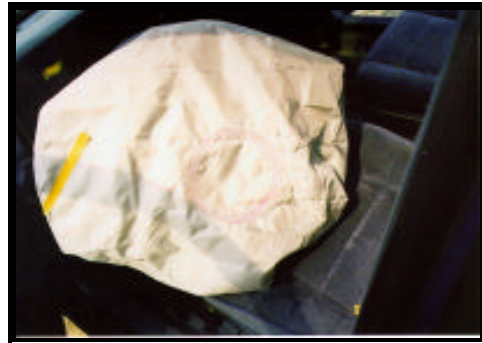
view of the face of the air bag. A 1.0 cm x 12.7 cm (0.4 in x 5.0 in) dark colored transfer was identified on the perimeter of the bag, in the 10 o'clock sector. This transfer was linked to the fabric transfer on the left aspect of the windshield previously identified (refer to **Figure 7**).

**Figure 9:** View of the transfer on the face of the air bag.

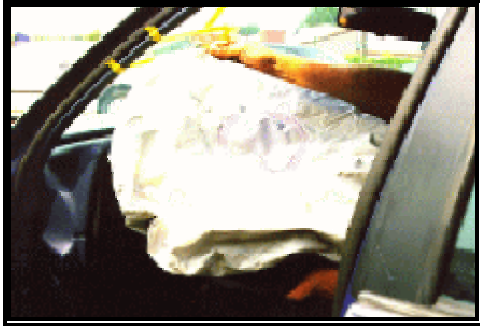
**Figure 10:** Altered deployment path of the air bag.

The forward position of the driver coupled with the steering wheel's fractured tilt adjustment altered the normal deployment path of the air bag resulting in the fabric transfers to the windshield as the air bag expanded, **Figure 10**. The 10 o'clock sector of the steering wheel rim contacted the left aspect of the instrument panel. The driver then rebounded back into the seat and slumped to the right where he was found.
