**TRANSPORTATION SCIENCES
CRASH DATA RESEARCH CENTER**

ON-SITE SIDE IMPACT PROTECTION/DRIVER FATALITY INVESTIGATION

VERIDIAN CASE NO: CA98-045

VEHICLE: 1997 CADILLAC DEVILLE

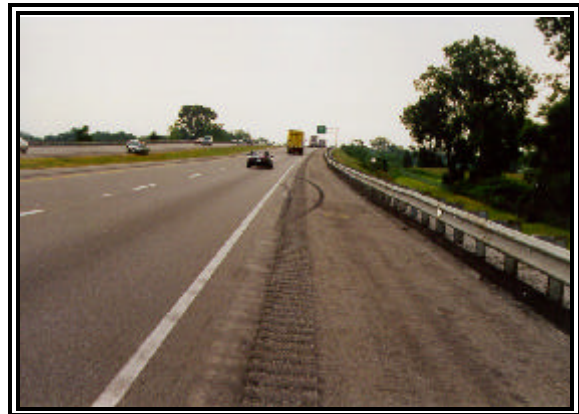
This six-vehicle crash occurred during the afternoon hours of August 1998. At the time of the crash, it was daylight and the weather was not a factor. The crash occurred on a four lane divided (two eastbound, two westbound) concrete state highway. The respective travel lanes were separated by a 12 m (40 ft) wide depressed grass median. There was a positive 1.7 percent grade in the eastbound direction. The outboard travel lanes were bordered by 3.2 m (10.5 ft) wide breakdown lanes and guardrails in the area of the crash. The posted speed limit was 105 km/h (65 mph). **Figure 1** is an eastbound view at the crash site.

Figure 1: Eastbound view at the loss of control.

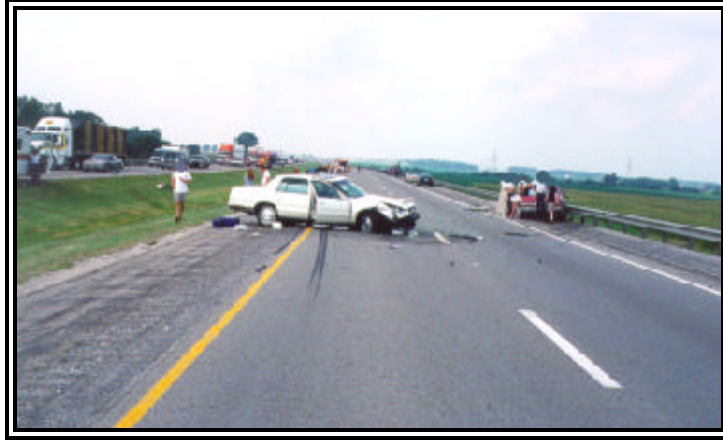
The Cadillac rotated an additional 180 degrees counterclockwise from this impact and came to the rest blocking the inboard westbound lane facing northward. The Oldsmobile was redirected to the right where it departed the right roadway edge and struck the W-beam guardrail with the left front bumper. The Oldsmobile came to rest in contact with the guardrail, in the breakdown lane. **Figure 2** is a westward view of the final rest positions of the Cadillac and Oldsmobile.

Figure 2: Final rest position of the Cadillac and Oldsmobile.

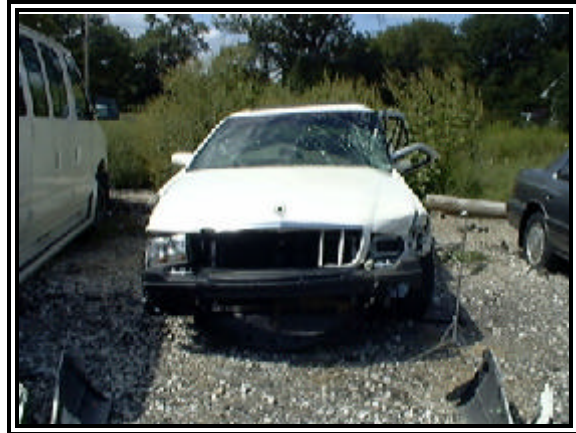
Figure 3: Front view of the Cadillac.

The vehicle’s frontal plane sustained two below (air bag deployment) threshold end-swipe contacts. Refer to **Figure 3** above. These impacts were minor and did not warrant deployment of the frontal air bag system, considering the vehicular engagement and configuration. The crush profile of the front plane along the bumper reinforcement bar was a resulted of the two overlapping impacts. The combined width of the direct and induced damage extended across the vehicle’s entire 163 cm (64 in) end width. The documented residual crush was as follows: C1 = 17.8 cm (7.0 in), C2 = 6.4 cm (2.5 in), C3 = 1.9 cm (0.75 in), C4 = 0.6 cm (0.25 in), C5 = 0, C6 = 7.6 cm (3.0 in).

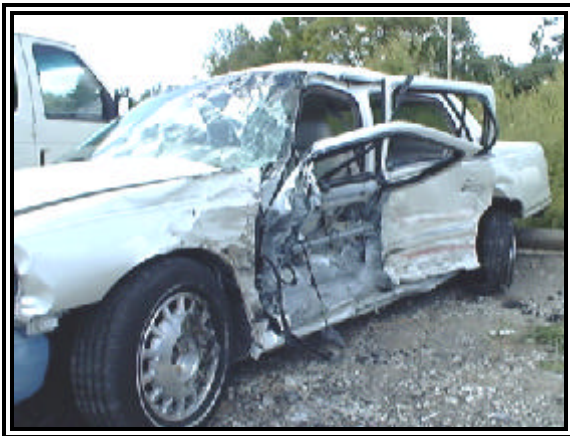
The left side of the Cadillac sustained moderate damage as a result of the impact with the Oldsmobile, **Figures 4 and 5**. The combined width of the direct and induced left side damage began 95.2 cm (37.5 in) forward of the left rear bumper corner and extended forward 323.9 cm (127.5 in). The width of the direct damage field measured 303.5 cm (119.5 in) and began 108.0 cm (42.5 in) forward of the left rear bumper corner. The maximum left lateral crush of 35.6 cm (14.0 in) was located 224.8 cm (88.5 in) forward of the left rear bumper corner, on the mid-aspect of the left front door and left B-pillar. The left side crush profile resultant to the impact with the Oldsmobile was as follows: C1 = 2.5 cm (1.0 in), C2 = 25.4 cm (10.0 in), C3 = 35.6 cm (14.0 in), C4 = 35.6 cm (14.0 in), C5 = 19.7 cm (7.75 in), C6 = 6.4 cm (2.5 in). The Collision Deformation Classification (CDC) was 11-LDAW-3. The delta V calculated by the Damage model of the WINSMASH program was 33.0 km/h (20.5 mph). The longitudinal and lateral delta V components were -25.3 km/h (-15.7 mph) and 21.2 km/h (13.2 mph), respectively. The WINSMASH calculated delta V was underestimated compared to the crash event data recorded by the Sensing Diagnostic Module (SDM).

Figure 4: View of the Cadillac's left side damage.

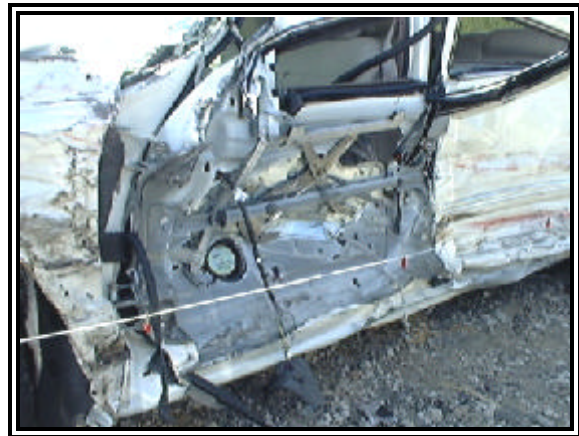
Figure 5: Close-up of the damaged left front door.

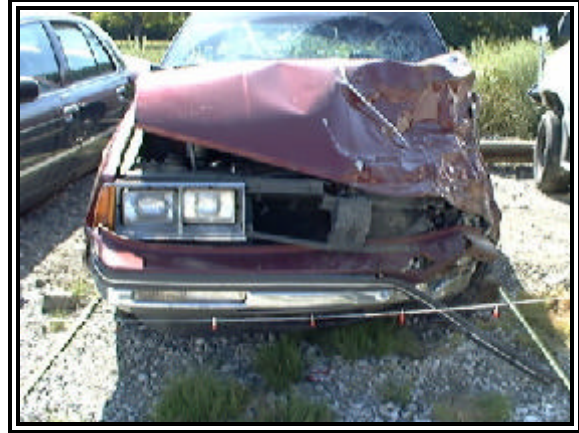
The front plane of the Oldsmobile sustained 104 cm (41 in) of direct contact damage during the impact with the left side plane of the Cadillac. The direct damage began 22.9 cm (9.0 in) right of center and extended to the left corner of the front bumper. The combined with of the direct and induced frontal damage extended across the entire 162.6 cm (64.0 in) frontal end-width of the vehicle. The maximum crush of 83.8 cm (33.0 in) was located at the left front bumper corner. Vehicle components damaged included the front bumper, grille, hood, windshield, left headlight assembly, left A-pillar, left front door and window glazing, and the left front and right front wheel. The crush profile measured along the front bumper was as follows: $C_1 = 83.8$ cm (33.0 in), $C_2 = 59.7$ cm (23.5 in), $C_3 = 40.0$ cm (15.75 in), $C_4 = 20.3$ cm (8.0 in), $C_5 = 5.1$ cm (2.0 in), $C_6 = 0$ cm. The left wheelbase was reduced 20 cm (8 in). The right wheelbase measurement was unchanged. The total delta V calculated by the Damage algorithm of the WINSMASH model was 40.0 km/h (24.9 mph). The longitudinal and lateral delta V components were -40.0 km/h (-24.9) and 0 km/h (0 mph), respectively. The CDC of the impact was 12-FYEW-3.

Figure 6: Front view of the Oldsmobile 98.

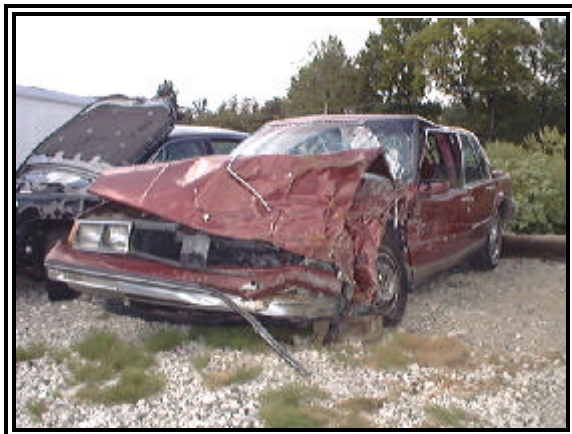
Figure 7: Left front view.

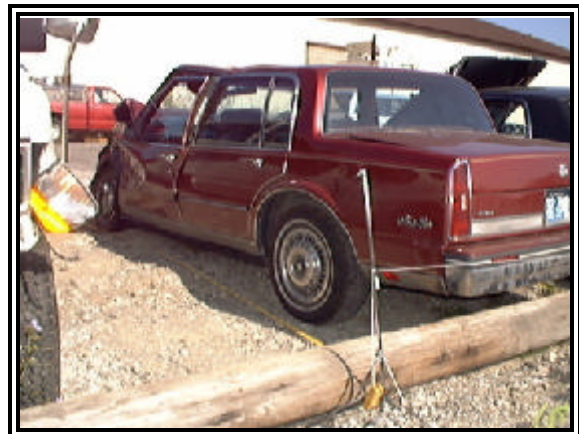
Figure 8: Left rear view.

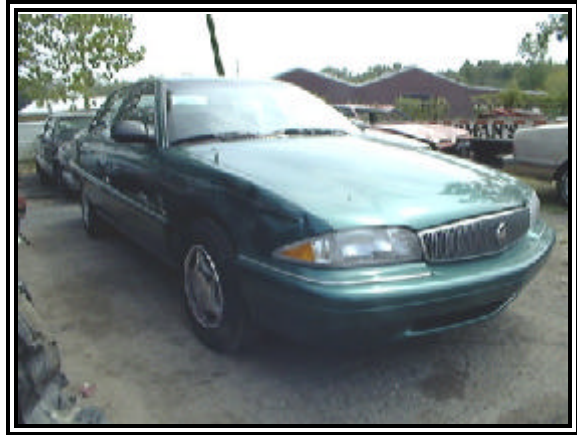
Figure 9: Right front view of the Buick Skylark.

The exterior damage to Buick Skylark involved the abrasions and paint transfers to right rear quarterpanel and the right front fender, as well as abrasions to both right side wheels. There was a 12.7 mm (0.5 in) elongation of the right wheel base. There were two minor areas of direct contact along the right side plane. The first area began 19.1 cm (7.5 in) rearward of the right front axle and extended forward on the right front fender 82.6 cm (32.5 in) in length. The maximum crush measured 3.8 cm (1.5 in). The second direct contact area measured 92.7 cm (36.5 in) in length. This contact pattern began 19.1 cm (7.5 in) forward of the right rear axle and extended rearward onto the right rear quarterpanel. The maximum crush of the quarterpanel measured 3.8 cm (1.5 in). The Collision Deformation Classification (CDC) for the impact was 06-RDES-1.

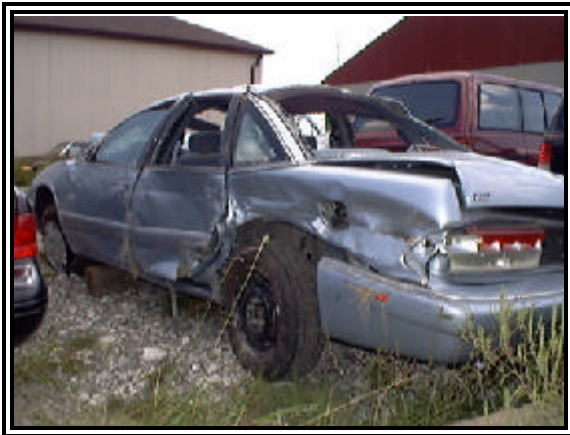
left side plane began 235.0 cm (92.5 in) rearward from the left front bumper corner and extended rearward 237.5 cm (93.5 in). The crush profile measured at the mid-door elevation was as follows: $C_1 = 16.5$ cm (6.5 in), $C_2 = 20.3$ cm (8.0 in), $C_3 = 17.8$ cm (7.0 in), $C_4 = 12.1$ cm (4.75 in), $C_5 = 7.6$ cm (3.0 in), $C_6 = 4.4$ cm (1.75 in). Both side planes and the top plane were damaged in the rollover event with the roof sustaining a maximum crush of 20.3 cm (8.0 in). The center portion of the windshield was holed and the right side glazing and left rear side glazing was disintegrated from the rollover event. All four doors were jammed due to damage. The right front window frame was displaced forward a distance of 55.9 cm (22.0 in). The CDC's of the left side impact and the rollover event were 11-LZEW-2 and 00-TDDO-4, respectively.

Figure 10: Left rear view of the damaged Buick Regal.

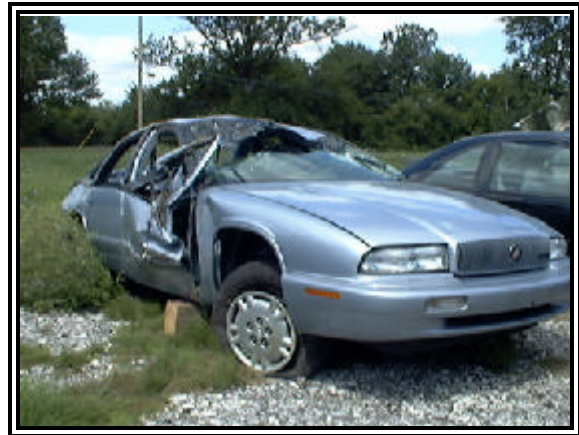
Figure 11: Right front view of the Buick Regal.

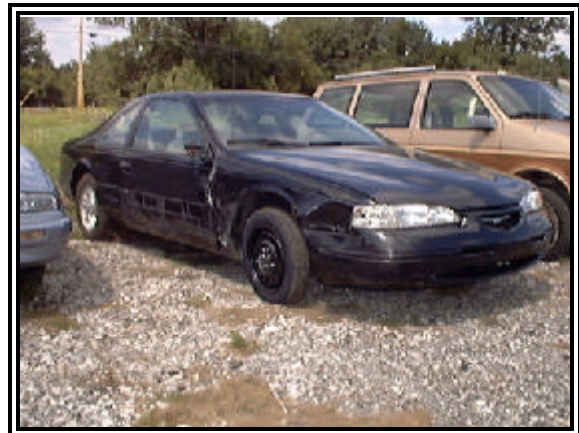
Figure 12: Right front view of the Ford Thunderbird.

The right side of the Ford end-swiped the front plane of the Cadillac. The damage began at the right front bumper corner and extended rearward 303.5 cm (119.5 in) to the side panel behind the right front door.

The exterior damage consisted of abrasions and paint transfers to the vehicle's body panels. The maximum crush was an estimated 3.8 cm (1.5 in). The CDC for this impact was 12-RYES-1.

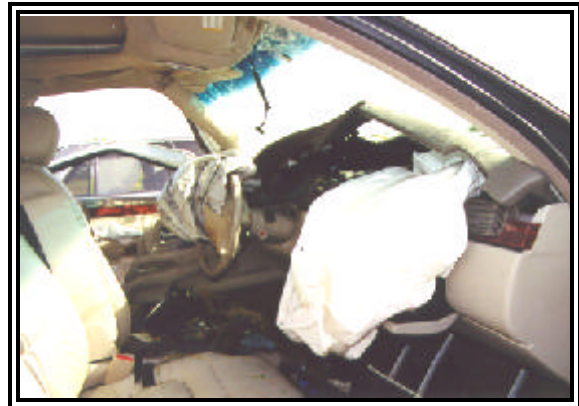
Interior vehicle damage to the 1997 Cadillac DeVille, **Figure 13**, was attributed to intrusion, occupant contacts, and the deployment of the Supplemental Restraint System (SRS). The left side of the vehicle sustained the highest magnitude of intrusion from the impact with the 1985 Oldsmobile Ninety-Eight. The left rear door surface, the left B-pillar, and the sill below the left rear door intruded laterally into the left rear occupant space 27.9 cm (11.0 in). The left front door panel at the armrest was intruded laterally 12.7 cm (5.0 in) while the left roof side rail and the sill below the left front door was displaced 6.4 cm (2.5 in) laterally. The left A-pillar was displaced longitudinally 16.5 cm (6.5 in).

Figure 13: Right interior view.

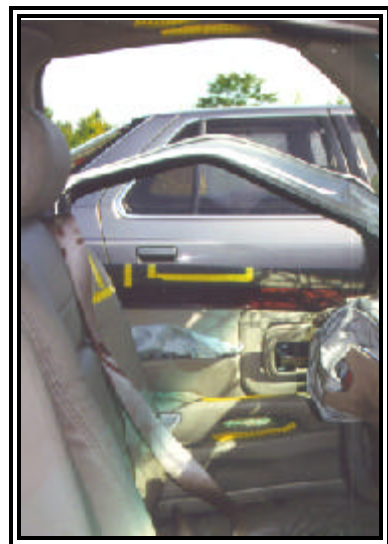
Figure 14: Left front interior contacts.

There were indentations, hair, scuffs, and transfers noted to the left front interior side structure of the vehicle which were attributed to contact by the driver during the impact sequence with the Oldsmobile. Refer to **Figure 14**. A heavy scuff was observed on the left ceiling mounted grab handle which measured 4.5 cm (1.75 in) in length and was located 54.0 cm (21.25 in) rearward of the instrument panel. This was attributed to contact by the driver's head. Just below this area there was a 10.2 cm (4.0 in) long heavy abraded mark on the fabric of the roof side rail. This mark was located 39.4 cm (15.5 in) rearward from the instrument panel and was also attributed to contact by the driver's head.

Strands of hair were detected in the rubber gasket of the upper front portion of the left window frame. The hair strands were located below the abraded mark and 38.1 cm (15.0 in) rearward from the instrument panel. The hair strands were visible over a 12.7 cm (5.0 in) length.

There was a 1.3 cm (0.5 in) indentation of the door closure grab bar which measured 14.0 cm (5.5 in) in length and was located 32.4 cm (12.75 in) rearward from the instrument panel. This indentation was attributed to contact by the driver's left hip area. The driver's left hip also contacted the door panel just below the door closure grab bar which was noted by a transfer mark which measured 10.2 cm (4.0 in) in length and was located 34.3 cm (13.5 in) rearward from the instrument panel.

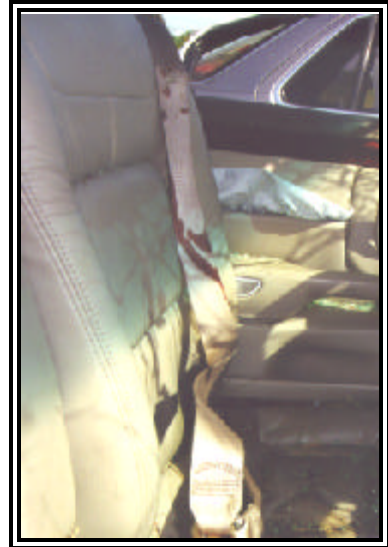
The Cadillac was equipped with manual lap and shoulder restraints in the four outboard positions. The front outboard restraints consisted of two separate lap and shoulder belt webbings sewn to a common latch plate. The left front inertial locking retractor was locked due to the B-pillar deformation and the driver's webbing was extended at inspection. There was visible deposits of blood on the torso belt which indicated that the female driver was wearing the restraint at the time of the crash, **Figure 15**. The adjustable D-ring was in the lowest position over a 7.6 cm (3.0 in) adjustment range.

Figure 15: Driver restraint.

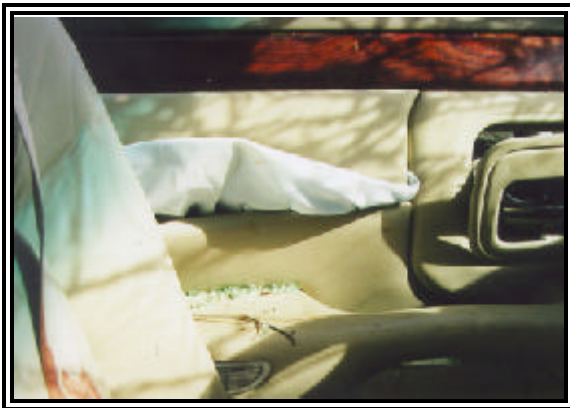
The driver seat was adjusted forward along the seat track which resulted in partial occlusion of the air bag by the seat back support. The forward vertical edge of the air bag module cover was located 21.6 cm (8.5 in) forward of the seat back support. The remaining rearward portion of the module cover was masked by the 20.3 cm (8.0 in) thick outboard aspect of the seat back support.

The left front side air bag deployed and was compressed against the outboard aspect of the driver seat back support by the intruding door surface and B-pillar. A 16.5 cm (6.5 in) portion of the air bag was longitudinally forward of the seat back support with a 8.9 cm (3.5 in) portion rearward of the seat back support. Refer to **Figures 16 and 17**. The longitudinal dimension of the air bag measured 48.3 cm (19.0 in). The lateral excursion of the air bag into the occupant space measured 7.6 cm (3.0 in), **Figure 18**. There was no evidence of occupant contact noted on the air bag.

Figure 16: View of the left side impact air bag forward of the driver seat back.

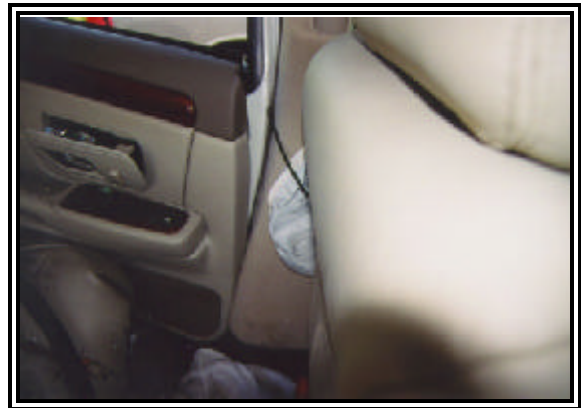
Figure 17: View of the left side impact air bag behind the driver's seat back.

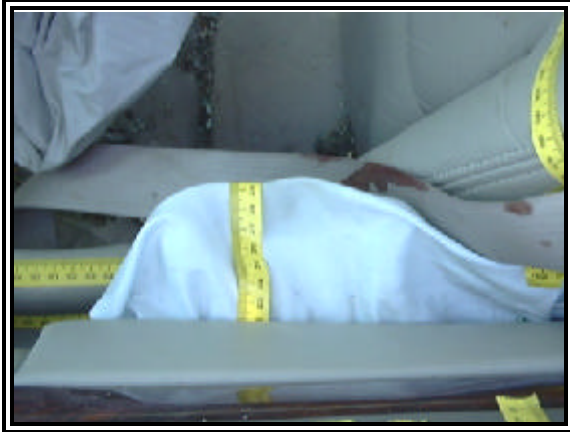
Figure 18: Top view of the lateral excursion of the left side impact air bag.

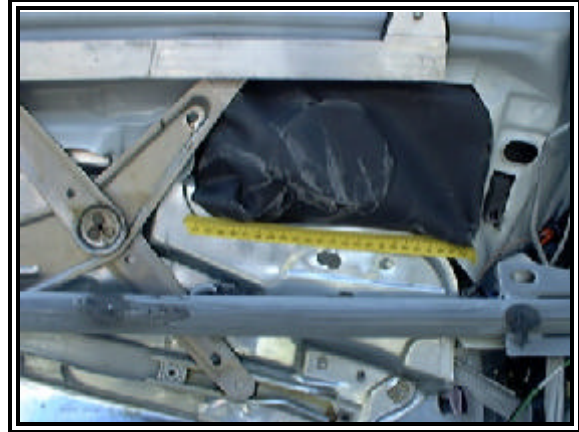
The left side impact air bag inflator unit was visible from the outside of the vehicle due to the separation of the door panel during the crash sequence, **Figure 19**. The inflator unit was a circular design which measured 8.6 cm (3.375 in) in diameter and was attached by a six bolt mounting system to the inner door panel. The identification was as follows:

Figure 19: Exterior view of the left side impact module.

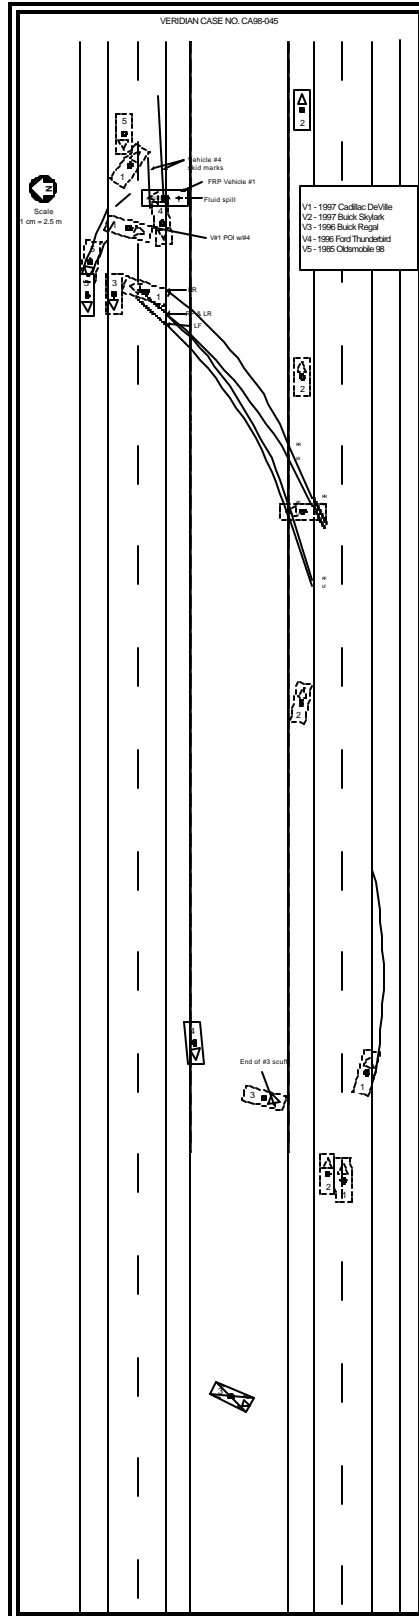
Figure 20, page 17, is a schematic depicting the crash sequence. The 1997 Cadillac DeVille was traveling eastbound in the outboard (right) travel lane driven by a 58 year old restrained female. The front right

Figure 20: Scene schematic.
