**ON-SITE AIR BAG/CHILD PASSENGER FATALITY
INVESTIGATION**

VERIDIAN ENGINEERING CASE NO. CA 98-047

VEHICLE #1 - 1995 TOYOTA COROLLA

CRASH DATE - AUGUST, 1998

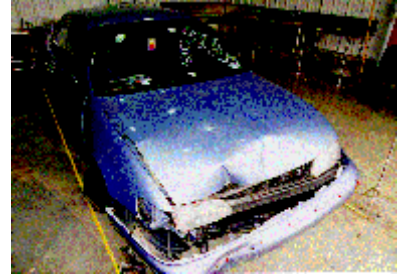
Figure 1. Frontal damage to the Toyota.

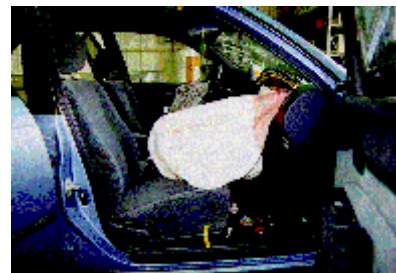
Figure 2. Profile view of front right seated position and the deployed air bag.

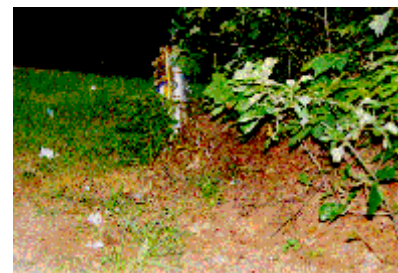
The right frontal area of the Toyota engaged the fire hydrant (12 o'clock direction of force). This impact resulted in a maximum crush to the frontal plane of 32.4 cm (12.8") located 38.7 cm (15.3") to the right of the vehicle's centerline. The top of the fire hydrant was displaced approximately 15.2 cm (6") to the northeast as a result of this impact (**Figure 6**). Shortly after the frontal engagement was initiated, the right front wheel of the Toyota struck a tree root. During this impact, the right front tire sustained an air out, the right front wheel rim was deformed, and the right wheelbase dimension was reduced 10.8 cm (4.3"). The velocity change associated with the frontal impact was estimated at 20 km/h (12 mph) using the SMASH program. This value, however, should be regarded as a minimal level estimate since the right front wheel impact could not be incorporated in the SMASH run.

Figure 6. Close-up view of the fire hydrant and tree root.

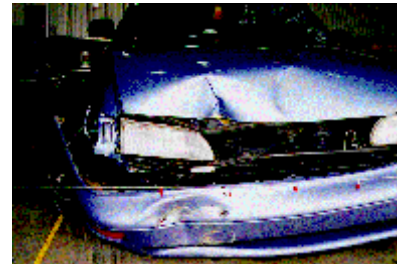
As indicated previously, components sustaining damage during this crash sequence were limited to the front bumper, grille, hood, right headlight and parking light assemblies, the right front fender, and the right front wheel and suspension components. The width of direct contact damage as a result of striking the fire hydrant was 36.5 cm (14.4"). Maximum crush within this contact pattern was 32.4 cm (12.8") located 38.7 cm (15.3") to the right of the vehicle's centerline (**Figure 8**). The width of the direct and induced damage envelope was 108 cm (42.5") as measure from the right front corner to the left. The corresponding set of crush dimensions associated with this envelope was as follows:

Figure 8. Close-up of damage from impacting fire hydrant.

Toyota Corolla Crush			
Crash Impact with fire hydrant	$C_1 = 3.3 \text{ cm (1.3")}$	$C_2 = 7.6 \text{ cm (3.0")}$	$C_3 = 14.7 \text{ cm (5.8")}$
	$C_4 = 22.4 \text{ cm (8.8")}$	$C_5 = 27.9 \text{ cm (11.0")}$	$C_6 = 16.0 \text{ cm (6.3")}$

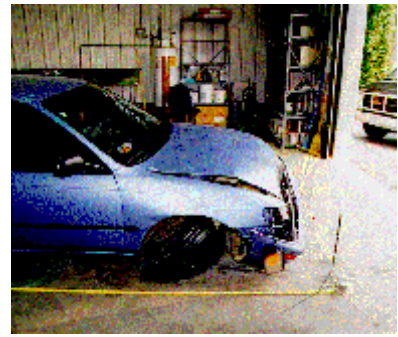
The frontal structure of the Toyota had crushed approximately 5.1 cm (2.0") when the right front wheel struck the exposed tree root (**Figure 9**). As a result of this second impact, the right front suspension strut was deformed inward and rearward, the right front tire experienced an air out, the right front wheel rim was deformed, and the right wheel base dimension was reduced 10.8 cm (4.3"). This impact added to the total delta V level experienced by the vehicle.

Figure 9. Damage to right front wheel and suspension.

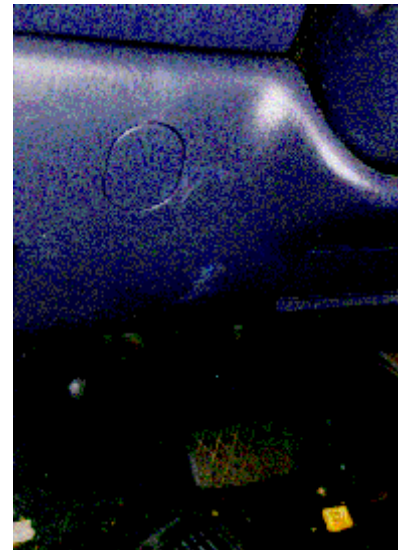
The driver's left knee and lower leg contacted the knee bolster to the left of the steering column (**Figure 10**). This contact resulted in two white colored cloth transfers to the knee bolster. The highest transfer (left knee) was 1.3 cm (0.5") by 5.1 cm (2") and located 48.3 cm (19") to the left of the vehicle centerline and 5.1 cm (2") below the top of the holster. The lower transfer (left leg) was vertically oriented transfer that was 1.9 cm (0.75") wide and 3.8 cm (1.5") high. This second transfer was located 47 cm (18.5") to the left of the vehicle centerline and 10.2 cm (4") below the top of the bolster. There was no deformation of the bolster as a result of these contacts.

Figure 10. Driver contact with knee bolster.

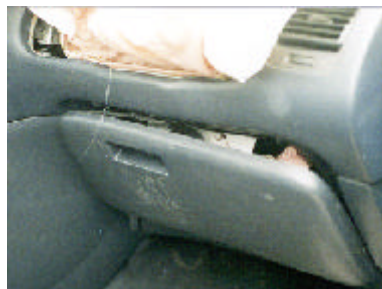
The right front male passenger moved forward during the pre-crash braking phase. At impact, he was in very close proximity to the right portion of the instrument panel. He loaded the glove box door (chest), depositing a 3.8 cm (1.5") by 6.4 cm (2.5") white colored transfer immediately below the glove box latch mechanism (**Figure 11**). This transfer was located 30.5 cm (12.0") to the right of the vehicle centerline and 12.7 cm (5.0") below the bottom edge of the air bag module cover flap. He also loaded the glove box latch mechanism which broke and separated from the glove box door.

Figure 11. Passenger contact with the glove compartment door.

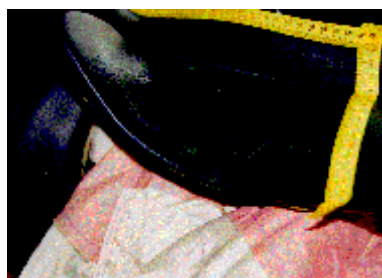
As the right front air bag deployed, the module cover flap contacted the upper chest, anterior neck, and chin of the right front passenger (**Figure 12**). This contact resulted in a tissue/body fluid transfer to the flap which was 12.7 cm (5.0") wide and extended across the full height of the flap. The left edge of the transfer was located 5.7 cm (2.3") inboard of the left edge of the flap. The contact resulted in a permanent 7.6 cm (3.0") deformation of the flap (e.g., ends of flap were curved upward 7.6 cm (3.0") from the contact area).

Figure 12. Passenger contact with air bag module cover flap.

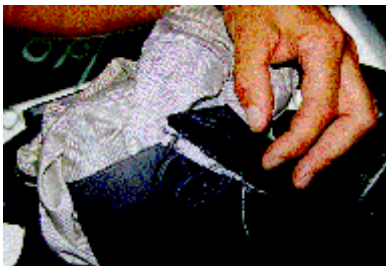
Figure 13. View of the module flaps for the front left driver air bag.

The tear then extended up and to the left, intersecting the left edge of the upper flap approximately 3.8 cm (1.5") below the top of the flap. As shown in **Figure 13**, a piece of the flap which abutted against this tear line was found in the vehicle. The lower portion of this piece had the same white colored cloth transfer as was noted on the lower deployment flap. The lower left corner of the upper flap was not found during the vehicle

examination. Based on the pattern of the cloth transfer on the piece shown in **Figure 13**, however, it was assumed that the cloth transfer extended onto the piece of the flap (lower left corner) that was missing.

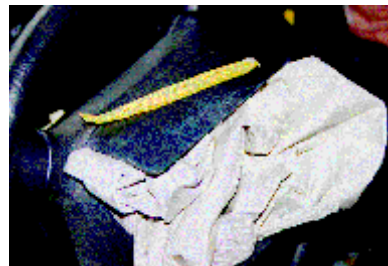
Figure 14. Lower flap of driver's air bag module.

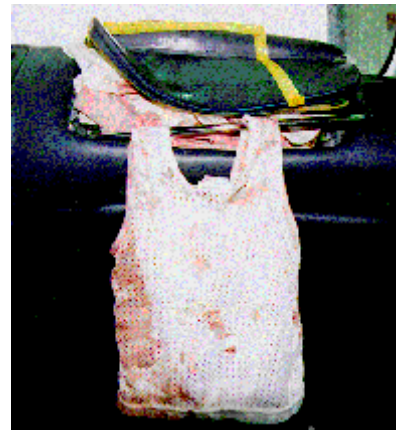
The front right passenger was located in very close proximity to the front right air bag module cover flap when deployment occurred. He loaded the right glove box area with his chest and was then struck by the deploying module cover flap in his upper chest, anterior neck, and chin areas. The center area of the cover flap was held by the chin contact as the ends of the flap continued upward, in effect, molding around the passenger's face. The left end of the flap struck his left maxillary (cheek) area and the right end of the flap struck his right maxillary (cheek) area. As a result of this contact, the cover flap sustained a permanent bow which was approximately 7.6 cm (3.0") deep. A tissue/body fluid transfer was noted to the center area of the flap. This contact was 12.7 cm (5.0") wide and extended across the full height of the flap. The left edge of the transfer was located 5.7 cm (2.3") inboard of the left edge of the flap (**Figure 15**).

Figure 15. Shirt worn by passenger (back view).
