CALSPAN REMOTE AIR BAG DEPLOYMENT INVESTIGATION

CALSPAN CASE NO. CA98-054

VEHICLE #1 - 1990 CHRYSLER LEBARON

LOCATION - STATE OF VIRGINIA

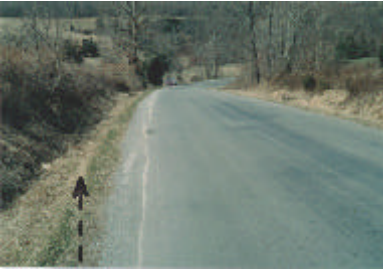
Upon exiting the left curve, the vehicle crossed over into the oncoming lane and departed the left side of the roadway at a police determined departure angle of 4 degrees. The roadway at this point had a police measured -9.4 percent slope. The driver apparently initiated a right steer avoidance maneuver and re-entered the roadway at an 8 degree angle (**refer to Figures 1&2**). From the tire marks noted along the shoulder, the vehicle was in a clockwise yaw as it re-entered the roadway.

Figure 1 View of the vehicle's trajectory at the point of the first departure

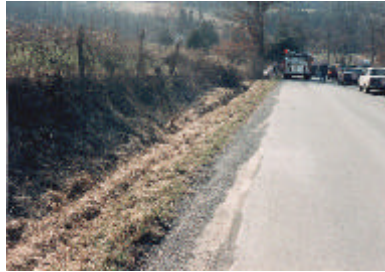
Figure 2 View of the vehicle's roadway re-entry

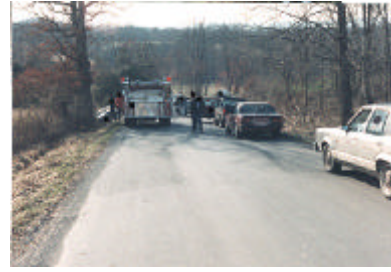
Figure 3 View of the vehicle's trajectory from the re-entry showing the oversteer to the left leading to the second departure

The vehicle was proceeding back across the roadway when the driver apparently oversteered to the left. The vehicle subsequently reversed the rotational pattern to a counterclockwise yaw as noted by the heavy tire scuff/skid marks noted in police scene photographs (**refer to Figures 3&4**).

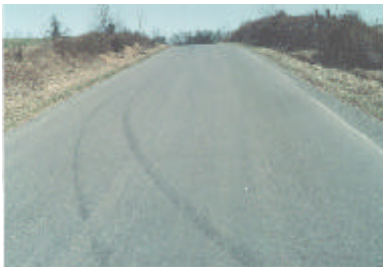
Figure 4 Reverse trajectory showing the counterclockwise scuff marks prior to the second roadway departure

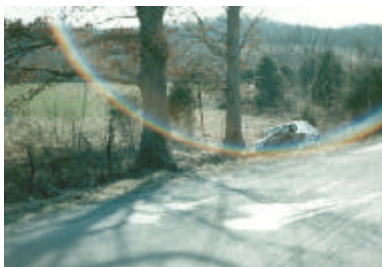
As the vehicle departed the left side of the roadway a second time, the driver appeared to again countersteer to the right as the lateral gap between the right front and right rear tire pattern appeared to narrow (**refer to Figures 5&6**). The left front bumper of the vehicle contacted a large tree resulting in an estimated Collision Deformation Code (CDC) of 12-FLEE-2 with a WinSMASH computed delta V of 28.0 km/h (17.4 mph). The vehicle rotated counterclockwise 145 degrees where it came to the final rest position (FRP) on the roadside parallel to the roadway edge and 11 m (36') beyond the tree (**refer to the police scene diagram in Figure 7**).

Figure 5 View showing the vehicles's counterclockwise rotation prior to the second roadway departure

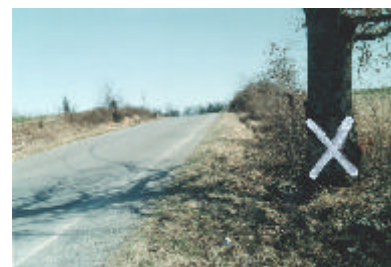
Figure 6 Reverse view illustrating the vehicle's heading at the point of impact with the 73.7 cm diameter tree and the roadway profile prior to the crash

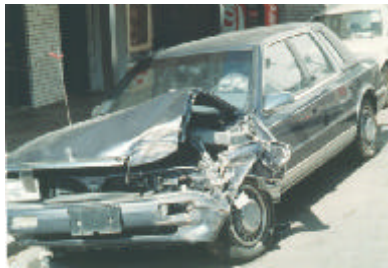
The 1990 Chrysler LeBaron was equipped with a front left driver air bag which deployed as the result of the impact with a large tree measured by police at 73.7 cm (29.0") in diameter. Exterior damage to the vehicle involved the front bumper, left parking light, left headlight assembly, grille, hood, left front fender, and left front wheel. The 43.2 cm (17.0") contact pattern began at the left front bumper corner and extended to just inboard of the left front parking light. The contact appeared to continue along the surface of the left front fender and ending forward of the left front axle. The left front axle was displaced rearward 7.1 cm (2.8"). The windshield was cracked along the left side which was attributed to impact forces and not occupant contact. The CDC was **12FLEW2**.

Figure 8 Corner view of the vehicle showing the area of direct contact damage at the left front corner

Crush values in the following table were determined from police documentation and photographs(**refer to Figures 8 &9**).

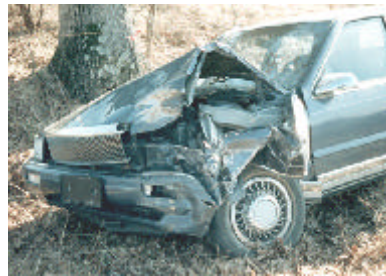
Figure 9 Lateral view of the vehicle while at the scene showing the longitudinal crush pattern and the displacement of the left front axle

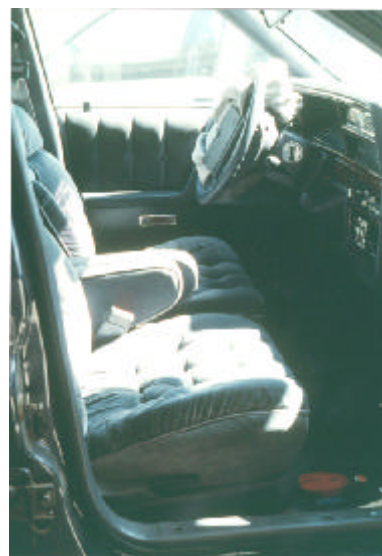
The front interior area of the 1990 Chrysler LeBaron (from the limited view provided by police photographs) revealed limited visible/discernable damage from driver contact. The lower portion of the steering wheel rim appeared to be deformed forward an estimated distance of 0.6 cm (0.25"). This was attributed to driver contact during the impact sequence. The steering wheel according to police was adjusted one notch up from the full down position (**refer to Figure 10**).

The front seat was design as a split bench with fold down center armrests. The armrest were in the down position as shown in **Figure 10**. The police investigative report indicated that the driver's seat was in

a full forward position at the time of the crash with the rear portion of the seat cushion located 49.5 cm (19.5") rearward from the steering wheel. In **Figure 10**, the driver's seat appeared to be forward of the right front seat an estimated distance of 5 cm (2").

The driver side manual restraint belt was a continuous loop lap and shoulder belt design. The belt was intact and fully retracted as shown in **Figure 10**.

Figure 10 Lateral view of the vehicle interior taken from the right side illustrating the relative seat track positions, the steering wheel adjustment, the air bag, and the restraint belt
