THREE-VEHICLE SCHOOL BUS CRASH INVESTIGATION

VERIDIAN CASE NO. CA98-061

LOCATION: NEW YORK

CRASH DATE: NOVEMBER, 1998

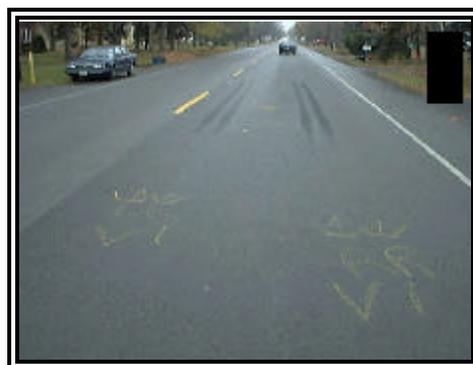
Figure 1: Westbound trajectory view of the crash scene.

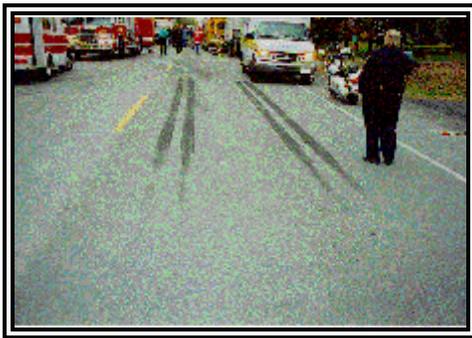
estimated he was traveling approximately 56 km/h (35 mph). When he returned his concentration to the roadway, he observed the stopped Isuzu truck, applied counterclockwise steer and immediately applied the brakes. The rear tires of the bus locked and the vehicle skidded approximately 1.9 m (6.2 ft) where it struck the rear of the Isuzu in a 12/6 o'clock impact configuration. The point of impact was identified by a series of gouge marks attributed to contact from the rear lift gate of the truck.

Figure 2: Westward trajectory view of the 1994 International bus.

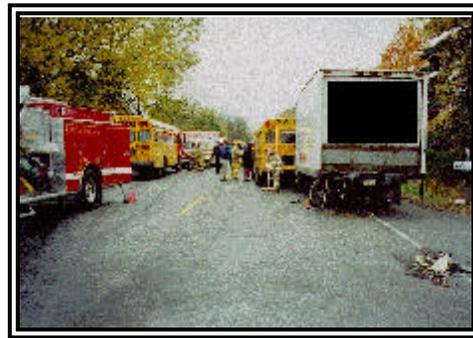
The International continued skidding westward and pushed the truck forward, approximately 10.3 m (33.8 ft), where the front of the truck struck the rear of the Ford mini-bus in a secondary 12/6 o'clock impact. This secondary impact displaced the Ford mini bus and the Isuzu forward and the vehicles came to rest in the westbound lane of the road approximately 12.8 m (42 ft) from the point of the secondary impact. After the second impact, the driver of the International school bus released the brakes and drove the bus to a controlled stop on the eastbound shoulder of the roadway. Inspection of the scene identified a total skid distance of 17.3 m (56.7 ft) of attributed to the rear tires of the International bus. **Figures 2 and 3** are westward views of the crash scene taken during the police investigation. **Figure 4** is a schematic of the crash scene.

Figure 3: Westward view of the vehicles at final rest.

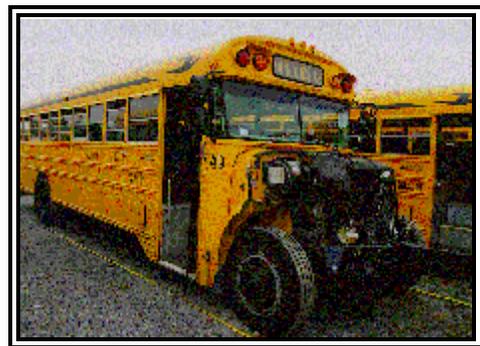
Figure 5: Left front three-quarter view of the International bus.

The vehicle sustained 201 cm (79 in) of direct contact across the entire width of the frontal plane. The maximum crush was 50.2 cm (19.75 in) and was located 8.9 cm (3.5 in) left of vehicle centerline. The maximum crush occurred at the unsupported center section of the front bumper and was resultant to direct contact with the bed frame of the Isuzu truck. The hood fractured in the impact and was removed prior to SCI inspection. The radiator was damaged and displaced rearward due to the direct contact with the truck bed. The bus's engine and transmission shifted rearward and down and the drive shaft buckled. The right wheelbase was foreshortened 7.6 cm (3.0 in). The left wheelbase dimension was unchanged.

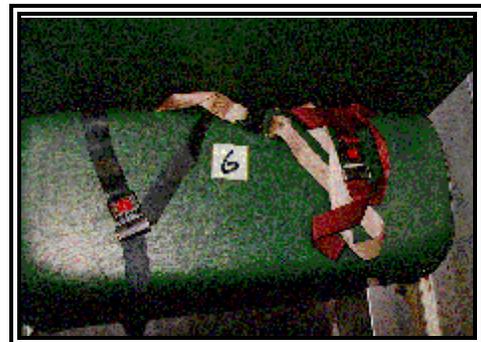
Each seat was equipped with three sets of Type 1 lap belts, except the left seat in row 11 which was equipped with two belts. The belts were color coded and configured as follows: red outboard, tan center and black inboard. **Figure 8** is a view of the typical belt condition found during the inspection. Examination of the restraints revealed that 61 of the 65 lap belts were buckled and could not have been used in the crash. Three of the belts were tucked between the side wall and the seat, not readily available. Further, 49 of the 65 belts were improperly adjusted, either the latch plate adjustment was too short or too long to provide a means of proper restraint. In his

Figure 8: View of the typical condition of the lap belts.

interview with the police, the driver indicated it was his daily practice to latch the belts together, thus making sure the seat belts were available for the students. However, this practice may have been a disservice to the passengers in that the passengers were more likely to sit on the belts rather than unbuckle, adjust and re-buckle. SCI and police investigations determined that none of the students on-board the bus were restrained in the crash. The driver indicated that the students were not restrained as well. Further it was not their practice to wear the seat belts.

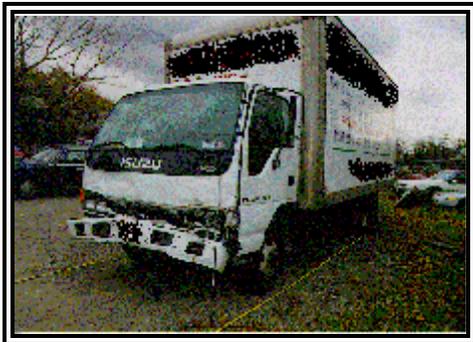
The truck sustained 191.8 cm (75.5 in) of direct contact damage along the rear edge of the platform, **Figure 10**, as a result of the impact from the International full size bus (Vehicle 1). The direct damage began 72.4 cm (28.5 in) right of center and extended to the left corner. The maximum crush measured 14.0 cm (5.5 in) and was located 72.4 cm (28.5 in) left of center. The crash forces deformed the 2 dock guards located left of center and displaced the step platform attached to the end of the guards, refer to Figure 9.

The 6 o'clock direction of the impact displaced the Isuzu forward into the back plane of the van-based bus (Vehicle 3). The Isuzu's front plane sustained direct contact damage across its full 175 cm (69 in) frontal width. The measured crush profile was as follows: C1=34.3 cm (13.5 in), C2=10.7 cm (4.2 in), C3=6.4 cm (2.5 in), C4=12.7 cm (5.0 in), C5=3.0 cm (1.2 in), C6=2.3 cm (0.9 in). The damaged components included: the front bumper, grille, hood and head lamps.

Figure 9: Left front three-quarter view of the Isuzu.

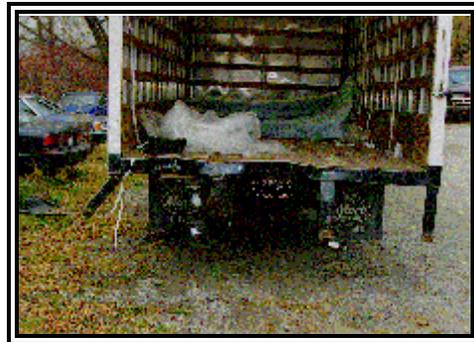
Figure 10: Rear view of the Isuzu.

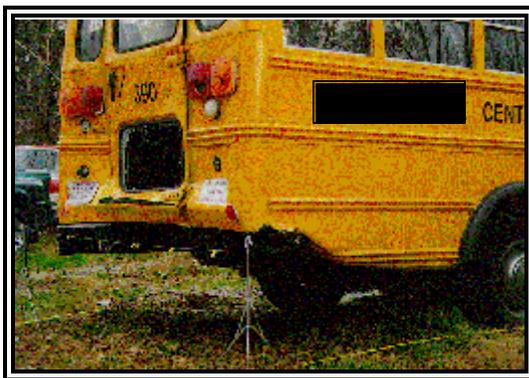
Figure 12: Right rear three-quarter view of the damaged back plane.

The Ford sustained direct contact damage across the entire 188 cm (74 in) rearend width of the vehicle, **Figure 12**. The Collision Deformation Classification (CDC) for the impact with the Isuzu truck was 6-BDEW-3. The measured crush profile was as follows: C1=2.8 cm (1.1 in), C2=9.4 cm (3.7 in), C3=29.7 cm (11.7 in), C4=24.1 cm (9.5 in), C5=23.4 cm (9.2 in), C6=24.1 cm (9.5 in). The maximum deformation measured 30.5 cm (12.0 in) and was located 7.4 cm (2.9 in) left of the vehicle centerline. The force of the impact deformed and foreshortened the right frame rail 4.6 cm (1.8 in).

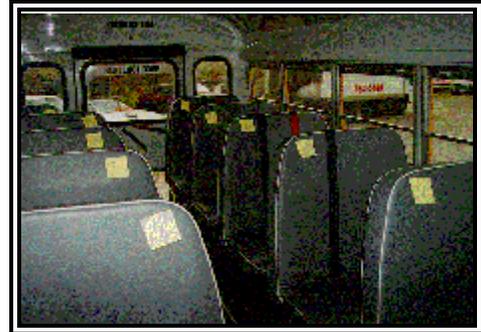
Figure 13: Interior seat configuration of the Ford mini-bus.

Each seat was equipped with two sets of Type 1 lap belts, except the right seat in row 5 which was equipped with 1 belt. The belts were color coded and configured with the outboard belt red and the inboard belt black. Inspection of the restraints indicated that none of the seat belts were in use at the time of the crash. Examination revealed that the sliding latch plates of all 19 lap belts were at the maximum adjustment. This manner of adjustment would have been inappropriate for use by students. Referring to Figure 13, some of the belts were found slung over the seat backs at inspection. The balance of the belts were tucked between the seat cushion and seat back or trapped between the cushion and side wall. The driver of the bus reported that none of the passengers were restrained.

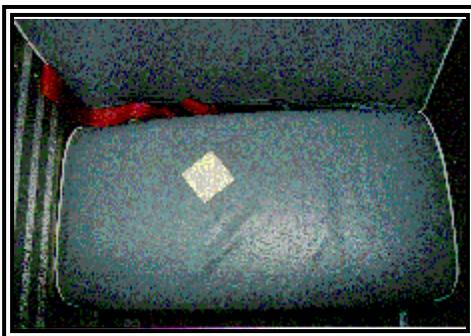
An adult monitor and three students were on-board the van-based school bus at the time of the crash. The monitor was a 37 year old female with a reported height and weight of 165 cm (65 in) and 75 kg (165 lb). She was seated on the right side of the bus in the first row. She was facing forward in a normal posture. At impact, she responded to the 6 o'clock direction of force by initiating a rearward trajectory and loaded the seat back. Her head/neck was above the level of the seat back and extended rearward. She reportedly hit her head on the right side wall and/or glazing. She then rebounded without further contact. Inspection of the seat revealed approximately 6.0 cm (2.4 in) of deformation along the lower aspect of the seat back, at the juncture with the seat cushion, **Figure 14**. The deformation was located 18 cm (7.0 in) from the right side wall of the bus. This deformation occurred as a direct result of occupant loading.

Figure 14: View of the deformed seat back - Row 1 right side.
