REMOTE AIR BAG NON-DEPLOYMENT INVESTIGATION

VERIDIAN CASE NO. CA98-062

VEHICLE - 1996 FORD CROWN VICTORIA (POLICE CRUISER)

LOCATION - WASHINGTON D.C.

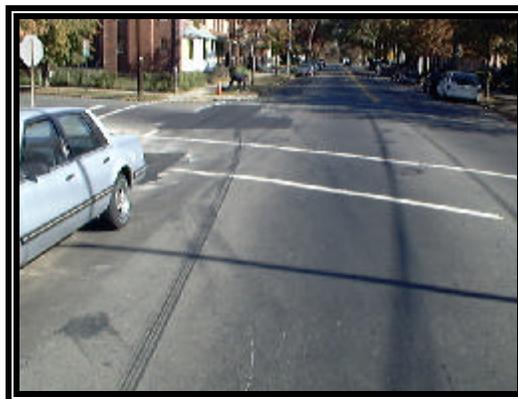
This two vehicle/fixed object crash occurred in the afternoon hours of October 1998. At the time of the crash, it was daylight and the weather was not a factor. The asphalt road surface was dry. The crash occurred at the 4-leg intersection of a northeast/southwest two lane roadway and a north/south two lane roadway. The intersection was controlled by stop signs for the north/south traffic. **Figure 1** is a northeast trajectory view of the Ford. The police investigation identified 41 m (136 ft) of pre-crash tire marks attributed to the police vehicle. The 1996 Ford Crown Victoria struck the frangible base supporting a breakaway pole located in the northeast quadrant of the intersection. The impact partially fractured the frangible base and it was removed prior to the scene inspection. The pole was located at the traffic cone in the background of Figure 1. The speed limit in the area of the crash was 40 km/h (25 mph).

Figure 1: Trajectory view of the Ford.

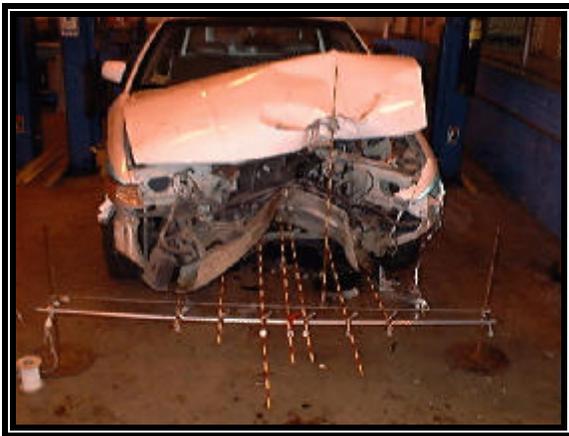
Figures 2 and 3 are the front and left lateral views of the Ford Crown Victoria taken during the inspection. The vehicle's front plane sustained 36 cm (14 in) of direct contact damage that began 8 cm (3 in) right of the vehicle's centerline and extended to the left. The measured crush profile was as follows: C1=38.1 cm (15.0 in), C2=72.4 cm (28.5 in), C3=80.0 cm (31.5 cm), C4=54.6 cm (21.5 in), C5=27.9 cm (11.0 in), C6=8.0 cm (3.0 in). The field L used in this profile was 88.0 cm (34.6 in). The maximum crush measured 86.5 cm (34.0 in) and was located 3.6 cm (1.4 in) right of centerline. The left and right side wheelbases were foreshortened approximately 13 cm (5 in) and 5 cm (2 in), respectively. The CDC was 12-FYEN-3. The barrier model of the WINSMASH program calculated a damaged based delta V of 34.9 km/h (21.7 mph). Technical representatives from Ford indicated the must fire deployment threshold's for the Supplemental Restraint System in the 1996 Ford Crown Victoria were 14 mph barrier/17 mph pole.

Figure 2: Front view of the 1996 Ford Crown Victoria.

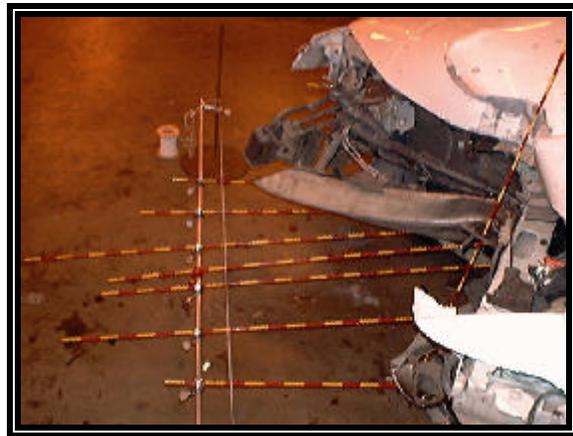
Figure 3: Left lateral view across the Ford's front plane.

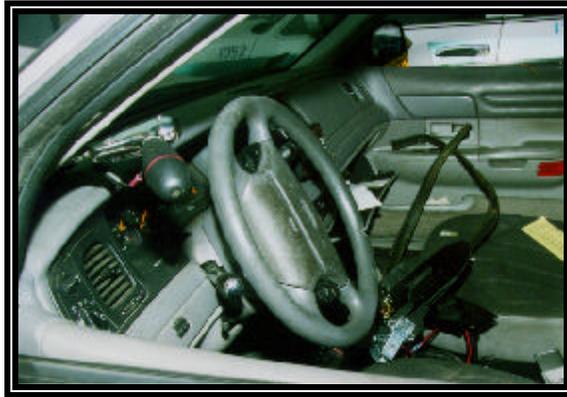
In an effort to determine the cause of the non-deployment, technical representatives from Ford performed a diagnostic test of the Supplemental Restraint System. The fault codes stored in the system's diagnostic module were read as a flash sequence from the air bag indicator light mounted in the instrument cluster. The results of the diagnostic test revealed that the only stored active code was Code 52 - internal thermal fuse open. This open circuit prevented the deployment of the SRS at the time of the crash. The root cause of the open fuse was not determined. The police department reported that a review of the vehicle's history indicated the SRS had not required service. Further, to their knowledge the indicator light was not illuminated at the time of the crash.

The Ford Crown Victoria was driven by a 33 year old unrestrained female. She was seated in a mid to forward track position at the time of the crash. Upon impact with the pole, the unrestrained driver initiated a forward trajectory in response to the 12 o'clock direction of the impact. Her left knee contacted and loaded the knee bolster. The bolster reportedly deformed from this contact. Her right hip contacted the center console. This contact displaced the radio units mounted to this region. The driver reportedly sustained a fracture of the upper femur as a result of this contact. The driver's chest loaded and compressed the energy absorbing steering column. Approximately 2.5 cm (1.0 in) of compression was noted during the inspection, refer to **Figure 4**. The driver was subsequently removed from the vehicle, transported and admitted to a local hospital for treatment of her injury.

Figure 4: View of the non-deployed SRS and compressed steering column.
