**VERIDIAN ON-SITE AIR BAG RELATED
CHILD SERIOUS INJURY INVESTIGATION
VERIDIAN CASE NO. CA98-065
VEHICLE: 1996 TOYOTA COROLLA
LOCATION: FLORIDA
CRASH DATE: NOVEMBER 1998**

Contract No.
DTNH22-94-D-07058

**VERIDIAN ON-SITE AIR BAG RELATED
CHILD PASSENGER SERIOUS INJURY INVESTIGATION
VERIDIAN CASE NO. CA98-065
VEHICLE - 1996 TOYOTA COROLLA
LOCATION - FLORIDA
CRASH DATE - NOVEMBER 1998**

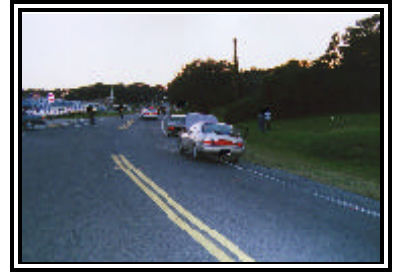
Figure 1 is an on-scene view of the crash site. The improperly restrained child passenger of the Toyota was displaced forward by pre-crash braking, into the path of the deploying front right air bag. The child's involvement with the deploying air bag membrane resulted in a closed head injury with brief loss of consciousness, cervical strain, abrasions of the scalp, face, chin, anterior neck, and a right brachial plexus injury. Her loading of the improperly placed shoulder belt webbing resulted in soft tissue injuries of the chest, and a right pulmonary contusion. She was transported by helicopter to a regional pediatric trauma center where she was admitted for treatment for a period of six days. Her parents discharged her from the hospital against the directives of the attending physicians.

Figure 1. On-scene view of the involved vehicles at final rest.

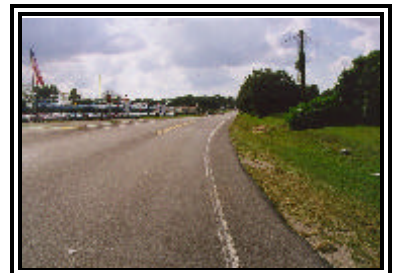
The crash occurred on a two lane, north/south state route near a three-leg T intersection (**Figure 2**). In the vicinity of the crash site, the asphalt road surface was level and curved to the right, with respect to the involved vehicle's direction of travel. The radius of curvature was calculated at 136.2 m (446.8'). The travel lanes were 3.8 m (12.5') and 3.6 m (11.8') in width for the south and northbound lanes respectively. The travel lanes were bordered by asphalt shoulders that were 1.2 m (3.9') in width with grass bordering both shoulders. At the

Figure 2. Crash site in the area of impact.

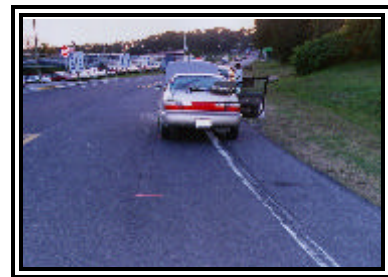
The driver of the Toyota Corolla steered to the right, while applying full brakes in an attempt to avoid the crash. The Toyota skidded 8 m (26') in a tracking mode (**Figure 3**) on the dry asphalt road surface to impact with the rear of the Chevrolet. It should be noted that the crash occurred to the right of the southbound travel lane, therefore it was unknown if the driver of the Chevrolet attempted to steer right to avoid the impending crash or if she was driving to the right of the travel lane. The crash schematic is attached as **Figure 15**, Page 13.

Figure 3. Pre-crash skid marks of the Toyota.

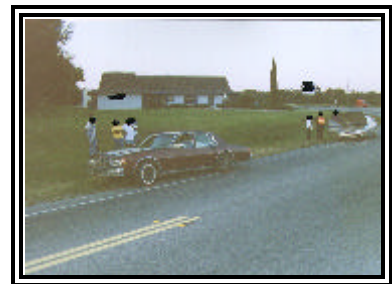
The full frontal area of the Toyota impacted the rear of the Chevrolet Impala in a 12/6 o'clock impact configuration. The damage and trajectory algorithm of the WinSMASH program computed impact speeds of 32.5 km/h (20.2 mph) for the Toyota Corolla and 2.1 km/h (1.3 mph) for the Chevrolet. The Chevrolet was accelerated to match the speed of the striking Toyota. As the Toyota crushed and decelerated due to continuous braking by the driver, the vehicles separated. The damage output from the WinSMASH reconstruction program indicated that the Toyota Corolla sustained a total delta V of 21.3 km/h (13.2 mph) while the Chevrolet Impala experienced a 11.5 km/h (7.1 mph). The longitudinal components were -21.3 km/h (-13.2 mph) and 11.5 km/h (7.1 mph) respectively. The delta V values were consistent with the crush profiles of both vehicles. The Impala was displaced forward and came to rest approximately 15 m (49') south of the point of impact, straddling the right asphalt shoulder and the adjacent grassy area (**Figure 4**). The position of the Impala indicated that the driver may have steered to the right after the impact, or had the wheels turned to the right prior to impact. The Toyota Corolla continued approximately 3 m (10') forward before coming to rest straddling the west (right) edgeline.

Figure 4. Final rest of the involved vehicles.

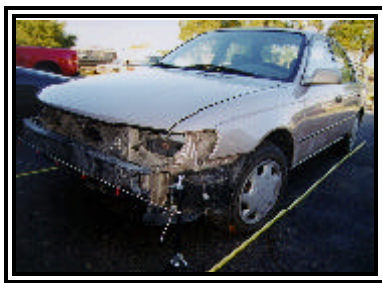
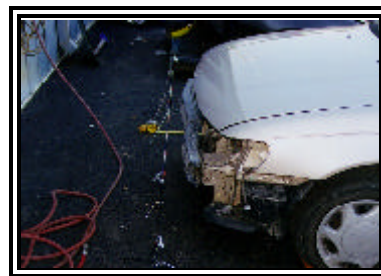
The Toyota Corolla sustained moderate frontal damage as a result of its impact with the rear of the 1978 Chevrolet Impala. Maximum crush was 6.4 cm (2.5") located 11.4 cm (4.5") left of the vehicle centerline. The direct contact damage length was 127 cm (50") that was distributed across the entire width of the front

bumper fascia. This damage involved abrasions to the bumper fascia. The underlying bumper reinforcement bar was minimally crushed, however, this damage was concealed by the bumper fascia. The fascia was removed and a crush profile was documented at the level of the reinforcement bar. The crush profile is documented in the following table:

The Collision Deformation Classification (CDC) for the frontal damage to the 1996 Toyota Corolla was 12-FDEW-1. **Figures 5 and 6** are exterior views of the Toyota Corolla.

Figure 5. Front left view of the exterior damage to the Toyota.

Figure 6. Profile view documenting the extent of frontal crush.

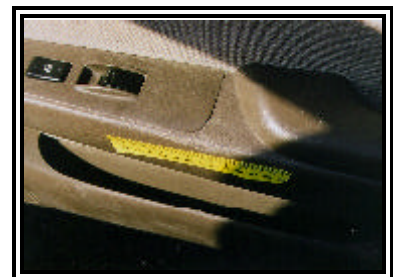
Figure 7. Tissue transfer to the right door armrest.

The right door armrest exhibited a tissue transfer along the upper edge that was attributed to contact by the front right child passenger during the crash event. The tissue transfer measured 8.9 cm (3.5") in length and was located 20.3 cm (8.0") rearward of the instrument panel (**Figure 7**).

The child's right arm subsequently contacted the top surface of the right door armrest which produced a tissue transfer to the armrest and an abrasion over the elbow area. She then rebounded rearward against the seat back support and came to rest with her hips forward on the seat cushion and her back leaning rearward with her head and shoulder against the seat back support. The driver initially held the child upright on the seat cushion and unbuckled the manual belt system.

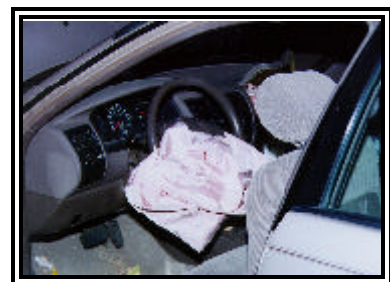
The 1996 Toyota Corolla was equipped with front air bags for the driver and right passenger positions that deployed during the crash sequence (**Figure 8**). The front left driver air bag was mounted in a typical configuration within the four-spoke steering wheel with H-configuration module cover flaps. The cover flaps opened at the designated tear points. The upper flap measured 7.6 cm (3.0") vertically while the lower flap measured 7.0 cm (2.75"). The width of the flaps measured 15.2 cm (6.0") at the horizontal tear seam. There were no apparent occupant contact points or damage to the cover flaps.

Figure 8. On-scene image of the deployed frontal air bag system

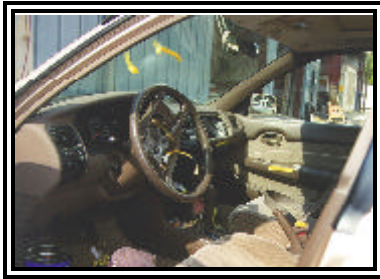
There was a circular pattern of air bag generant residue on the left side of the windshield that resulted from the exhaust gases from the front left

driver air bag. The pattern measured 8.9 cm (3.5") in diameter and was located 15.2 cm (6.0") left of the vehicle centerline and 12.7 cm (5.0") above the instrument panel.

Figure 9. Driver position with air bag generant on windshield.

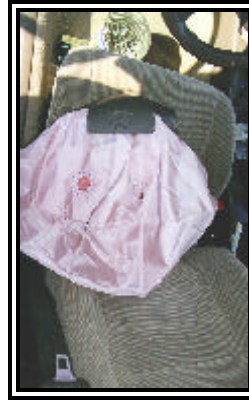
Figure 10. Cover flap and vent ports of the driver air bag.

The front left air bag was removed from the steering wheel by the body shop prior to this on-site investigation. The air bag membrane was constructed of a woven nylon-type fabric and measured 67.9 cm (26.5") in diameter in its deflated state. The bag was tethered internally by four tethers that were stitched to the face of the bag with a 19.7 cm (7.75") tether reinforcement. The bag was vented by two vent ports that measured 3.2 cm (1.25") in diameter and were located 15.9 cm (6.25") apart (**Figure 10**).

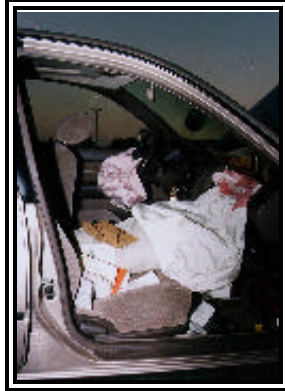
The front right air bag was a mid mount design (**Figure 11**) which had a single air bag module cover flap that opened in an upward motion. The module cover measured 34.3 cm (13.5") along the lateral seam line, 12.1 cm (4.75") along the left vertical seam, 10.8 cm (4.25") along the right seam, and 35.6 cm (14.0") along the hinged side. It measured 1.4 cm (9/16") thick and was comprised of a high density foam over a sheet metal backing plate. The cover was deformed in a curved shape. The cover flap was deformed with the left leading edge 7.6 cm (3.0") below the right leading edge and the center located 8.9 cm (3.5") below the right leading edge (**Figure 12**). This deflection was not attributed to child passenger contact. It probably resulted from bag expansion as the forward positioned child passenger interacted with the expansion of the bag, thus altering its deployment path. There were a series of four light vertical scrapes on the cover surface in the area of the lower left corner which measured 11.4 cm (4.5") laterally and 3.8 cm (1.5") vertically. These marks were not attributed to any occupant injuries and were considered the result of module removal from the instrument panel during collision repair.

Figure 11. Deployed front right air bag.

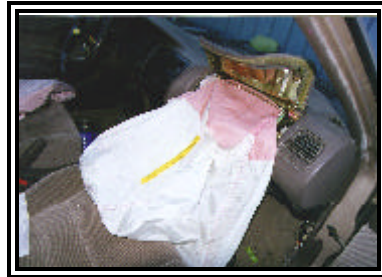
Figure 12. Deformed module cover flap.

The longitudinal excursion of the front right air bag measured 54.6 cm (21.5") from the air bag inflator unit (**Figure 12**).

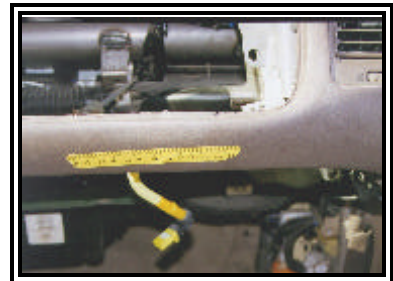
The front right passenger air bag exhibited tissue transfers along the inboard surface of the air bag. The transfer measured 19.7 cm (7.75") in length and 6.4 cm (2.5") in width. It was located 22.9 cm (9.0") rearward of the inflator unit. These transfers were attributed to contact with the right front occupant's face and neck during the expansion of the air bag. There was an air bag membrane transfer on the right instrument panel located immediately below the module location. The transfer measured 8.9 cm (3.5") laterally and 1.9 cm (0.75") vertically and began 35.6 cm (14.0") right of the vehicle centerline (**Figure 13**).

Figure 13. Membrane transfer to the mid instrument panel.

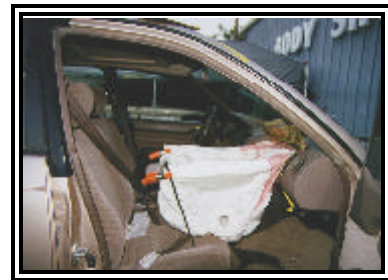
Figure 14. Excursion of the front right air bag.

The expanding right front (**Figure 14**) air bag initially contacted the child's right arm resulting in an abrasion of the anterior aspect of the forearm. The expanding air bag displaced the arm rapidly in an upward, rotational motion that resulted in a right glenohumeral joint separation and a right brachial plexus injury. The front right air bag contacted her upper chest, facial, neck, and scalp regions which resulted in multiple soft tissue abrasions and a closed head injury with concussion and brief loss of consciousness. It should be noted that these abrasions wrapped beyond the right ear which indicated the child's head was probably turned to the left at impact. Air bag expansion deflected the child's head in a rearward direction that resulted in cervical strain. The face/head contact by the expanding air bag, in combination with the head
