CASE NO. CA98-066

ELECTRIC POWERED VEHICLE CRASH

1998 FORD ELECTRIC RANGER PICKUP TRUCK

ON-SITE INVESTIGATION

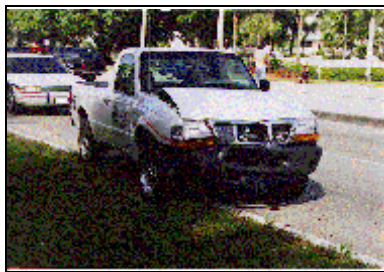
The frontal plane of the Ford Electric Ranger struck the rear of the Buick Century in a 60 percent right offset configuration which began at the right front bumper corner and extended 91.0 cm (35.8") to the left (**Figures 2 and 3**). The Collision Classification Code (CDC) was 12-FZEW-1 for the Ford and 06-BDEW-6 for the Buick. The output from the WinSMASH speed reconstruction program indicated that the Ford sustained a total delta V of 27.7 km/h (17.2 mph) while the Buick experienced a 41.7 km/h (25.9 mph) delta V. The delta V values, however, did not appear to be representative of the vehicle crush profiles. The barrier equivalent values generated by WinSMASH were considered more in-line with delta Vs experienced in the crash. The barrier equivalent delta V for the Ford was computed at 15.4 km/h (9.6 mph) while the Buick experienced a 50.3 km/h (31.3 mph).

Figure 2- On-scene view of the frontal damage to the Ford EV

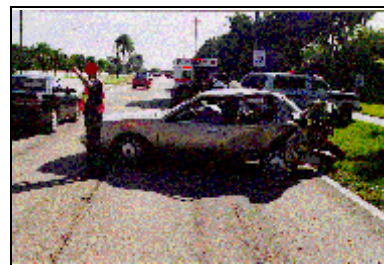
Figure 3- On-scene view of the rear plane damage to the Buick

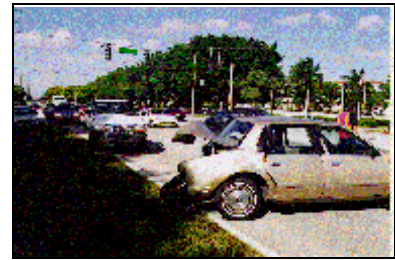
The impact speed of the Ford was computed by the trajectory algorithm of WinSMASH as 53.8 km/h (33.4 mph). This was consistent with the post impact travel distance and the degree of damage to both vehicles. The Ford came to the final rest position (FRP) 5 m (16') from the point of impact (POI) and rotated 5 degrees clockwise from its impact heading angle. The left tires remained on the roadway while the right side tires were on the adjacent grass shoulder. The Buick rotated 78 degrees counterclockwise and traveled 11.6 m (38.1') from POI to the FRP. It came to rest broadside to its original travel lane (**Figure 4**).

Figure 4- On-scene lookback view of the Ford's and Buick's final rest position

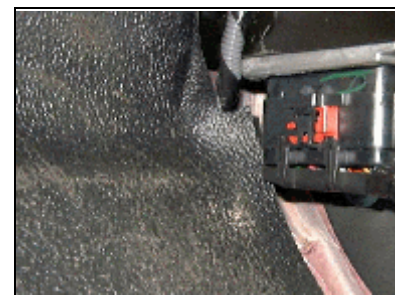
The collision shop representative drove the vehicle to the mechanical repair side of the dealership so that it could be placed on a lift for this investigation. The mechanical technician indicated that the vehicle was equipped with an inertia shut-off-switch which may have been tripped during the crash. The reset switch was located behind the right kick panel and was designed to be reactivated by pressing a red color button (**Figure 5**).

Figure 5- View of inertia shut-off switch located behind the right kick panel

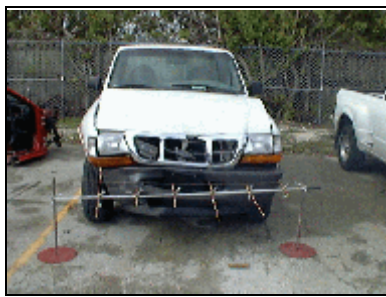
Figure 7- View showing damage to the frontal plane of the Ford

The maximum crush of 22.0 cm (8.7") was located at the right bumper corner. The crush profile obtained along the front bumper and upper radiator support is listed in the following table:

The Collision Deformation Classification (CDC) coding scheme for the Ford was 12-FZEW-1. The direct damage began at the right front bumper and extended 91.0 cm (35.8") to the left.

The recharging connector panel located in the right front section of the front grille panel was designed to blend in with the grille design. To accommodate this device in this location, however, the right crash sensor for the supplemental restraint system (SRS) was moved 17.8 cm (7.0") below its OEM position on the panel behind the grille. In this position, the leading surface of the crash sensor was coincidentally aligned with the top edge of the front bumper. During the crash, the front bumper moved rearward and contacted the crash sensor

housing resulting in a minor indentation which extended 4.1 cm (1.625") laterally across the face of the housing (**Figure 7**).

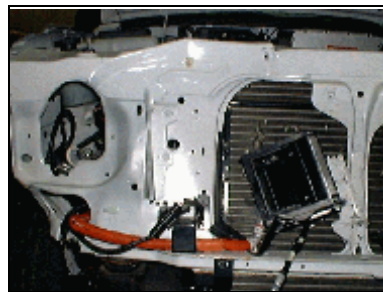
Exterior damage to the vehicle involved the front bumper, the grille, the recharging connector panel located in the right grille, the hood, right turn head light/turn signal assembly, and right front fender (**Figure 7**). Although the housing for the recharging connector panel was damaged, the wires remained intact (**Figure 8**).

Figure 8- View of the recharging connector panel and associated wiring, and right SRS crash sensor

The recharging connector panel located in the front right section of the front grille panel was displaced during the crash as the result of direct contact damage. Although the housing for the connector panel was damaged, the wires remained intact.

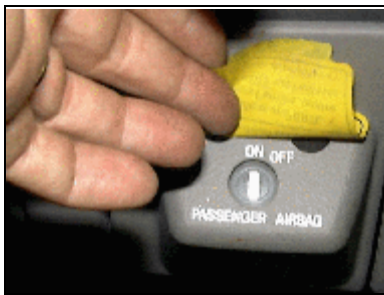
The front right air bag was equipped with a keyed shut-off switch located in the lower center instrument panel area. A bright yellow warning label covered the keyed switch which warned that the air bag should be switched off when using a rearward facing child safety seat in the right front seat. When the label was peeled back during the inspection, the switch was located in the “on” position (**Figure 9**).

Figure 9- View of the manual shut off switch for the front right passenger air bag

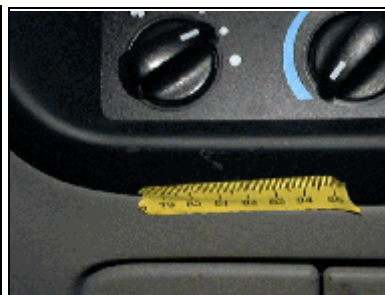
There were two driver contact artifacts noted in the interior of the vehicle. The first contact involved a small area of abrasion below the temperature control panel in the center of instrument panel. This was attributed to contact by the driver's right hand during the crash sequence (**Figure 10**). The second artifact was a 10.2 cm (4.0") vertical smudge mark on the left door glazing which was not associated with the crash sequence. The steering column did not appear to be displaced or show signs of driver loading (**Figure 11**).

Figure 10- View of the abraded surface of the trim below the temperature control panel

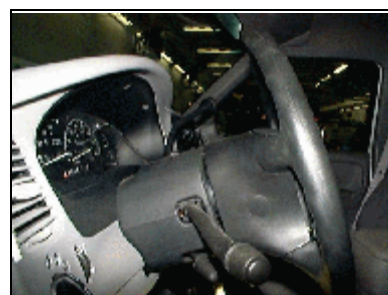
Figure 11- Lateral view of the Ford steering wheel and column

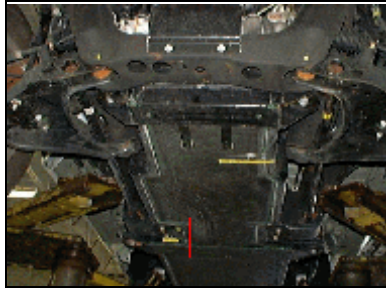
Crash related damage to the traction battery pack consisted of a small abrasion adjacent to the right front axle torsion bar bracket. It measured 1.4 cm (0.6") in length and was located on the leading vertical surface of the tray cutout for the torsion bar bracket and 9.8 cm (3.875") inboard from the right side of the tray (**Figures 13-15**). This mark was attributed to contact with the torsion bar

bracket during the crash sequence. There were other abrasions noted at various locations of the battery pack which were attributed to contact with the installation rack during routine maintenance. The traction battery pack did not appear to have been comprised during the crash.

Figure 14- View of the traction battery pack looking from front to rear with the crash induced damage to the lower battery tray marked

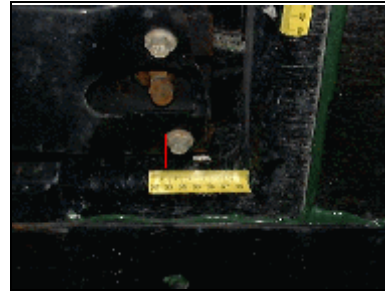
Figure 15- Close-up view of the contact damage between the front axle torsion bar bracket and the traction battery pack

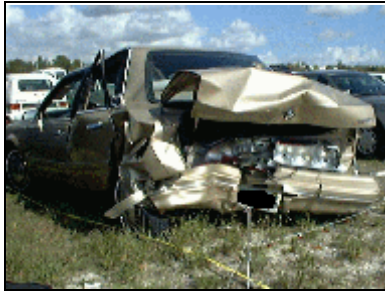
The 1993 Buick Century sustained severe deformation to the rear plane. Damage components included: the rear bumper; tail light assemblies; trunk lid; both rear fenders; rear axle; left rear wheel; the roof; the left rear door, and disintegrated left rear door glazing (**Figures 19 and 20**).

Figure 19- View of the damage to the rear plane of the Buick

The Collision Deformation Classification (CDC) coding scheme for the Buick was 06-BDEW-6. The direct damage began at the left rear bumper and extended 109.2 cm (43.0") to the right. The maximum crush of 85.7 cm (33.75") was located 34.3 cm (13.5") left of the vehicle centerline.

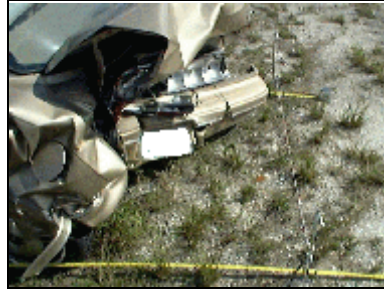
Figure 20- View showing the depth of the crush profile

Crush measurements along the rear bumper	$C_1 = 81.3 \text{ cm (32.0")}$	$C_2 = 76.2 \text{ cm (30.0")}$	$C_3 = 82.6 \text{ cm (32.5")}$
	$C_4 = 47.0 \text{ cm (18.5")}$	$C_5 = 22.9 \text{ cm (9.0")}$	$C_6 = 0.3 \text{ cm (0.125")}$

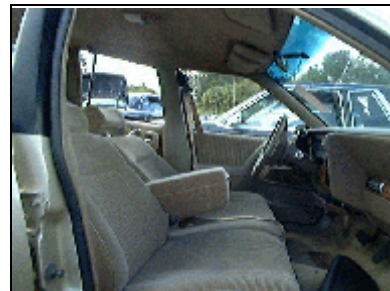
The interior damage was the result of occupant contacts and intrusion resulting from the crash sequence. The left and right front seat back supports were deformed rearward as the result of loading by the driver and right front occupant. The left rear seat back support was deformed forward 20 cm (8"). The right side surface of the center front seat arm rest was abraded from contact by the 87 year old female front right seat occupant during the crash.

Figure 21- Lateral view of the front row seats showing the rearward deflection of the seat back supports
