**REDESIGNED AIR BAG SPECIAL STUDY (RABSS)
SCI TECHNICAL SUMMARY REPORT**

NASS CDS CASE NO. 1999-06-029A

RABSS VEHICLE - 1998 FORD WINDSTAR

CRASH DATE - MARCH, 1999

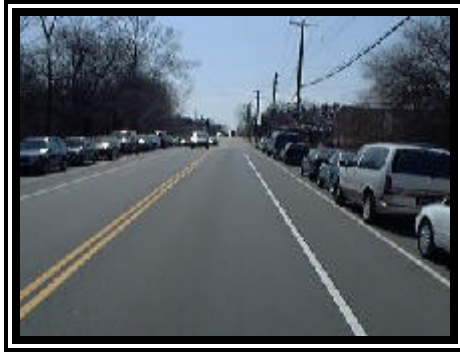
The 19 year old male driver of the 1997 Honda Accord LX was operating the vehicle southbound (**Figure 1**) when he allowed the vehicle to cross the centerline into the path of the northbound Ford Windstar. The driver stated during the NASS interview that he attempted to go around a construction area straddling the west shoulder when he observed the northbound Ford. Upon recognition of the

Figure 1. Southbound approach for the 1997 Honda Accord LX.

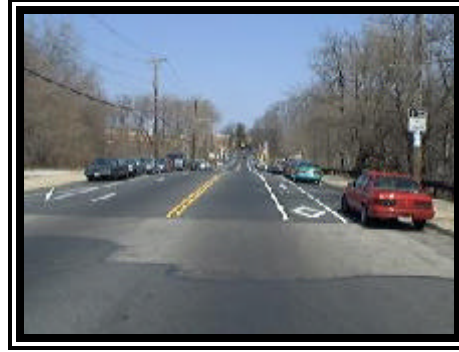
The 43 year old male driver of the 1998 Ford Windstar was operating the vehicle northbound (**Figure 2**) when he observed the southbound Honda encroach into his lane of travel. Upon recognition of the impending harmful event, the driver steered left and braked in avoidance. This maneuver was evidenced by the brake mark observed in the NASS scene images, however, it was not plotted on the scene diagram nor captured in the case file.

Figure 2. Northbound approach for the 1998 Ford Windstar.

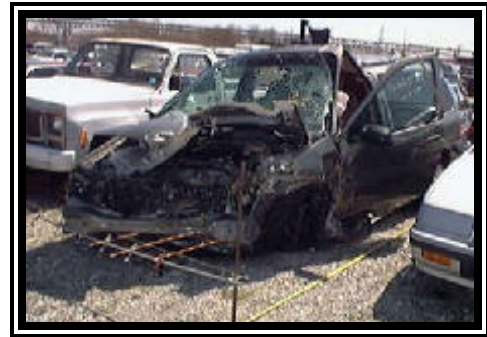
The 1998 Ford Windstar sustained severe frontal damage as a result of the impact with the Honda Accord (**Figure 3**).

The direct contact damage began at the front left bumper corner and extended 100.0 cm (39.4 in) inboard. The impact deformed the entire front end width resulting in a combined direct and induced damage length (Field L) of 124.0 cm (48.8 in). *Erroneous field documentation necessitated SCI revision of the crush profile.* Six crush measurements were documented at the level of the

reinforcement bar (*bumper fascia separation*): C1= 78.0

cm (30.7 in), C2= 69.0 cm (27.2 in), C3= 52.0 cm (20.5 in), C4= 33.0 cm (13.0 in), C5= 15.0 cm (5.9 in), C6= 0 cm. The *SCI revised* Collision Deformation Classification (CDC) for this impact to the Ford was 12-FYEW-4 with a principal direction of force of (-)10 degrees. The hood was deformed rearward from the impact force. The fenders were displaced rearward which restricted/deflated both front wheels/tires. Induced contact damage also produced extensive rearward displacement of the left A-pillar and windshield header. This resulted in roof buckling and outward displacement of the left front door upper-window frame (with integrity loss). Although structure failure was coded in the NASS case file as a source of the left front door opening, the researcher provided no closeup images of the door structure or latch/striker assembly for SCI verification. The windshield was fractured from exterior impact forces only. Reduction in the left side wheelbase measured 69.0 cm (27.2 in) as the right side wheelbase was elongated 13.0 cm (5.1 in). Surface scratching was noted to the left passenger area, however, this damage was not attributed to any subsequent event and was probably pre-existing.

Figure 3. Front left damage to the 1998 Ford Windstar.

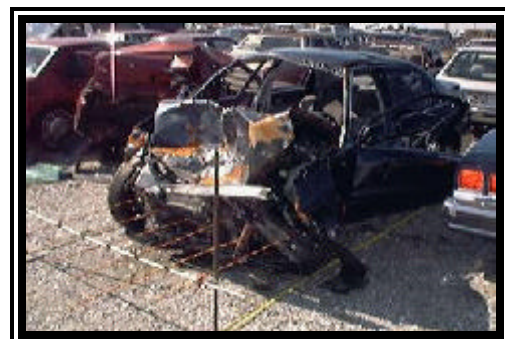
The 1997 Honda Accord LX sustained severe frontal damage as a result of the impact with the Ford Windstar (**Figure 4**). The direct contact damage encompassed the entire front end width resulting in a combined direct and induced damage length (Field L) of 124.0 cm (48.8 in). Six crush measurements were documented at the level of the reinforcement bar (*bumper fascia separation*): C1= 74.0 cm (29.1 in), C2= 72.0 cm (28.3 in), C3= 72.0 cm (28.3 in), C4= 72.0 cm (28.3 in), C5= 54.0 cm (21.3 in), C6= 48.0 cm (18.9 in). The *SCI revised* CDC for this impact to the Honda was 81-FDEW-3 with a principal

Figure 4. Front left damage to the 1997 Honda Accord LX.

direction of force of (+)30 degrees (principal direction of force incremented by “80” to reflect shifting of the end structure to the left). Shifting of the end structure to the left (*extent not measured by the NASS researcher*) and rearward displacement of the left fender restricted/deflated the left front wheel/tire and jammed the left front door. The hood was deformed rearward from the impact force. The windshield was fractured from exterior impact forces and interior occupant contact. The roof was cut as the front doors were pried open during post-crash occupant extrication activities by rescue personnel. Reduction in the left side wheelbase measured 35.0 cm (13.8 in) while reduction in the right side wheelbase measured 4.0 cm (1.6 in).

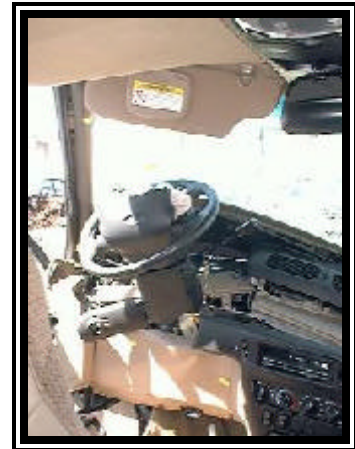
Interior damage to the Ford Windstar identified through the vehicle inspection was severe and was attributed to occupant contact and component intrusion (**Figure 5**). Scuff marks and indentations were documented on the left knee bolster. Deformation to the upper portion of the steering wheel rim measured 4.0 cm (1.6 in) as the steering column was displaced upward approximately 11.0 cm (4.3 in) and 5.0 cm (2.0 in) to the left. The left instrument panel and A-pillar cover panel were fractured and scuffed. The foot controls were bent to the left. A spider-web fracture pattern was identified to the left upper windshield. Longitudinal intrusions into the driver space involved 46.0 cm (18.1 in) of toe pan and 4.0 cm (1.6 in) of instrument panel intrusion (*intrusion of additional frontal components not captured by the NASS researcher*).

Figure 5. Interior view.

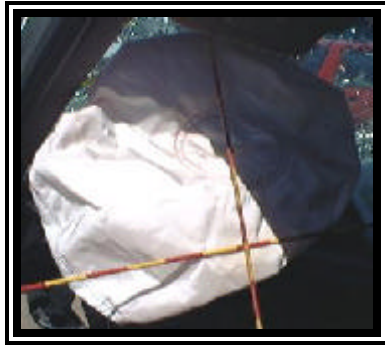
The 1998 Ford Windstar was equipped with redesigned frontal air bags for the driver and front right passenger positions. The air bags deployed as a result of the crash. The driver air bag was housed in the center of the steering wheel with a horizontally oriented flap tear seam (H-configuration). The flaps were rectangular in shape as the upper flap measured 19.0 cm (7.5 in) in width and 12.0 cm (4.7 in) in height while the lower flap measured 19.0 cm (7.5 in) in width and 7.0 cm (2.8 in) in height. Although no contact evidence was identified on the exterior surface of the module cover flaps, an unspecified transfer was reported on the air bag face. The NASS researcher measured the diameter of the driver air bag at 48.0 cm (18.9 in) in its deflated state (**Figure 6**). The bag was tethered by two internal straps and vented by two ports located at the 11 o'clock and 1 o'clock sectors on the rear aspect of the air bag.

Figure 6. 1998 Ford Windstar deployed redesigned driver air bag.

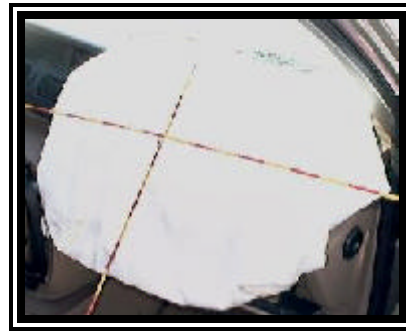
The front right passenger air bag deployed from the right mid-instrument panel area with a single cover flap design hinged at the top aspect. No contact evidence was identified on the air bag or exterior surface of the module cover flap. The cover flap was rectangular in shape and measured 33.0 cm (13.0 in) in width and 13.0 cm (5.1 in) in height. The NASS researcher measured the passenger air bag at 44.0 cm (17.3 in) in width and 60.0 cm (23.6 in) in height in its deflated state (**Figure 7**). No internal tether straps were present. The bag was vented by one port located at the 9 o'clock position on the side aspect of the air bag.

Figure 7. 1998 Ford Windstar deployed redesigned passenger air bag.

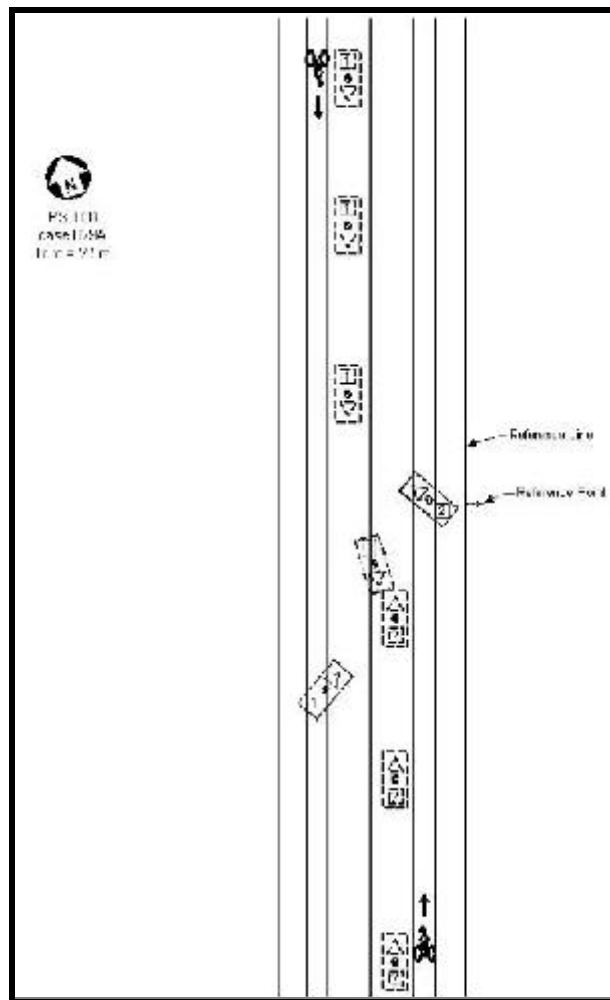
Figure 8. NASS Scene Diagram.

This two vehicle crash occurred during the late evening hours of March, 1999. At the time of the crash, it was dark (street lighted) with no adverse conditions as the road was dry. The crash occurred in the northbound lane of a (level) 2-lane north/south urban roadway (see **Figure 8 - page 7**). The asphalt roadway was bordered by bike lanes and parking spaces. No traffic control was present at the crash site which had a posted speed limit of 56 km/h (35 mph).
