SCI/NASS COMBINATION CASE REPORT

CASE NUMBER - NASS-1999-09-032C

LOCATION - Maryland

VEHICLE - 1998 TOYOTA COROLLA LE

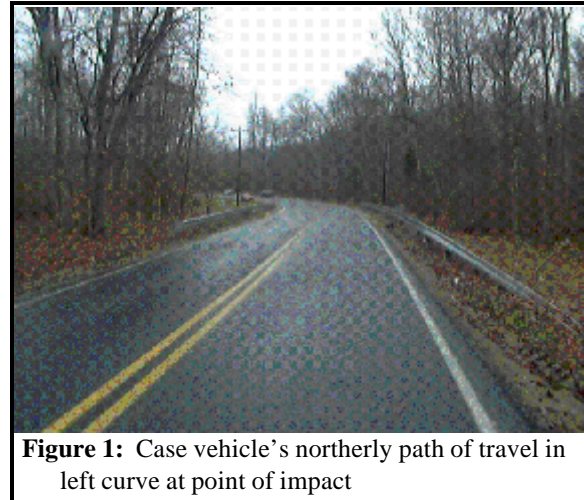
The case vehicle was traveling north in the northbound lane of a two-lane, two-way, undivided county roadway and was negotiating a curve left, intending to continue traveling north (**Figure 1**). The other vehicle was traveling south in the southbound lane of the same roadway and was negotiating a curve right when he crossed the center line. It is unknown whether the case vehicle driver was able to attempt any avoidance maneuvers prior to the crash. The crash occurred in the northbound lane just over the center line.

Figure 1: Case vehicle's northerly path of travel in left curve at point of impact

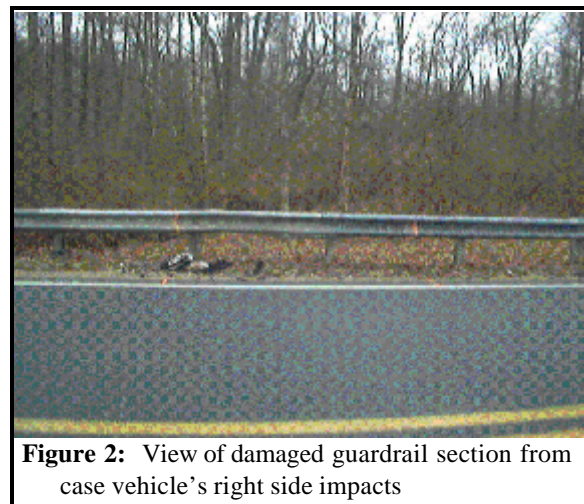
The front of the other vehicle impacted the front left bumper corner of the case vehicle, causing the case vehicle's front air bags and driver's side air bag to deploy. This impact redirected the case vehicle off the east edge of the roadway where the right front area swiped along a W-beam guardrail (**Figure 2**). This swiping-type engagement caused the front of the case vehicle to rebound such that the right back area also sustained a separate swiping-type impact with the guardrail. The case vehicle came to rest straddling the roadway edge and the shoulder, heading in a northerly direction. Both vehicles were towed from the scene due to damage.

Figure 2: View of damaged guardrail section from case vehicle's right side impacts

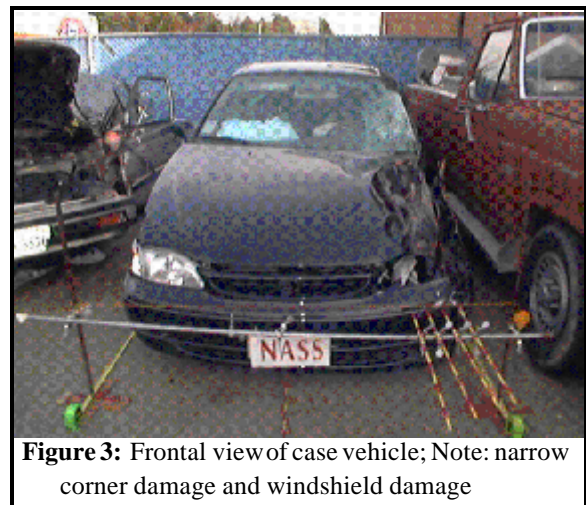
Figure 3: Frontal view of case vehicle; Note: narrow corner damage and windshield damage

The case vehicle’s initial contact with the other vehicle involved the front left bumper corner and extended down the left side (**Figures 3-4**). The case vehicle’s right side impact with the W-beam guardrail involved the entire right side. Direct damage from the case vehicle’s impact with the other vehicle, which deployed the front and left side air bags, extended from the front left bumper corner inwards 20

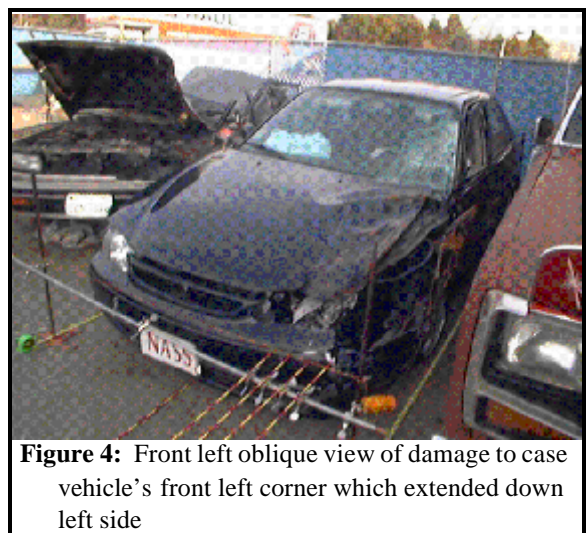
Figure 4: Front left oblique view of damage to case vehicle’s front left corner which extended down left side

centimeters [7.9 inches] with swiping-type damage extending down the left side. The direct damage for the case vehicle's second impact involving the guardrail began slightly rearward of the right front bumper corner and extended rearward to the right B-pillar. The maximum crush impact #2 was measured as 16 centimeters [6.3 inches] at C6. The direct damage from the third impact began at the right B-pillar and extended rearward to the right rear bumper corner (**Figure 5**), with maximum crush measured as 25 centimeters [9.8 inches], near the center of the right quarter panel. The wheelbase was shortened by 2 centimeters [0.8 inches] on both sides. The windshield glazing sustained multiple stress cracks and the driver's door glazing was disintegrated from the left side impact.

Based on the vehicle inspection, the CDCs were determined to be: impact one, **12-FLAE-9 (350)**, impact two **01-RYMW-1 (20)** and impact three **01-RZMS-1 (20)** for the case vehicle. Maximum crush was 7 centimeters [2.8 inches] at the front left corner, with 301 centimeters [118.5 inches] of swiping-type contact along the left side. The WinSMASH reconstruction program, damage algorithm based on the measured crush profile for both vehicles, was used on the case vehicle's narrow frontal impact. The Total, Longitudinal and Lateral Delta Vs are, respectively: 46 km.p.h. [29 m.p.h.], -45 km.p.h. [-28 m.p.h.], and +8 km.p.h. [+5 m.p.h.]. Because this impact involved a swiping-type engagement, these results should be considered as a borderline reconstruction.

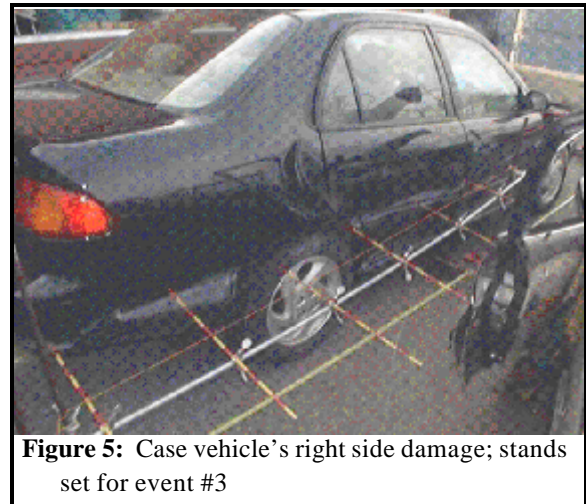
Figure 5: Case vehicle's right side damage; stands set for event #3

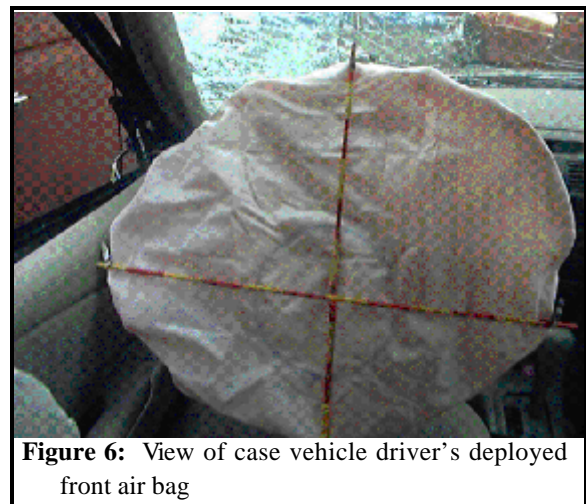
Figure 6: View of case vehicle driver's deployed front air bag

hub were it was mounted. The module cover consisted of H-configuration cover flaps made of thick vinyl with overall dimensions of 16 centimeters [6.3 inches] at the center horizontal seam and 6 centimeters [2.4 inches] vertically for the upper flap and 9 centimeters [3.5 inches] for the lower flap. The driver's air bag was designed without tethers. The driver's air bag was round with diameter 52 centimeters [20.5 inches] and was designed with two vent ports (unknown diameter) located at the eleven and one o'clock positions. Inspection of the case vehicle driver's front air bag revealed no visible evidence of contact by the case vehicle driver (**Figure 6**). In addition, the driver's air bag module cover flaps showed no visible evidence of direct contact from the driver.

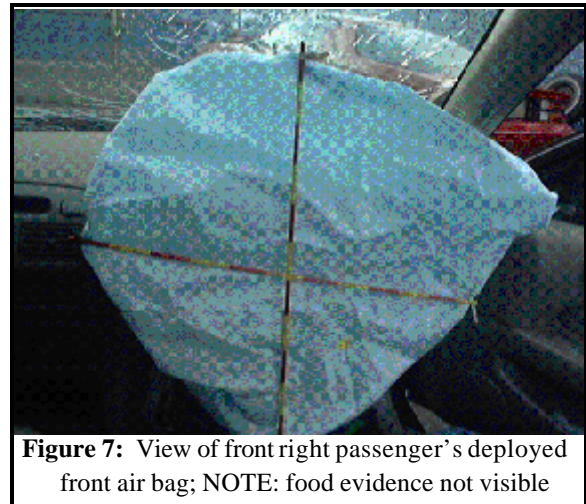
The front right passenger air bag was mounted on the top of the front right instrument panel. The cover flaps appear to be made of a thick vinyl-like substance. The flap's angled dimensions were 23 centimeters [9.1 inches] at the horizontal seam, 5 centimeters [2.0 inches] for the left upper vertical seam, 7 centimeters [2.8 inches] for the lower left vertical seam and 5 centimeters [2.0 inches] for the lower right vertical seam. The profile of the case vehicle's instrument panel with the leading edge of the cover flap was not measured. The front right passenger's air bag module cover flaps opened properly along the tear points. Inspection of the cover flaps revealed no damage. Examination of the front right passenger air bag showed no evidence of damage or contact other than what the investigator thought was a food splatter to the lower right corner of the air bag (**Figure 7**). The front right passenger air bag had no tethers but did have two vent ports at the nine and three o'clock positions. The air bag's front face was 64 centimeters [25.2 inches] wide and 60 centimeters [23.6 inches] tall.

Figure 7: View of front right passenger's deployed front air bag; NOTE: food evidence not visible

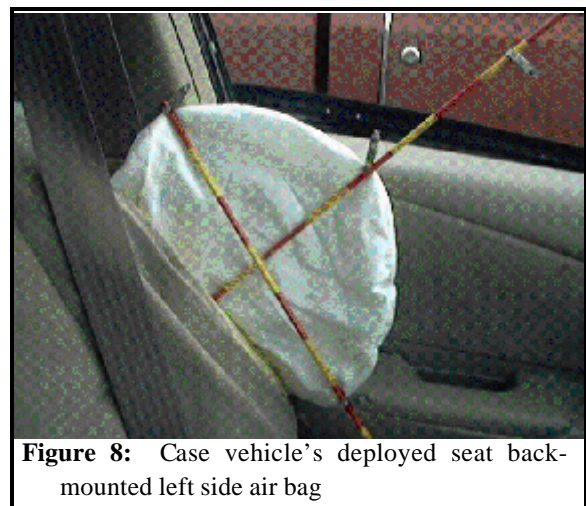
The driver's seat back-mounted side air bag (**Figure 8**) deployed as a result of the swiping-type damaged along the case vehicle's left side during the impact with vehicle #2. The driver's side air bag deployed through a seam on the outboard side of the driver's seat back. The side air bag was 33 centimeters [13 inches] longitudinally and 22 centimeters [8.7 inches] vertically. The driver's side air bag had no vent ports and was not tethered. An inspection of the case vehicle driver's side air bag revealed no visible evidence of direct contact from the driver.

Figure 8: Case vehicle's deployed seat back-mounted left side air bag

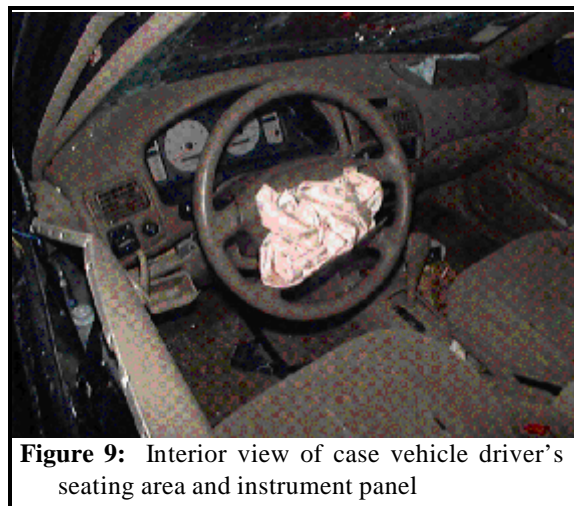
An examination of the case vehicle's interior showed evidence of contact by the vehicle's occupants to the driver's door panel including the side hardware and armrest, left A-pillar, and center instrument panel. The energy absorbing steering column was not inspected. The case vehicle driver's knee bolster showed evidence of minor deformation. There was visible evidence of minor intrusion to the case vehicle's driver door panel which measured 5 centimeters [1.9 inches] and the left side panel forward of the A-pillar which measured 4 centimeters [1.6 inches].

Figure 9: Interior view of case vehicle driver's seating area and instrument panel

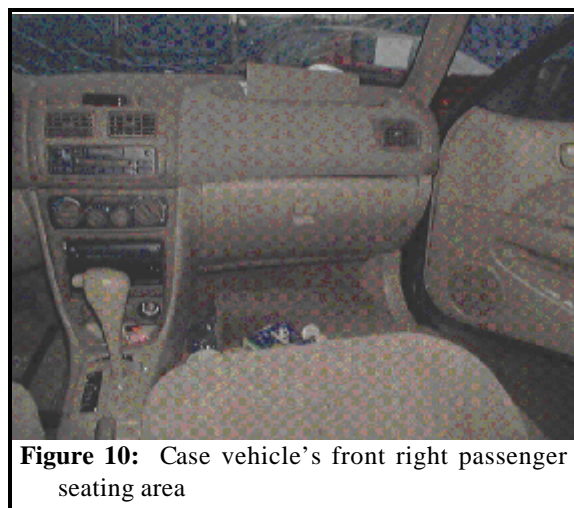
The case vehicle's front right passenger was probably seated in an upright posture with her feet on the floor and both hands on her lap (**Figure 10**). Her seat track was located in its middle position with the seat back slightly reclined.

Figure 10: Case vehicle's front right passenger seating area

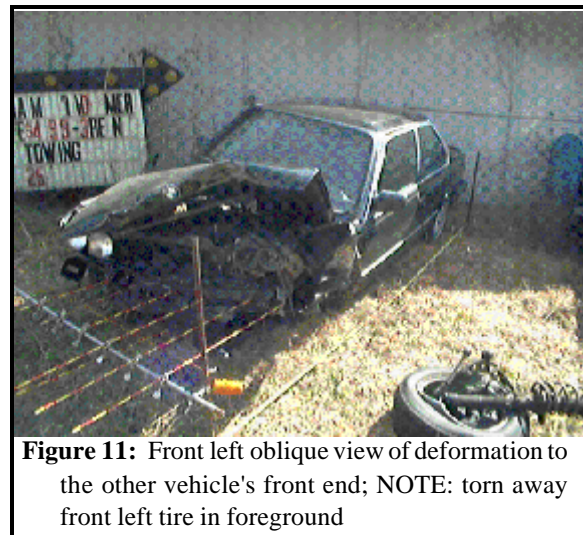
The vehicle was equipped with three-point lap-and-shoulder safety belts for the front outboard seat positions. The interior was equipped with a adjustable bucket seats with integral head restraints for the driver and front right passenger. Damage to the other vehicle was to the front end, primarily to the left half of the vehicle (**Figure 11**). The vehicle's front bumper was torn off its mounts and the left front wheel and tire assembly was torn off the vehicle's chassis. The vehicle's entire front end sustained induced damage with the maximum crush being 70 centimeters [27.6 inches] at the front left corner. The WinSMASH reconstruction program, damage algorithm based on the measured profiles of both vehicles, was used. The Total, Longitudinal and Lateral Delta Vs were, respectively: 45 km.p.h. [28 m.p.h.], -45 km.p.h. [-28 m.p.h.] and 0 km.p.h. [0 m.p.h.].

Figure 11: Front left oblique view of deformation to the other vehicle's front end; NOTE: torn away front left tire in foreground
