**REDESIGNED AIR BAG SPECIAL STUDY (RABSS)  
SCI TECHNICAL SUMMARY REPORT**

**NASS CDS CASE NO. 1999-11-132A**

**RABSS VEHICLE - 1999 PONTIAC SUNFIRE**

**CRASH DATE - AUGUST, 1999**

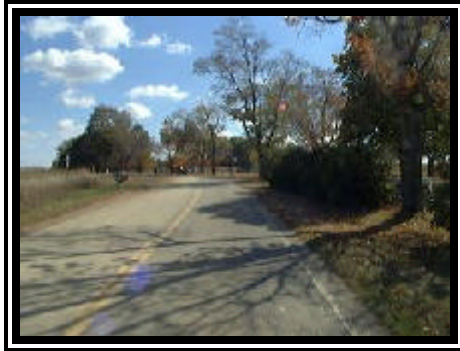
The 33 year old male driver of the 1999 Pontiac Sunfire was operating the vehicle eastbound (**Figure 1**) and negotiating a left curve when he became distracted by sexual activities with the passenger and allowed the vehicle to depart the right (south) pavement edge in a forward tracking mode (**Figure 2**). The police reported no pre-impact brake marks indicative of driver avoidance maneuvers.

**Figure 1.** Eastbound approach for the 1999 Pontiac Sunfire.

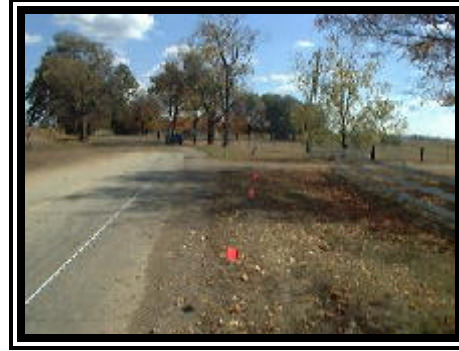
**Figure 2.** Pre-impact trajectory off the south pavement edge.

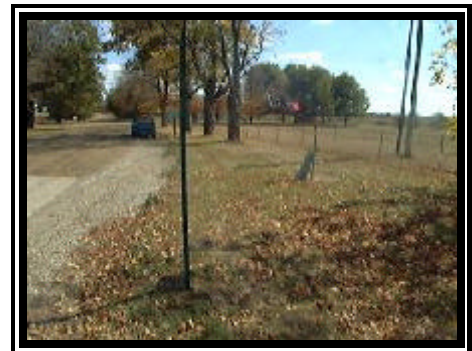
As the Pontiac Sunfire departed the right (south) pavement edge, the vehicle traveled 19.7 meters (64.6 feet) as the front right area made initial contact to a small diameter signpost (**Figure 3**) resulting in minor damage. The vehicle continued 7.2 meters (23.6 feet) in an easterly direction as the right rear side surface sideswiped a telephone junction box resulting in minor damage. At this point, the vehicle continued 12.0 meters (39.4 feet) as the front left area impacted a large diameter tree which resulted in moderate damage. The WinSMASH reconstruction program computed a barrier equivalent velocity change of 48.4 km/h (30.1 mph) with a respective longitudinal component of -47.7 km/h (-29.6 km/h), which seemed high. The impact induced deceleration was sufficient to deploy the Pontiac's redesigned frontal air bag system. At this point, the vehicle rotated approximately 30 degrees counterclockwise and came to rest in close proximity to the final point of impact facing southeast.

**Figure 3.** Impacts #1-3 (signpost-foreground, telephone junction box, and large diameter tree-background).

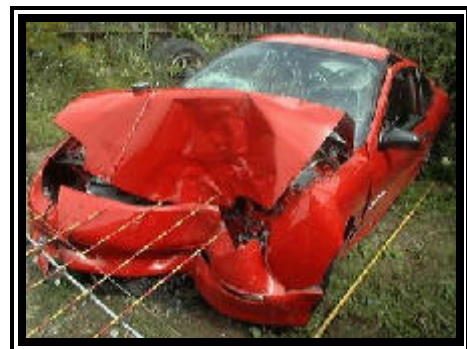
The 1999 Pontiac Sunfire sustained moderate frontal damage as a result of the impact with the tree (**Figure 4**). The direct contact damage began 5.0 cm (2.0 in) right of the front left bumper corner and extended 54.0 cm (21.3 in) inboard. The impact deformed the entire front end width resulting in a combined direct and induced damage length (Field L) of 90.0 cm (35.4 in). Six crush measurements were documented at the level of the bumper: C1= 64.0 cm (25.2 in), C2= 73.0 cm (28.7 in), C3= 69.0 cm (27.2 in), C4= 61.0 cm (24.0 in), C5= 22.0 cm (8.7 in), C6= 12.0 cm (4.7 in). The crush profile seemed overstated, however, inadequate field documentation prohibited further SCI analysis for correctional purposes. The *SCI revised* Collision Deformation Classification (CDC) for this impact to the Pontiac was 12-FYEW-3 with a principal direction of force of 0 degrees. The hood was displaced up and rearward from engagement against the tree. Rearward displacement of the left fender restricted the left front wheel/tire (not deflated) and jammed the left door. Induced rearward displacement of the left A-pillar buckled the roof and side rail areas. The windshield was fractured from exterior impact forces and the interior passenger air bag module cover flap. The right rear tire was deflated (not restricted). Reduction in the left side wheelbase measured 22.0 cm (8.7 in).

**Figure 4. Front left damage to the 1999 Pontiac Sunfire.**

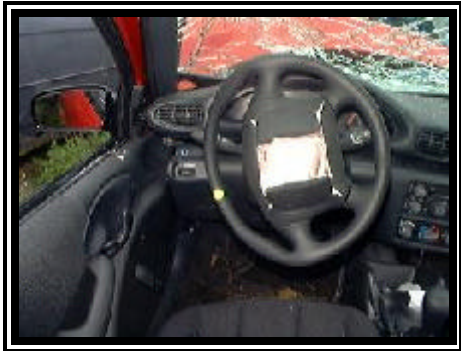
Interior damage to the Pontiac Sunfire identified through the vehicle inspection was moderate and attributed to occupant contact and component intrusion (**Figures 5 & 6**). Scuff marks and indentations were documented on the left knee bolster and glove compartment door. Additional scuff marks were identified on the left (mid) and center (lower) instrument panel areas. The (floor mounted) gearshift knob was displaced slightly to the left. Loading marks and possible tissue transfers were documented on the front left and right shoulder belt webbings. Deformation to the upper portion of the steering wheel rim measured 6.5 cm (2.6 in). Longitudinal intrusions into the front occupant space involved 12.0 cm (4.7 in) of left toepan and 10.0 cm (3.9 in) of center floor intrusion.

**Figure 5. Deformation to the steering wheel rim.**

tissue injury to the scalp makes this only a plausible scenario. It should be noted that the scuff marks and indentations identified to the left knee bolster accurately places the location of the driver's lower extremities at impact, and thus, may rule him out as a source of the rim deformation. At this point, the front right passenger struck the glove compartment door and (lower) center instrument panel area which resulted in abrasions/lacerations to the right lateral thigh and left anterior knee. These injury mechanisms were evidenced by the scuff marks and indentations documented to these components, and further indicates an abnormal pre-impact posture by the passenger. She also sustained lacerations to the right lateral forearm and posterior left hand from flying glass (non-contact injury). The deceased passenger was found by police 2.5 hours following the crash still in the vehicle and lying across the front seats partially in the prone position "*tangled in the restraint*". She was officially pronounced deceased at the scene approximately 6 hours following the crash and was subsequently removed from the vehicle for transport to the local morgue. Given the improper pre-impact posture and belt placement, the passenger redesigned air bag offered no protection to the occupant nor mitigate any of the fatal injuries sustained.

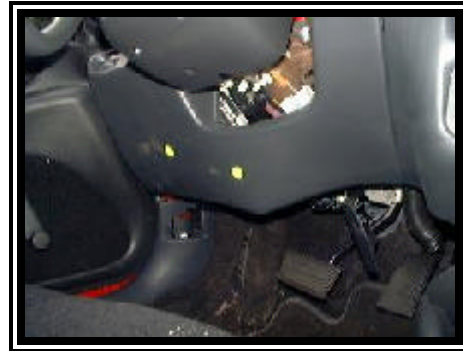
**Figure 6. Scuff marks and indentations to the driver knee bolster.**

o'clock impact force and loaded the manual restraint, knee bolster and deployed redesigned driver air bag. Contact to the knee bolster was confirmed by the scuff marks and indentations documented to this component. In addition, the pre-impact seat back recline position *may have* allowed the driver to submerge the restraint and load the upper portion of the steering wheel rim which rotated 180 degrees counterclockwise at maximum engagement against the tree. Deformation to the steering wheel rim confirmed occupant interaction, however, limited injury information prohibited further analysis of any potential injury mechanisms. Bag expansion against the left forearm compressed the driver's watch into the soft tissue, resulting in a small abrasion/laceration to the posterior wrist. Although data suggested this may be an air bag "fling" type injury, a pre-impact hand placement at the 8 o'clock position on the steering wheel rim is a more probable scenario for this injury mechanism, given the lack of associated soft tissue injury to the *anterior* forearm and contact evidence to the left A-pillar. The driver exited the vehicle under his own power and fled the scene on foot. He was found approximately 3 hours later by police wandering the area asking local residents for a ride home. He was subsequently transported by police vehicle to a local hospital for treatment and released into custody.

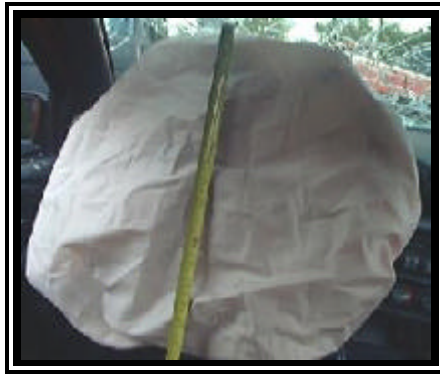
The 1999 Pontiac Sunfire was equipped with redesigned frontal air bags for the driver and front right passenger positions. The air bags deployed as a result of the crash. The driver air bag was housed in the center of the steering wheel with a vertically oriented flap tear seam (I-configuration). No contact evidence was identified on the air bag or exterior surface of the module cover flaps. The flaps were symmetrical in shape and measured 7.0 cm (2.8 in) in width and 10.0 cm (3.9 in) in height. The NASS researcher measured the diameter of the driver air bag at 54.0 cm (21.3 in) in its deflated state (**Figure 7**). The bag was vented by two ports located at the 9 o'clock and 3 o'clock sectors on the rear aspect of the air bag. No internal tether straps were present.

**Figure 7. 1999 Pontiac Sunfire deployed redesigned driver air bag.**

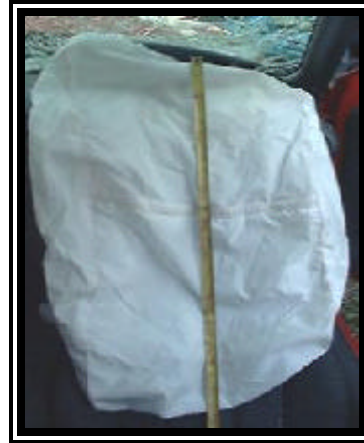
The front right passenger air bag deployed from the right top instrument panel area with a single cover flap design hinged at the forward aspect. No contact evidence was identified on the air bag or exterior surface of the module cover flap. The cover flap was rectangular in shape and measured 33.0 cm (13.0 in) in width and 17.0 cm (6.7 in) in height. The NASS researcher measured the passenger air bag at 44.0 cm (17.3 in) in width and 60.0 cm (23.6 in) in height in its deflated state (**Figure 8**). The bag was tethered by two internal straps. No vent ports were reported for the front right passenger air bag.

**Figure 8. 1999 Pontiac Sunfire deployed redesigned passenger air bag.**

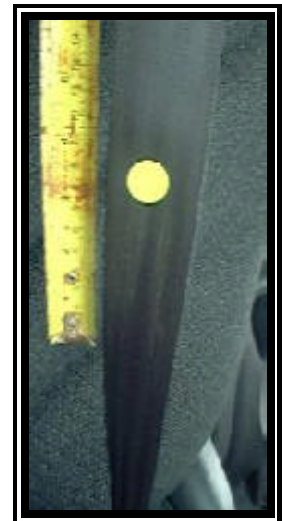
The 34 year old female front right passenger of the 1999 Pontiac Sunfire was out-of-position sitting sideways and leaning to the left. Her left hip was against the seat back with her upper torso in the prone position across the center console and arm(s) extended into the driver's lap. She was improperly restrained by the available 3-point manual lap and shoulder belt system with the lap portion riding high over the right hip and shoulder portion across the right neck. Belt usage was evidenced by the nature and extent of the injuries sustained relative to the loading marks documented on the front right shoulder belt webbing (**Figure 9**). Furthermore, the police found the deceased still in the vehicle "*slouched down and tangled in the restraint*". The seat track was adjusted to the middle position with the seat back slightly reclined.

**Figure 9. Loading marks to the front right shoulder belt webbing.**

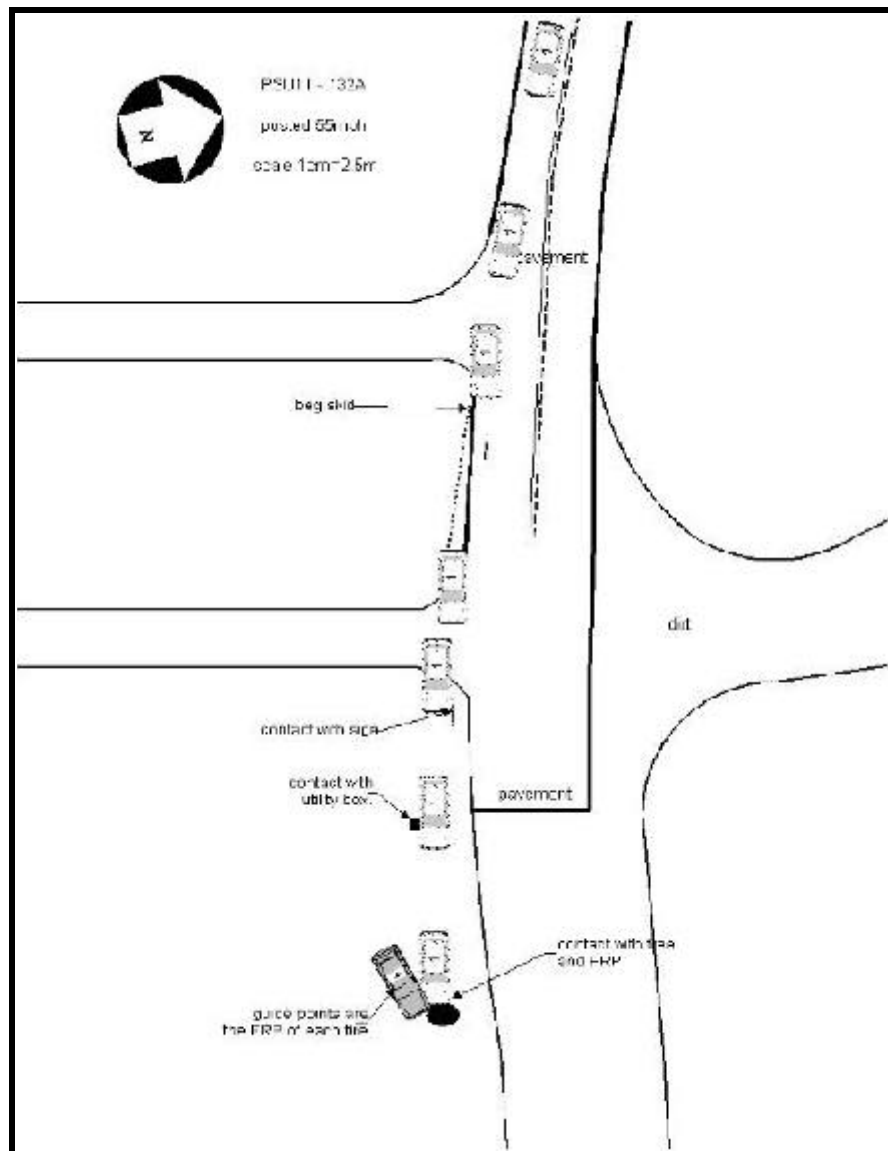
Figure 10. NASS Scene Diagram (impact #1 plotted incorrectly by researcher).
