# REDESIGNED AIR BAG SPECIAL STUDY (RABSS) SCI TECHNICAL SUMMARY REPORT

## NASS CDS CASE NO. 1999-11-146J

## **RABSS VEHICLE - 1998 FORD F-150 SUPER CAB PICKUP TRUCK**

## **CRASH DATE - SEPTEMBER, 1999**

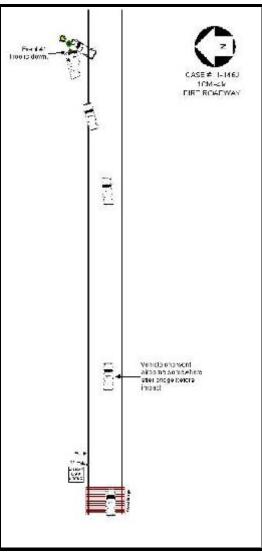
Figure 9. NASS Scene Diagram (pre-impact clockwise yaw not plotted by researcher).
