SCI/NASS COMBINATION CASE REPORT

CASE NUMBER - NASS-99-11-205J

VEHICLE - 1998 VOLKSWAGEN NEW BEETLE

CRASH DATE - December 1999

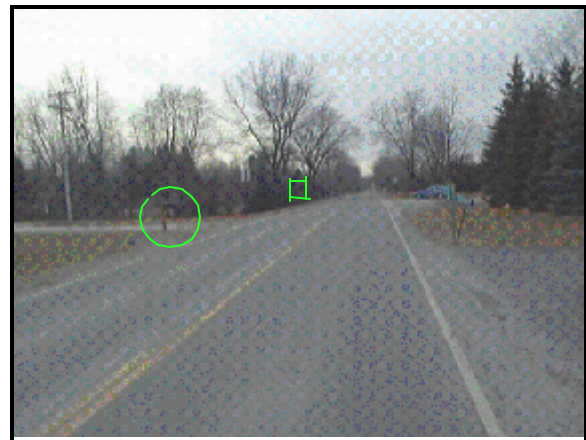
The case vehicle's right side impacted a wooden mailbox post at the south edge of the roadway (**Figure 1**). This impact had little affect on the case vehicle's motion and it continued its clockwise rotation while traveling in a westerly direction. The case vehicle's left side impacted one of a group of large trees off the south side of the roadway (**Figure 2**). This impact caused the case vehicle driver's seat back-mounted side air bag to deploy. The tree impact resulted in the case vehicle being slightly redirected in a northwesterly direction. The case vehicle rotated

Figure 1: Case vehicle's westbound approach before losing control and striking mailbox post (circled) and tree (square); the mailbox post was replaced prior to the scene photography

The case vehicle first sustained a minor impact with a wooden mail box post. The post was replaced prior to the scene inspection and there is no knowledge of its size and whether it was broken off or simply knocked over (**Figure 1**). The most severe impact was with a tree that was part of a group of trees, with a diameter of approximately 30 centimeters [1 foot]. There was no damage apparent on the tree (**Figure 2**).

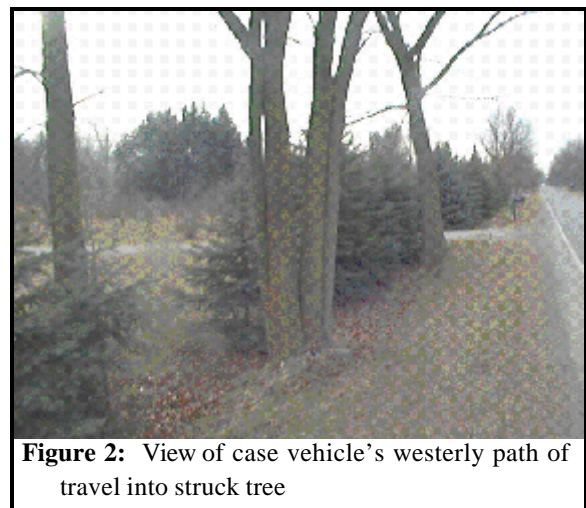
Figure 2: View of case vehicle's westerly path of travel into struck tree

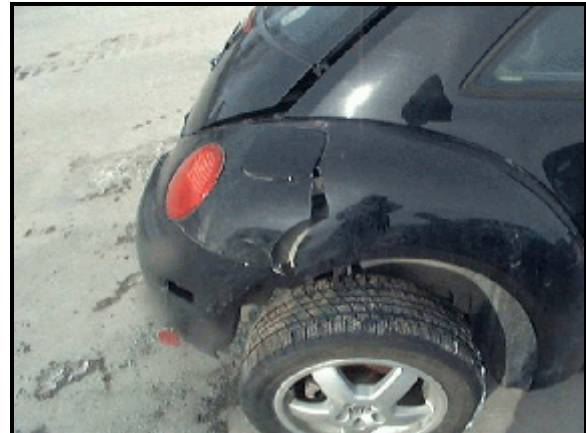
Figure 3: Minor damage on case vehicle's right rear quarter panel

The case vehicle's initial contact with the wooden mailbox post involved minor damage to the vehicle's right rear quarter panel (**Figure 3**). Maximum crush for this first impact was limited to surface scratches and apparently causing the plastic quarter panel to crack. The case vehicle's highest severity impact with the tree, which deployed the driver's side seat back-mounted side air bag, was centered just behind the vehicle's left B-pillar (**Figure 4**). The direct damage started 36 centimeters [14.2 inches] forward of the left rear axle and extended 79 centimeters [31.1 inches] forward. The maximum crush to the case vehicle's left side was a measured 41 centimeters [16.1 inches] and was located at C2. The wheel base on the left side was shortened 3 centimeters [1.2 inches] with the right side being extended 7 centimeters [2.8 inches]. The left rear tire was the only tire which was restricted, with none of the tires being deflated.

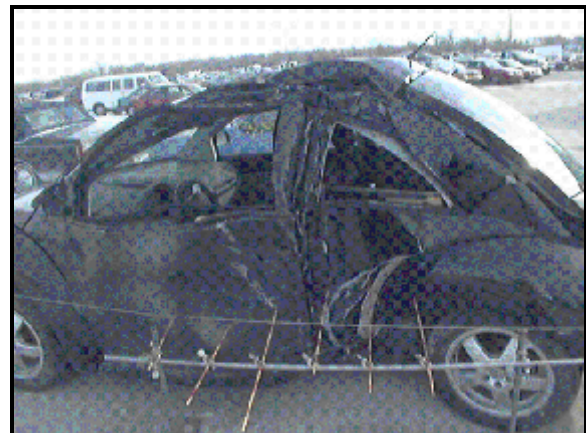
Figure 4: Case vehicle's left side damage from tree impact

Based on the vehicle inspection, the case vehicle's CDC for the most severe impact was determined to be: **09-LPAW-3 (280)**. The

WinSMASH reconstruction program, barrier algorithm, was used on the case vehicle's highest severity impact. The Total, Longitudinal, and Lateral Delta V's are, respectively: 24 km.p.h. [13 m.p.h.], -4 km.p.h. [-2 mph], and 23 km.p.h. [14 m.p.h.]. The NASS investigator wrote an incomplete CDC for the minor impact with the mailbox post, given as **99-RBEN-1** (direction of principal force unknown). The mailbox post impact was a swiping-type impact, with the direction of principal force probably in the 5 or 6 o'clock region and with visually estimated severity 2 - 5 km.p.h. [1 - 3 m.p.h.].

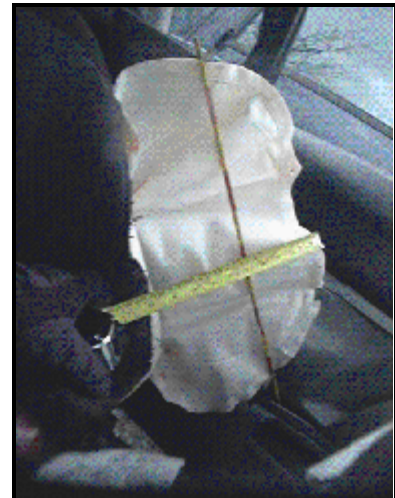
The case vehicle driver's side air bag deployed from along the outside seam of the driver's bucket seat back where it was mounted (**Figure 7**). The side air bag's dimensions were 23 centimeters [9.1 inches] horizontally and 52 centimeters [20.5 inches] vertically and was not tethered or vented. There was no visible evidence of direct contact from the case vehicle driver, nor was there any evidence that the air bag was damaged. The front right side air bag did not deploy (**Figure 8**).

Figure 7: Deployed driver's seat back-mounted side air bag showing no evidence of contact

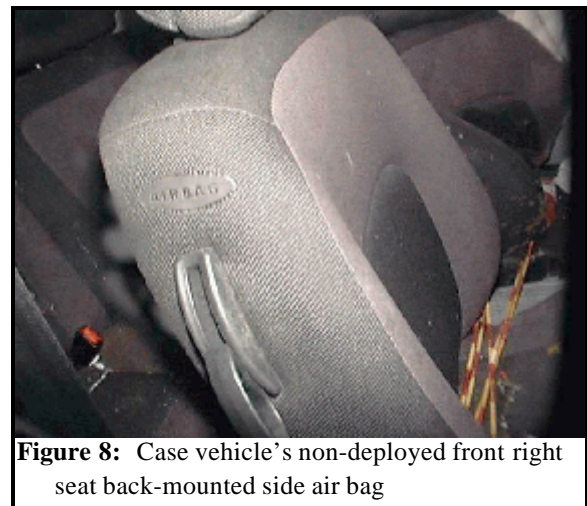
Figure 8: Case vehicle's non-deployed front right seat back-mounted side air bag
