**REDESIGNED AIR BAG SPECIAL STUDY (RABSS)  
SCI TECHNICAL SUMMARY REPORT**

**NASS CDS CASE NO. 1999-43-176J**

**RABSS VEHICLE - 1999 CHEVROLET CAVALIER Z24**

**CRASH DATE - OCTOBER, 1999**

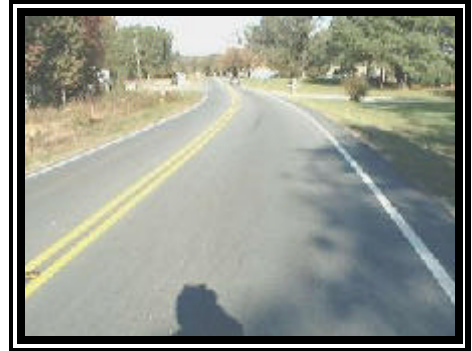
The 41 year old female driver of the 1999 Chevrolet Cavalier Z24 was operating the vehicle northbound (**Figure 1**) and negotiating a left curve at a (driver reported) speed of 64 km/h (40 mph) when she became distracted by a conversation with the passenger and allowed the vehicle to depart the right (east) pavement edge in a forward tracking mode. The vehicle continued in a northeasterly direction approximately 28.0 meters (91.9 feet) and subsequently entered a wooded area. The driver reported no avoidance maneuvers in anticipation of the impending crash. The vehicle's pre-impact approach was evidenced by the soil furrows noted in the NASS scene images, however, this physical evidence (*and forward tracking approach*) was not plotted on the NASS scene diagram.

**Figure 1.** Northbound approach for the 1999 Chevrolet Cavalier Z24.

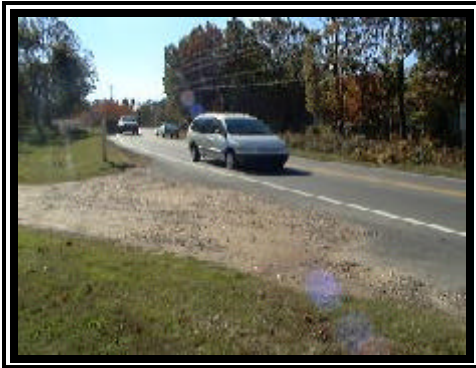
As the Chevrolet exited the right (east) pavement edge of the 2-lane rural roadway (**Figure 2**), the front right area impacted a large diameter tree resulting in severe damage (**Figure 3**). The WinSMASH reconstruction program computed a barrier equivalent velocity change of 56.1 km/h (34.9 mph) with a respective longitudinal component of -55.2 km/h (-34.3 mph), which seemed high. The impact induced deceleration was sufficient to deploy the Chevrolet's redesigned frontal air bag system. At this point, the vehicle rotated approximately 35 degrees clockwise and came to rest in close proximity to the point of impact facing northeast.

**Figure 2.** Look back view from road departure showing road curvature.

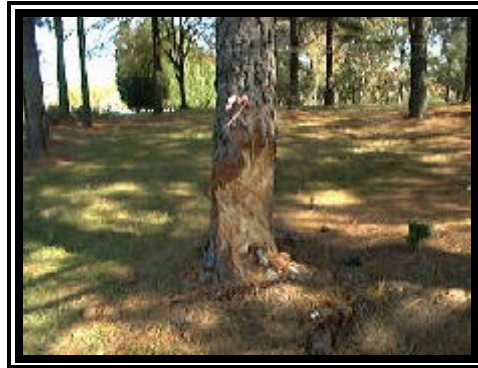
**Figure 3.** Struck tree.

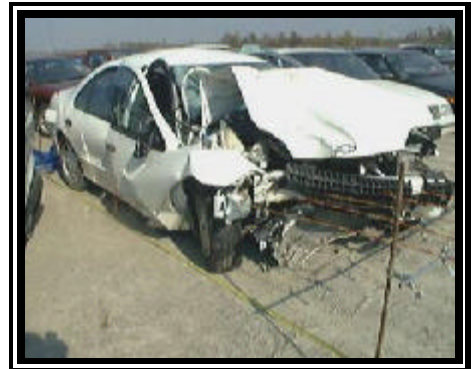
The 1999 Chevrolet Cavalier Z24 sustained severe frontal damage as a result of the impact with the large diameter tree (**Figure 4**). The direct contact damage began at the front right bumper corner and extended 45.0 cm (17.7 in) inboard. The impact deformed the entire front end width resulting in a combined direct and induced damage length (Field L) of 95.0 cm (37.4 in). Six crush measurements were documented at the level of the reinforcement bar (*bumper fascia and partial honeycomb separation*): C1= 14.0 cm (5.5 in), C2= 36.0 cm (14.2 in), C3= 49.0 cm (19.3 in), C4= 71.0 cm (28.0 in), C5= 88.0 cm (34.6 in), C6= 82.0 cm (32.3 in).

The Collision Deformation Classification (CDC) for this impact to the Chevrolet was 12-FREW-4 with a principal direction of force of (+) 10 degrees. The NASS researcher reported no right side wheelbase reduction while (conversely) the crush seemed overstated, however, inadequate field documentation prohibited further SCI analysis for correctional purposes. The hood was deformed up and rearward from engagement against the tree. The right fender was displaced rearward which restricted the right front wheel/tire (not deflated), jammed the right side doors and produced outward buckling to the right front door window frame (with integrity loss). Induced contact damage also resulted in buckling to the right A-pillar, windshield header and roof area. The windshield was fractured from (exterior) impact forces (only).

**Figure 4. Front right damage to the 1999 Chevrolet Cavalier Z24.**

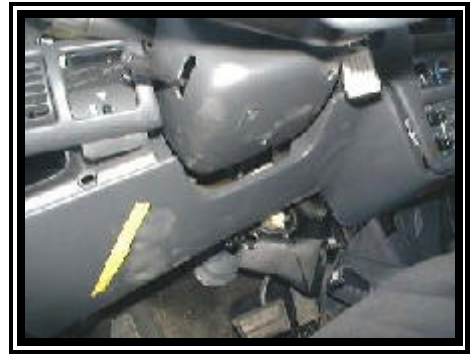
Interior damage to the Chevrolet Cavalier identified through the vehicle inspection was moderate and was attributed to occupant contact and component intrusion. Loading marks were identified on the front left/right shoulder belt webbings. Scuff marks were documented on the left knee bolster, instrument panel and steering column (**Figure 5**) which was also displaced to the left. An indentation and fracture were documented on the glove compartment door. Longitudinal intrusions into the front passenger space involved 32.0 cm (12.6 in) of right instrument panel, 20.0 cm (7.9 in) of center instrument panel, and 20.0 cm (7.9 in) of right toe pan intrusions.

**Figure 5.** Scuff marks to the driver's knee bolster.

contusions and a laceration to the right medial knee from the car keys (*per the driver interview*) in the ignition. These mechanisms were evidenced by the scuff marks documented to the knee bolster and steering column. Contact to the deployed driver air bag resulted in a left eyelid contusion and laceration to the upper lip (“split lip”). Her left hand struck the mid-left instrument panel area which resulted in a contusion to the posterior aspect of the wrist, evidenced by the scuff marks and panel displacement identified to the left of the steering column. She also sustained a right ankle fracture from contact to the toepan as evidenced by the specific location of the injury in conjunction with the driver’s placement of the foot on the accelerator pedal pre-crash. During clockwise vehicle rotation to final rest, she loaded the steering column as evidenced by the left shift noted to this component, however, no injury was reported as a result of this action. Following the crash, she exited the vehicle with some assistance from rescue personnel and was subsequently transported by ambulance to a local trauma center for treatment and admitted for 5 days. The redesigned driver air bag provided additional protection from further contact to the steering wheel hub/rim, and potential serious injury.

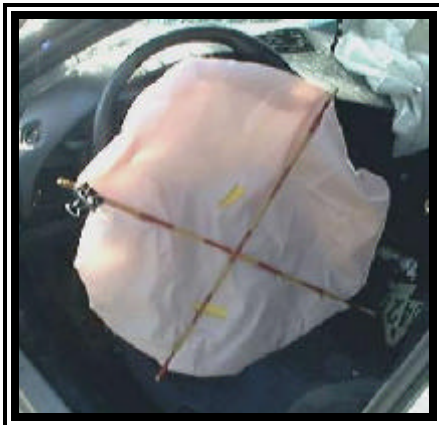
The 1999 Chevrolet Cavalier Z24 was equipped with redesigned frontal air bags for the driver and front right passenger positions. The air bags deployed as a result of the crash. The driver air bag was housed in the center of the steering wheel with a vertically oriented flap tear seam (I-configuration). The flaps were symmetrical in shape and measured 9.0 cm (3.5 in) in width and 11.0 cm (4.3 in) in height. Although no contact evidence was identified on the exterior surface of the module cover flaps, small areas of blood spattering were noted across the face of the air bag. The NASS researcher measured the diameter of the driver air bag at 54.0 cm (21.3 in) in its deflated state (**Figure 6**). The bag was vented by two ports located at the 9 o'clock and 3 o'clock sectors on the rear aspect of the air bag. No internal tether straps were present.

**Figure 6.** 1999 Chevrolet Cavalier Z24 deployed redesigned driver air bag.

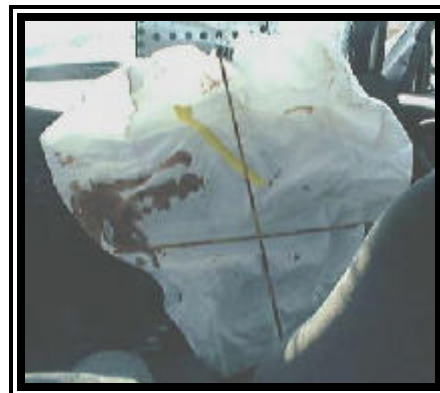
The front right passenger air bag deployed from the right top instrument panel area with a single cover flap design hinged at the forward aspect. Although no contact evidence was identified on the exterior surface of the module cover flap, blood spattering was noted across the face and rear left aspect of the air bag. The cover flap was rectangular in shape and measured 36.0 cm (14.2 in) in width and 16.0 cm (6.3 in) in height. The NASS researcher measured the passenger air bag at 48.0 cm (18.9 in) in width and 65.0 cm (25.6 in) in height in its deflated state (**Figure 7**). No internal tether straps or vent ports were reported for the front right passenger air bag.

**Figure 7.** 1999 Chevrolet Cavalier Z24 deployed redesigned passenger air bag.

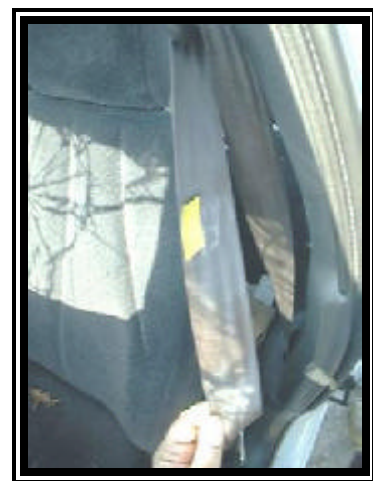
The 41 year old female driver of the 1999 Chevrolet Cavalier Z24 was restrained by the available 3-point manual lap and shoulder belt system, seated in an upright posture with the seat track adjusted to a mid-to-forward position. Belt usage was evidenced by the loading marks documented to the front left shoulder belt webbing (**Figure 8**) relative to the soft tissue injuries sustained across the occupant belt path. At impact, she initiated a forward trajectory in response to the 12 o’clock impact force and loaded the manual restraint, knee bolster and deployed redesigned driver air bag. Loading of the manual restraint resulted in abrasions and contusions to the right hip and left chest. Contact to the knee bolster resulted in bilateral knee

**Figure 8. Loading marks to the driver’s shoulder belt webbing.**
