**REDESIGNED AIR BAG SPECIAL STUDY (RABSS)  
SCI TECHNICAL SUMMARY REPORT**

**NASS RABSS CASE NO. 1999-45-807E**

**RABSS VEHICLE - 1998 FORD F-150 PICKUP TRUCK**

**LOCATION - STATE OF TENNESSEE**

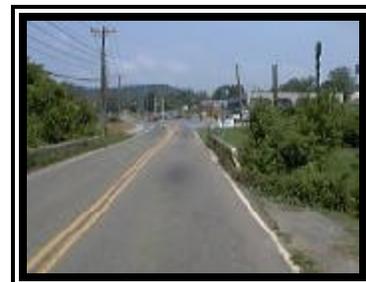
**Figure 1. Northbound approach for the 1998 Ford F-150 pickup truck.**

encroaching into his path of travel. Upon recognition of the impending harmful event, he steered right and exited the east pavement edge (**Figure 1**). There were no brake marks within the vehicle's trajectory indicative of pre-impact braking.

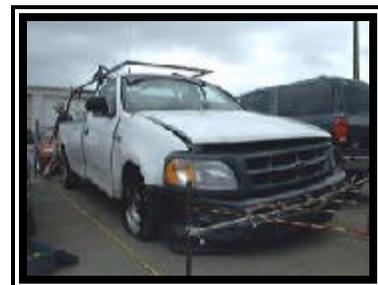
The Ford pickup sustained moderate frontal damage as a result of the impact with the bridge (**Figure 2**). The direct contact damage began at the front right bumper corner and extended 26.0 cm (10.2 in) inboard. The impact resulted in a combined direct and induced damage length (Field L) of 146.0 cm (57.5 in). Six crush measurements were documented at the level of the bumper: C1= 0 cm, C2= 0 cm, C3= 3.0 cm (1.2 in), C4= 8.0 cm (3.1 in), C5= 13.0 cm (5.1 in), C6= 44.0 cm (17.3 in). The direct contact damage extended 86.0 cm (33.9 in) rearward to the right front wheel which restricted and deflated the tire. The right wheelbase was displaced 27.0 cm (10.6 in). The windshield was fractured from interior occupant contact (only).

**Figure 2. Frontal damage to the 1998 Ford F-150 pickup truck.**

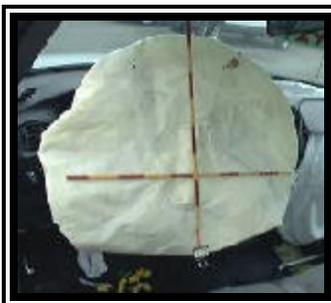
**Figure 4. 1998 Ford F-150 redesigned driver air bag.**

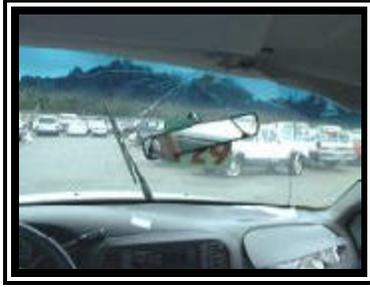
**Figure 7. Occupant contact damage to the sunvisor/rear-view mirror.**

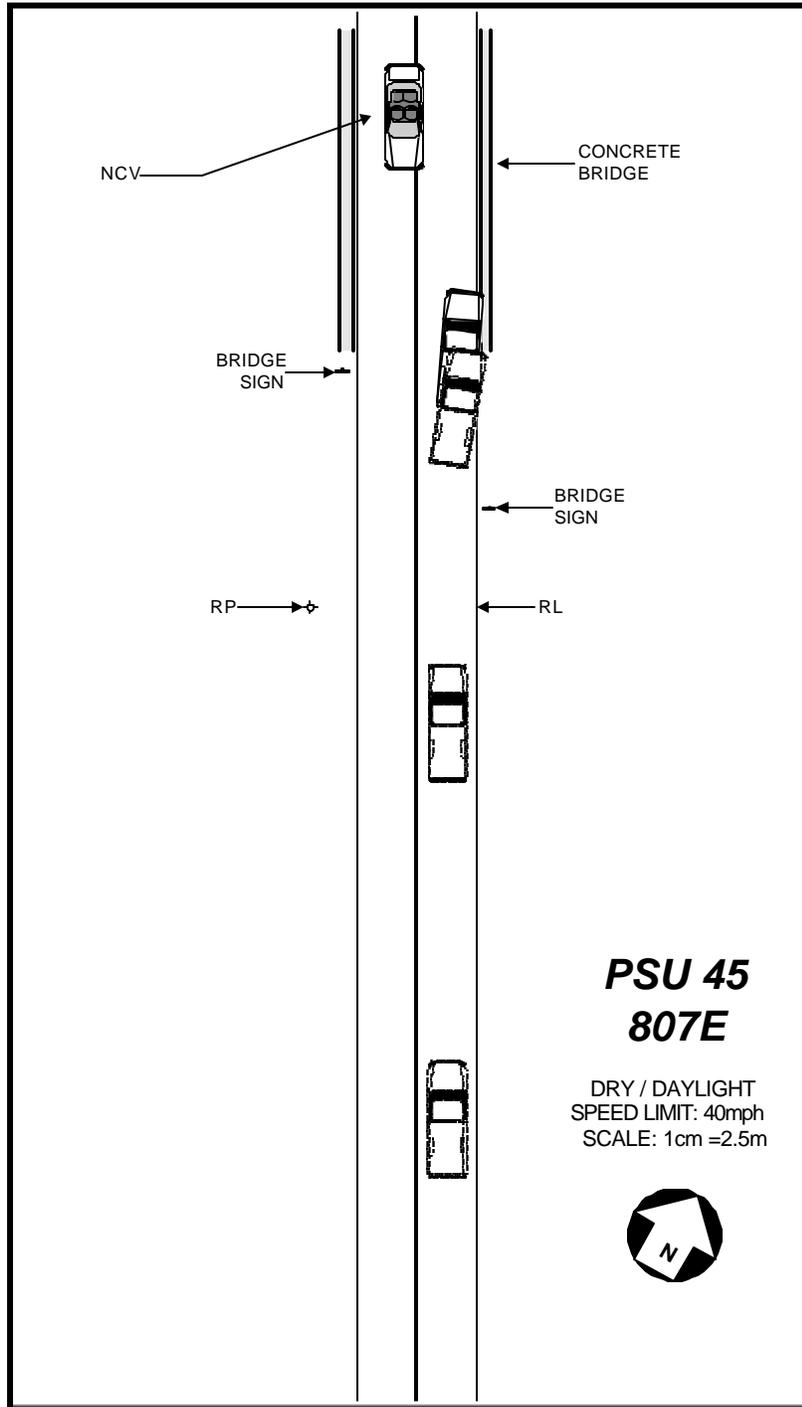
Figure 8. NASS Scene Diagram

This single vehicle crash occurred during the early evening hours of July, 1999. At the time of the crash, it was daylight with no adverse conditions as the roads were dry. The crash occurred off the east pavement edge of a 2 lane north/south asphalt roadway (see **Figure 8 - page 5**). No traffic controls were present at the scene which had a posted speed limit of 64 km/h (40 mph).
