Remote, Redesigned Air Bag Special Study

Dynamic Science, Inc., Case Number (1999-48-134C)

1998 Chevrolet Cavalier

August, 1999

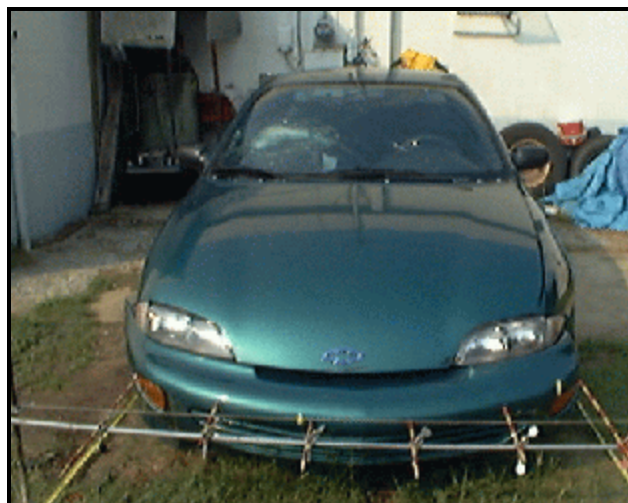
**Figure 2.** Exterior, Vehicle 2 (case vehicle)

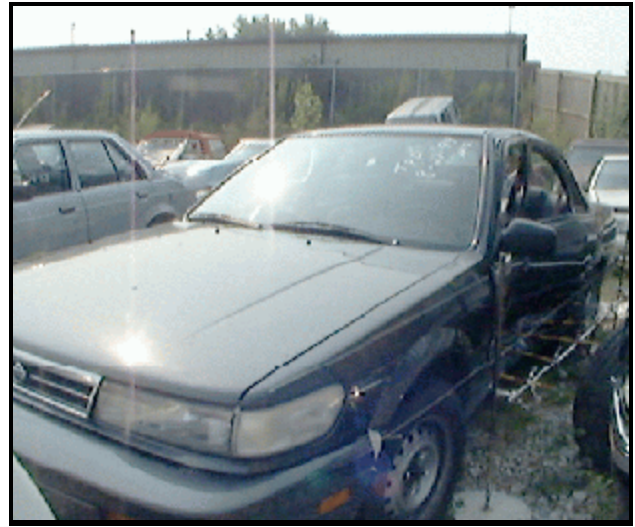
Figure 3. Exterior, Vehicle 1

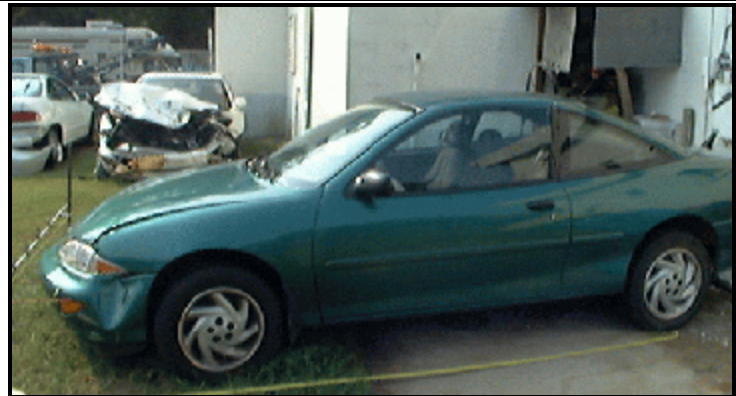
Figure 4. Exterior, Vehicle 2 (case vehicle)

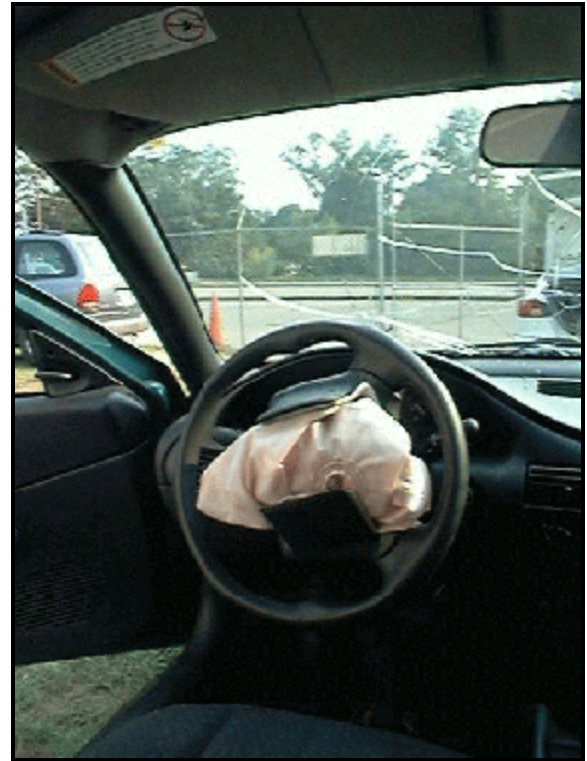
The 1998 Chevrolet Cavalier two-door coupe was equipped with a redesigned air bag system which consisted of a crash sensor diagnostic control module, air bag warning lamp, front left and front right air bag modules which housed the air bags and inflator units. The front left air bag was housed in the steering wheel hub and was concealed by symmetrical double vertical module cover flaps. The circular air bag was an untethered design equipped with two vent port holes. The lower instrument panel is equipped with a rigid plastic knee bolster. There was no discernible contact damage to the knee bolster, air bag, or module cover flaps.

**Figure 5.** Interior, Vehicle 2—left front seat position

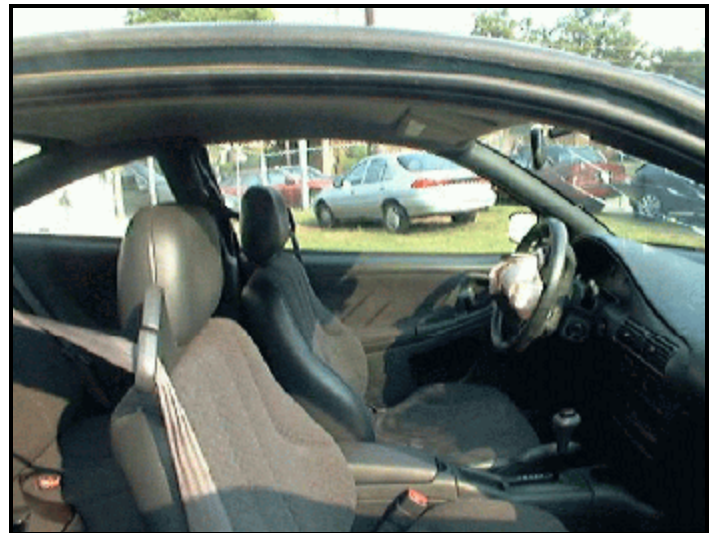
The interior of the 1998 Chevrolet Cavalier was undamaged as a result of this moderate frontal crash. The case vehicle maintained its integrity and there were no intruding components. There was a light brown cloth transfer to the right side of the driver’s air bag, a scratching contact to the transmission lever, and the mirror had been moved. This vehicle is equipped with bucket seats with folding backs and adjustable head restraints. Both front seats were in the middle track position. The second row was equipped with a bench seat with folding backs. There was no intrusion or integrity loss.

**Figure 6.** Interior, Vehicle 2

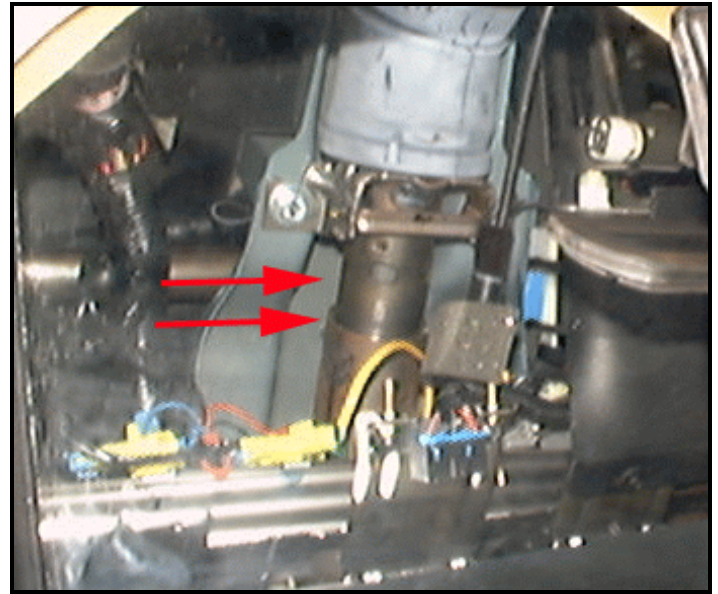
The 44-year-old female driver of the Chevrolet Cavalier was wearing the available three-point manual lap and shoulder belt. She was seated in a forward facing position. The cloth-covered bucket seat was in the middle track position. Prior to impact, the driver began braking (no lockup). At impact, the driver reacted to the slight positive principle direction of force by moving forward and to the right. The driver's forward momentum was restrained by the lap and shoulder harness but there appears to have been some significant loading of the air bag. This was evidenced by what appears to be some compression of the steering column (see Figure 8). This contact likely caused the chest contusion.

**Figure 8.** Steering column
