Remote, Redesigned Air Bag Special Study

Dynamic Science, Inc., Case Number (1999-75-019E)

1998 Ford Contour (Vehicle 1) 1998 Honda Civic (Vehicle 2)

February/ 1999

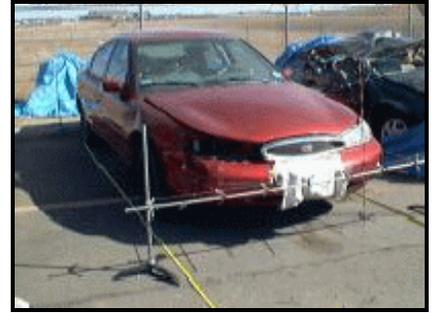
As Vehicle 1 & 2 entered the intersection, the frontal plane of Vehicle 1 (01FREE4) impacted the front of Vehicle 2 (11FDEW2) in an offset, head-on impact configuration. The calculated delta V for Vehicle 1 was 15.8 km/h (9.8 mph) with a longitudinal delta V of -13.6 km/h (-8.5 mph)¹ which is at the low end of the threshold necessary for air bag deployment. Vehicle 2's delta V was calculated at 19.8 km/h (12.3 mph) with a longitudinal delta V of -18.6 km/h (-11.6) which is within the threshold necessary for air bag deployment.

Figure 3. Front, three-quarter view showing front damage to Vehicle 1

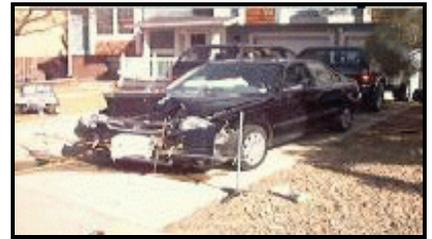
Figure 4. Front, three-quarter view showing frontal damage to Vehicle 2

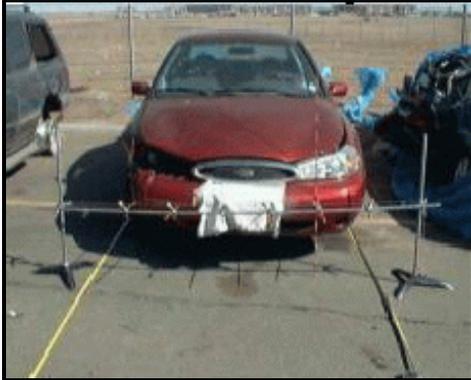
Figure 5. Full frontal view of Vehicle 1

Plane of Impact	Field L cm/in.	C1 cm/in.	C2 cm/in.	C3 cm/in.	C4 cm/in.	C5 cm/in.	C6 cm/in.
Front bumper	142	1	0	0	0	0	15
	55.9	0.4	0	0	0	0	5.9

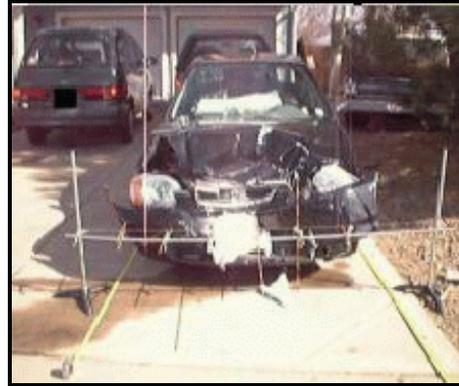
Figure 6. Full frontal view of Vehicle 2

Plane of Impact	Field L cm/in.	C1 cm/in.	C2 cm/in.	C3 cm/in.	C4 cm/in.	C5 cm/in.	C6 cm/in.
Front bumper	139	0	9	37	11	0	0
	54.7	0	3.5	14.6	4.3	0	0

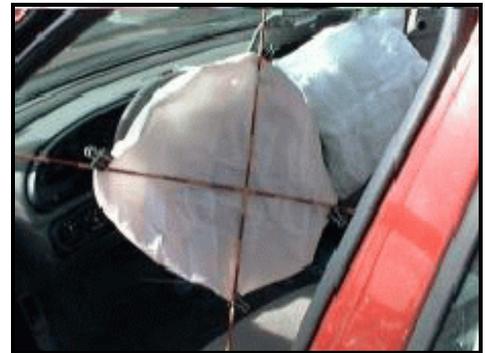
The front left air bag was housed in the steering wheel hub and was concealed by symmetrical double horizontal module cover flaps. The circular air bag was tethered by one straps and was equipped with two vent port holes. The lower instrument panel is shrouded with a rigid plastic knee bolster. There were no discernable areas of occupant contact to the air bag fabric, however, the driver did contact the deploying air bag. The air bag was undamaged and the air bag module flap covers separated at their designated tear points.

Figure 7. Deployed driver's air bag

The 32 year-old-male driver of the 1998 Ford Contour was unrestrained and responded to the 1 o'clock principle direction of force by moving forward and to his right. His knees probably contacted the knee bolster, however there was no physical evidence or injury data to support this. His face impacted the deploying air bag which resulted in numerous facial abrasions (AIS-1). His head continued forward and possibly contacted the rear view mirror which resulted in a right frontal scalp laceration and abrasion (AIS-1). It is suspected that he sustained a cervical neck strain (AIS-1) as a result of this impact. The driver rebounded rearward into his respective seatback support.

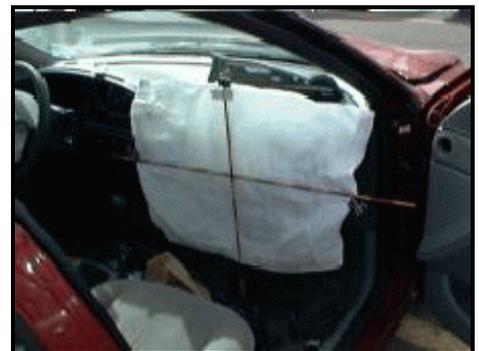
Damage to the interior of the 1998 Ford Contour consisted only of windshield glazing damage due to the passenger side air bag module flap cover contacting the windshield during deployment. There were no intruding components and the interior was void of any discernable occupant contacts.

Figure 8. Deployed front passenger air bag

The front right air bag was located on the instrument panel, top surface plane. The module cover flap is an asymmetric shape that contours the instrument panel. It is primarily a rectangular shape. The module cover flap opened at its designated tear points and broke the laminated windshield glazing upon deployment. The untethered air bag was undamaged and was equipped with one vent port hole. There was no occupant positioned in front of this air bag.

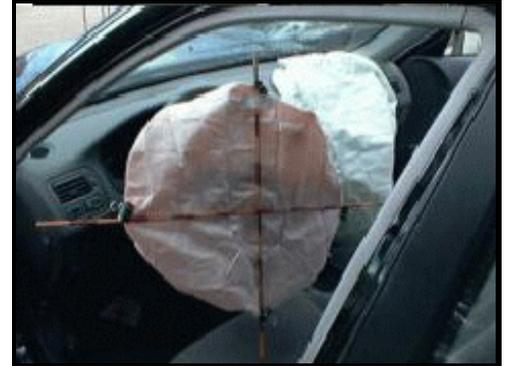
The driver's air bag is housed in the steering wheel hub and encases the nylon air bag unit. The double, horizontal, module cover flaps are asymmetric in design and opened at their designated tear points. The circular air bag is 63 cm (24.8 in.) in diameter and is equipped with two tether straps and two exhaust vent port holes. The vent ports are located at the 11 and 1 o'clock positions respectively. The rigid plastic knee bolster was undamaged and did not reveal any detectable occupant contacts.

Figure 9. Deployed driver's air bag

The 16 year-old-male driver of Vehicle 2 (1998 Honda Civic) was fully restrained by the available three-point manual lap and shoulder belt. He responded to the 340 degree principle direction of force by moving primarily forward and slightly to his left. The interior components were basically void of any obvious occupant contacts, however, the driver's face impacted the deploying air bag which resulted in a nose contusion and a nasal fracture (AIS-1). He rebounded rearward into his respective seatback where he came to rest.

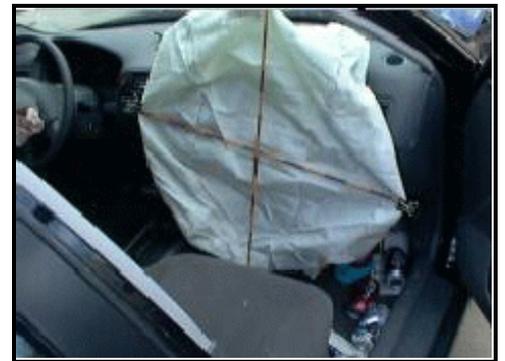
The interior of the 1998 Honda Civic four-door sedan sustained minor interior damage that was isolated to a cracked windshield. The laminated windshield was damaged as a result of the passenger air bag deployment. The interior was void of any remarkable areas of occupant contact evidence. This vehicle is equipped with front bucket seats and adjustable head restraints. The front, left seat was adjusted between the middle and rearmost track position. The seatback was adjusted to be slightly reclined. The front, right seat track was adjusted between the middle and rearmost position. The front adjustable head restraints were undamaged. The second row was equipped with a bench seat with folding back(s). There were integral head restraints available at the rear seat, outboard positions.

The front, right passenger air bag is located on the instrument panel (top mount). The module deployment door is rectangular in design and is equipped with double horizontal cover flaps that are symmetrical in design (23 cm wide x 5 cm in height). Upon deployment, the encased air bag fully deployed. The non-tethered air bag was undamaged and was equipped with two vent port holes which are at the 9 and 3 o'clock positions.

Figure 10. Deployed front passenger air bag
