Remote, Redesigned Air Bag Special Study

Dynamic Science, Inc., Case Number (1999-079-803E)

2000 Audi TT 3-door hatchback

November/1999

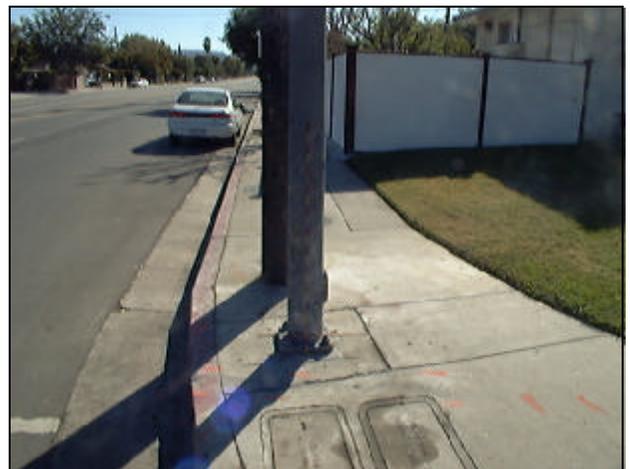
**Figure 2.** Crash scene. Point of impact with utility pole.

The driver of Vehicle 1 initiated the left turn at a high rate of speed and lost control of the vehicle. Vehicle 1 struck the southwest raised concrete curb with both front wheels (12FDWN3) damaging the rims and deflating the tires (event 1). Vehicle 1 then continued off the roadway and struck a metal utility pole (event 2) with the front plane (12FLEN4).

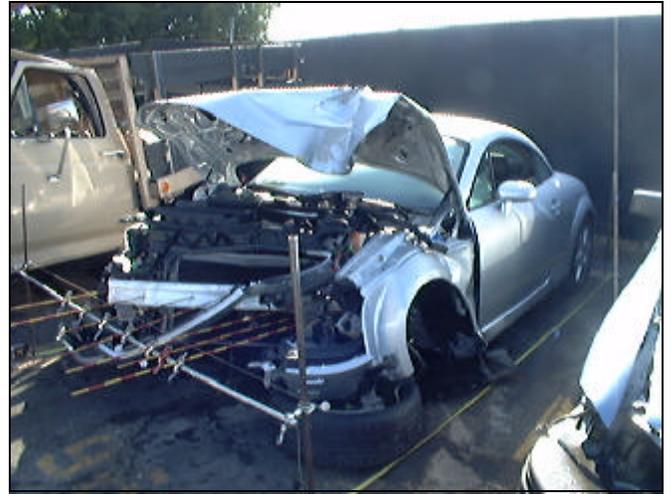
Figure 3. Exterior, Vehicle 1 (Audi TT)

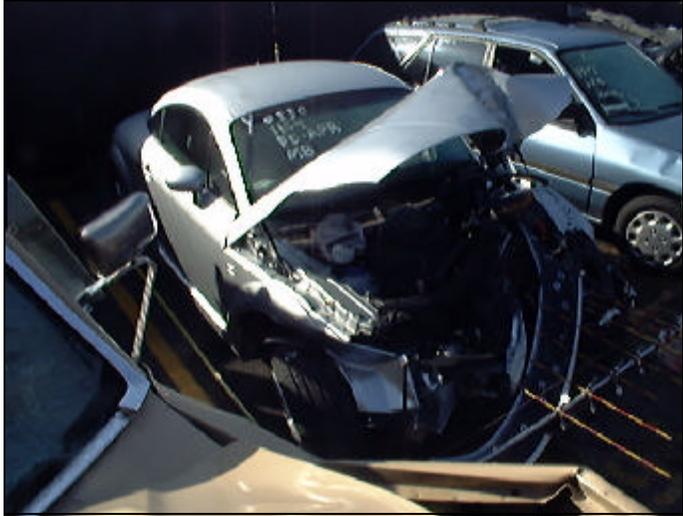
**Figure 4.** Exterior, Vehicle 1 (2000 Audi TT 3-door hatchback)

Plane of Impact	Field L cm/in.	C1 cm/in.	C2 cm/in.	C3 cm/in.	C4 cm/in.	C5 cm/in.	C6 cm/in.
Bumper	142	57	70	43	25	8	0
	55.9	22.4	27.6	16.9	9.8	3.1	0

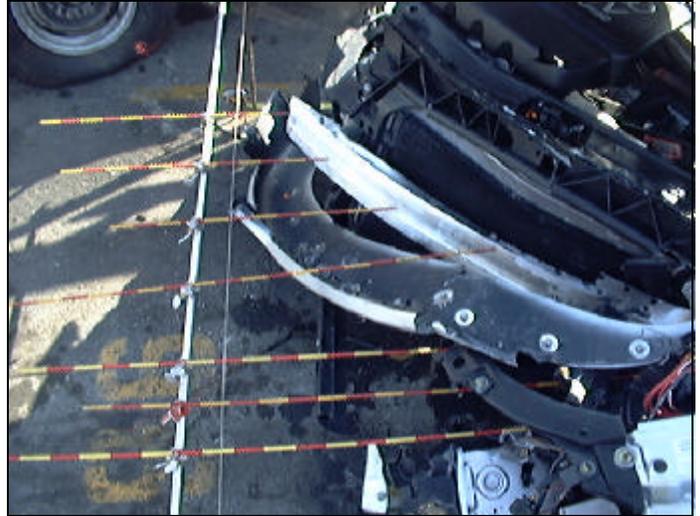
**Figure 5.** Exterior, Vehicle 1 (2000 Audi TT 3-door hatchback)

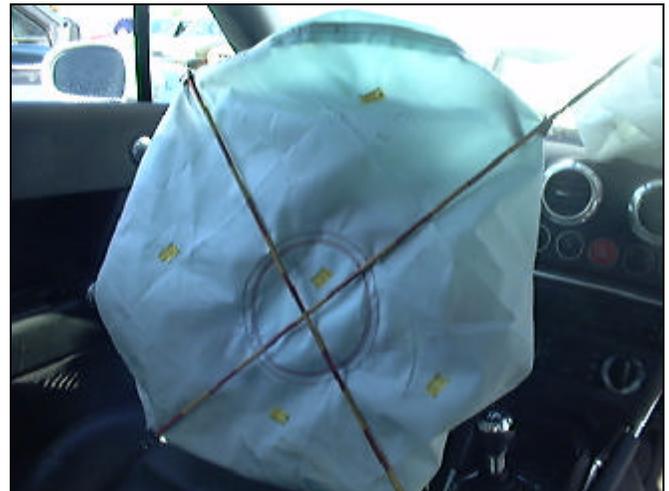
The front left air bag was housed in the steering wheel hub and was concealed by asymmetrical H-configuration cover flaps which were not damaged in the crash. The circular air bag was equipped with four tether straps and one vent port. Contact evidence consisting of blood, smudges, and scuffs was found on the front of the air bag. The bag was not damaged.

**Figure 6.** Interior, case vehicle. Driver's frontal air bag.

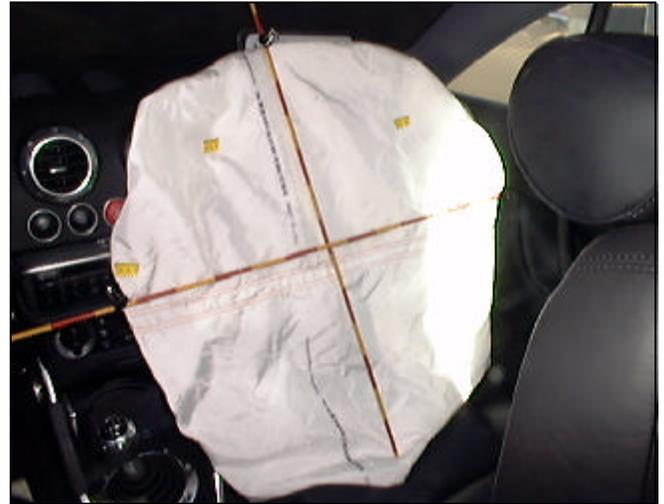
The front right air bag was housed in the mid-instrument panel position and was concealed by a single rectangular shaped cover flap which was not damaged in the crash. The rectangular air bag was equipped with one tether strap and two vent ports. Contact evidence consisting of “smudges” was found on the upper half of the front of the air bag. The bag was not damaged. The center instrument panel mounted passenger’s frontal air bag shut off switch was turned to the “on” position at the time of the crash.

**Figure 7.** Interior, case vehicle. Passenger’s frontal air bag.

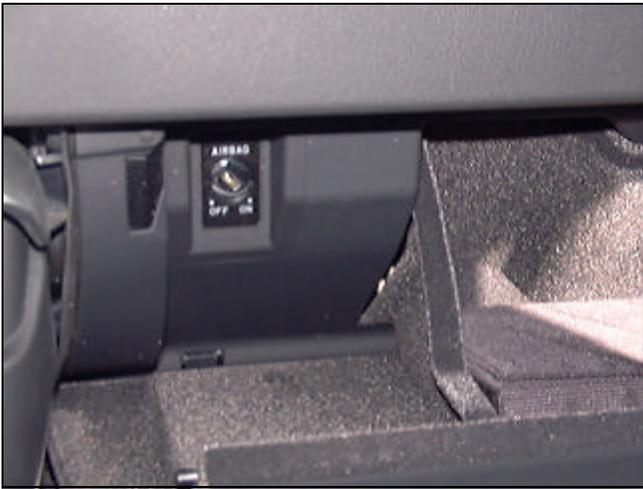
**Figure 8.** Interior, case vehicle. Passenger’s frontal air bag shut off switch.

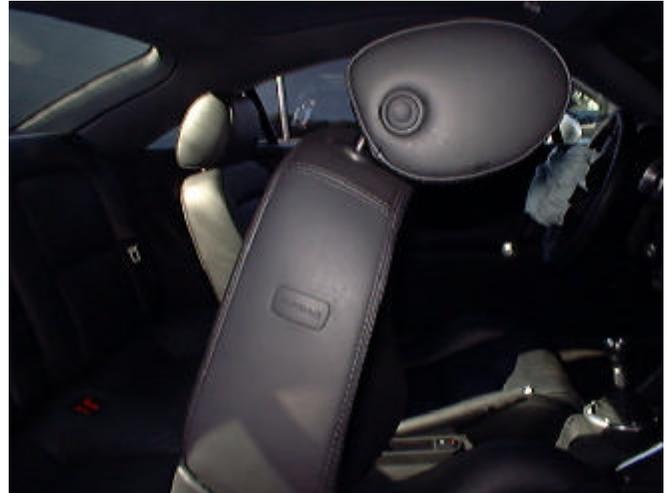
The Audi TT was also equipped with seat back mounted side air bags in the front left and front right seating positions which did not deploy in this frontal impact.

**Figure 9.** Interior, case vehicle. Side impact air bag system.

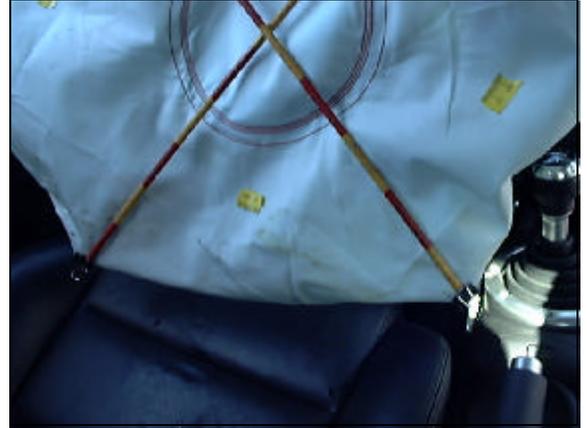
**Figure 10.** Interior, case vehicle. Driver's frontal air bag contact evidence.
