ON-SITE AIR BAG INVESTIGATION

CASE NUMBER - IN99-002

VEHICLE - 1999 PONTIAC GRAND AM SE

CRASH DATE - January, 1999

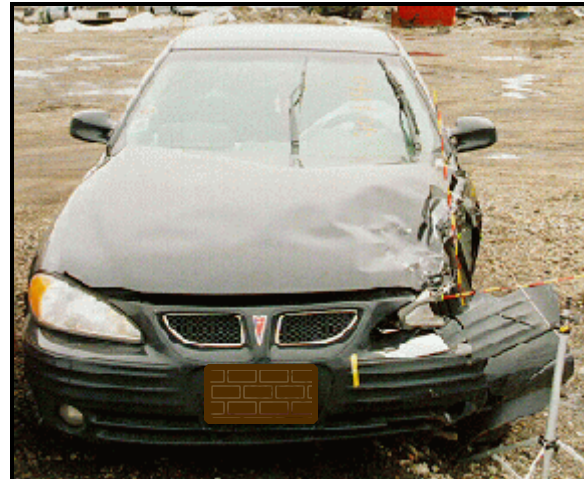
The left front (**Figures 3 and 4**) of the case vehicle was impacted by the front left (**Figures 5 and 6**) of vehicle #2. This initial impact triggered the case vehicle's driver and front right supplemental restraints (air bags) to deploy. The case vehicle was pushed backwards, in a northwesterly direction, a short distance and rotated approximately 50 degrees clockwise before coming to rest in the intersection heading south-southwestward (**Figure 7** below). Vehicle #2 continued westward a short distance post-impact while rotating approximately 20 degrees counterclockwise. The front right corner of vehicle #2 contacted the case vehicle's driver door during the rotation (**Figures 8, 9, and 10** below). Vehicle #2 also came to rest in the intersection, heading essentially westward (**Figure 7** below).

Figure 3: Case vehicle viewed from front showing damage to left fender and some direct damage to front left bumper (vertical tape mark); Note: string line down left side (case photo #13)

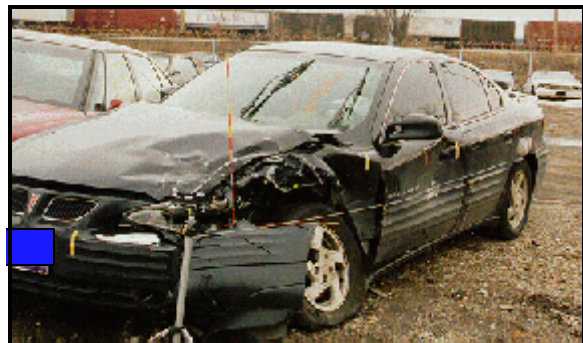
Figure 4: Case vehicle's damaged left front from impact with vehicle #2; Note: direct contact to front bumper (case photo #17)

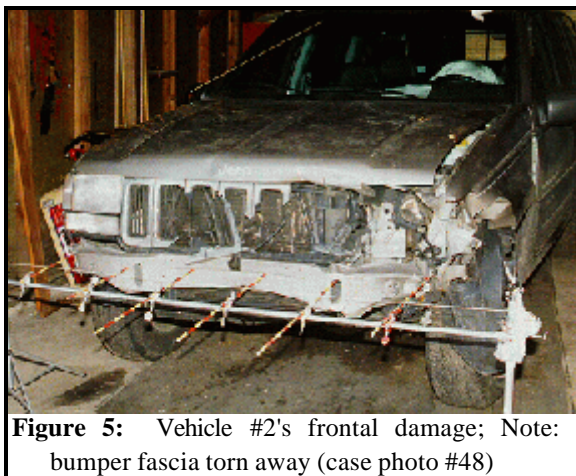
Figure 5: Vehicle #2's frontal damage; Note: bumper fascia torn away (case photo #48)

Vehicle #2's frontal impact with the case vehicle tore away the front bumper fascia, pushed the bumper reinforcement beam inward and knocked out the front left headlight assembly (**Figures 5** and **6** above). The entire grille and left front fender sustained induced damage. The field "L" and direct damage

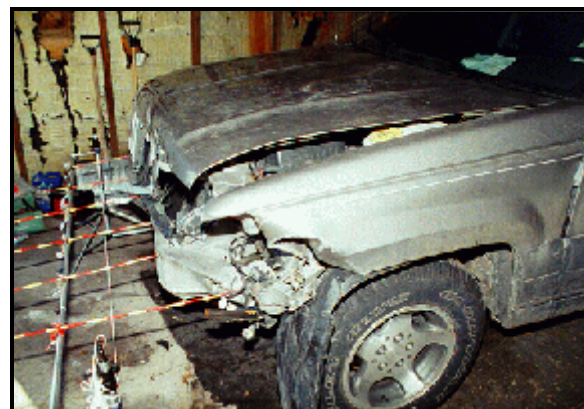
Figure 6: Reference line view of vehicle #2's frontal crush; Note: maximum crush at C₁ (case photo #49)

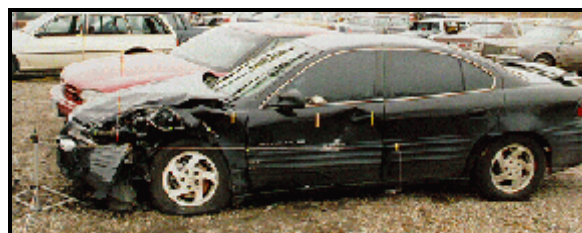
Figure 9: Case vehicle's left side damage extending from left front bumper to just past left "B"-pillar (case photo #18)

centimeters (53.5 inches), ending just forward of the “A”-pillar (**Figure 9** above). Visible direct damage starts again on the driver’s door, 65 centimeters (25.6 inches) further rearward of where the original direct damage ended (**Figure 10**), and continues backward for a measured distance of 41 centimeters (16.1 inches). This separation of visible direct damage resulted from vehicle #2’s front right bumper corner contacting the left front door as the front of vehicle #2’s bumper rotated counterclockwise off the case vehicle’s left front wheel assembly. The wheelbase on the case vehicle’s left side was shortened 11 centimeters (4.3 inches) with the right side being lengthened 6 centimeters (2.4 inches) from the crash. The front left bumper fascia, left fender and front left headlight assembly were crushed rearward. The windshield had a spider web crack from the front right passenger’s head. The left front tire was flattened and physically restricted from the left front impact damage (**Figures 4** and **8** above).

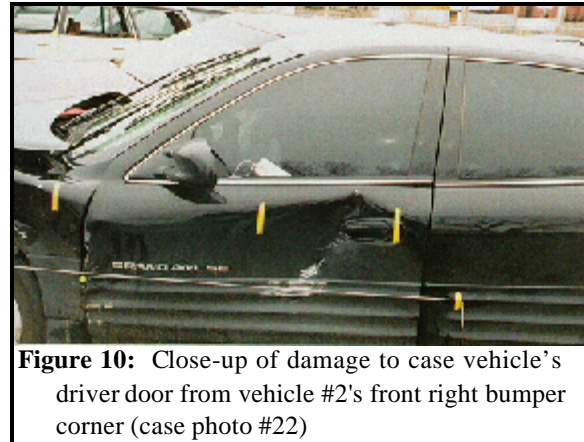
Figure 10: Close-up of damage to case vehicle’s driver door from vehicle #2’s front right bumper corner (case photo #22)

Based on the vehicle inspection, the CDCs for the case vehicle were determined to be: **11-LYEW-2 (330)** and **10-LPEN-1** [maximum crush was 23 centimeters (9.1 inches) at C₄ for the primary impact]. The WinSMASH reconstruction program, damage only algorithm, was used on the case vehicle’s highest severity (i.e., initial) impact. The Total, Longitudinal, and Lateral Delta Vs are, respectively: 20.7 km.p.h. (12.9 m.p.h.), -17.9 km.p.h. (-11.1 m.p.h.), and +10.4 km.p.h. (+6.5 m.p.h.). This contractor believes the longitudinal results are slightly low because the impact to the case vehicle involved the left front wheel (**Figure 4** above) assembly (i.e., stiffest part of vehicle), and the WinSMASH algorithm cannot be adjusted to account for the higher stiffness.

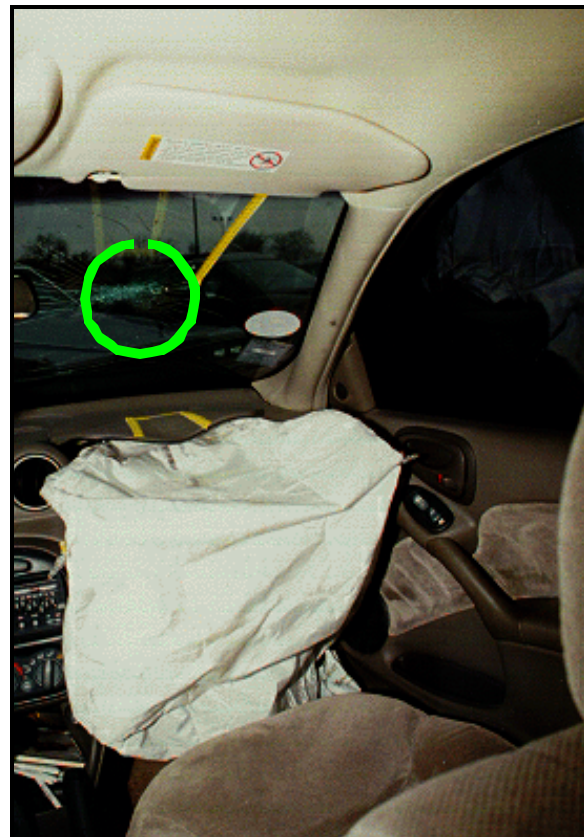
Figure 11: Vertical view of contact evidence from front right passenger to case vehicle’s front right air bag module’s cover flap as well as top and front portions of air bag; Note: contact and skin spray to windshield (case photo #34)

An examination of the case vehicle’s interior revealed a cracked windshield from the front right passenger contacting it with his head (**Figure 11**). The energy absorbing steering column showed no evidence of compression. The driver’s window glazing, at the top towards the front, had an oil smudge and several strands of hair hanging down from the frame near the roof, almost certainly from contact by the case vehicle’s driver. There was an area of puddled blood on the front right passenger’s seat cushion near the

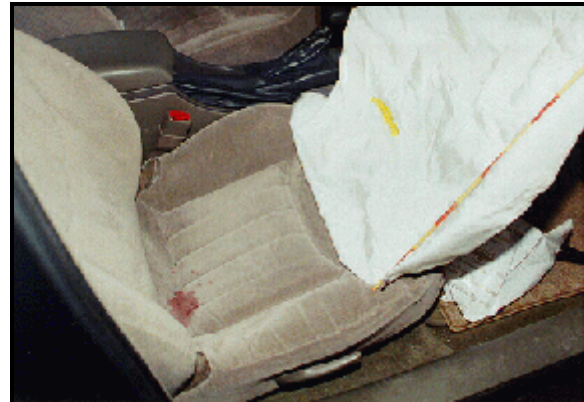
space between the seat cushion and seat back (**Figure 12**) and smeared blood on the right front door panel along the door handle area from the front right passenger. There was no intrusion noted within the interior.

Figure 12: Case vehicle's front right seat showing blood stain deposited by front right passenger at final rest position (case photo #43)

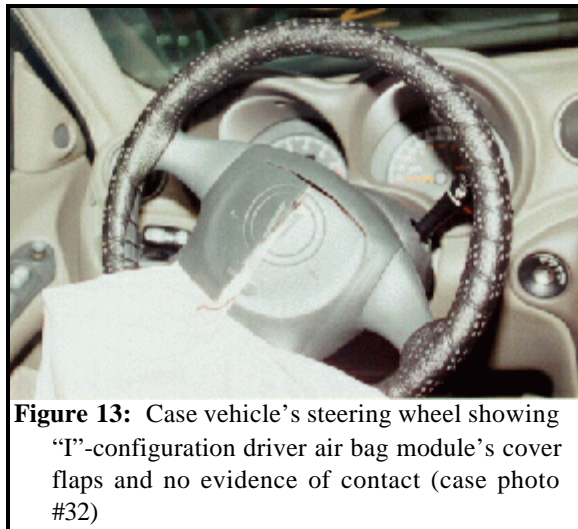
Figure 13: Case vehicle's steering wheel showing "T"-configuration driver air bag module's cover flaps and no evidence of contact (case photo #32)

points, and there was no evidence of damage during the deployment to the air bag or the cover flaps (**Figure 13** above). The driver's air bag was designed without any tethers. The driver's air bag had two vent ports, approximately 2 centimeters (0.8 inches) in diameter, located at the 11 and 1 o'clock positions. The deployed driver's air bag was round with a diameter of 67 centimeters (26.4 inches). There was a 22 x 16 centimeter (8.7 x 6.3 inch) area of contact evidence (i.e., a light pink make-up smear) that was not readily apparent on the driver's air bag in the upper right quadrant (**Figure 14** above).

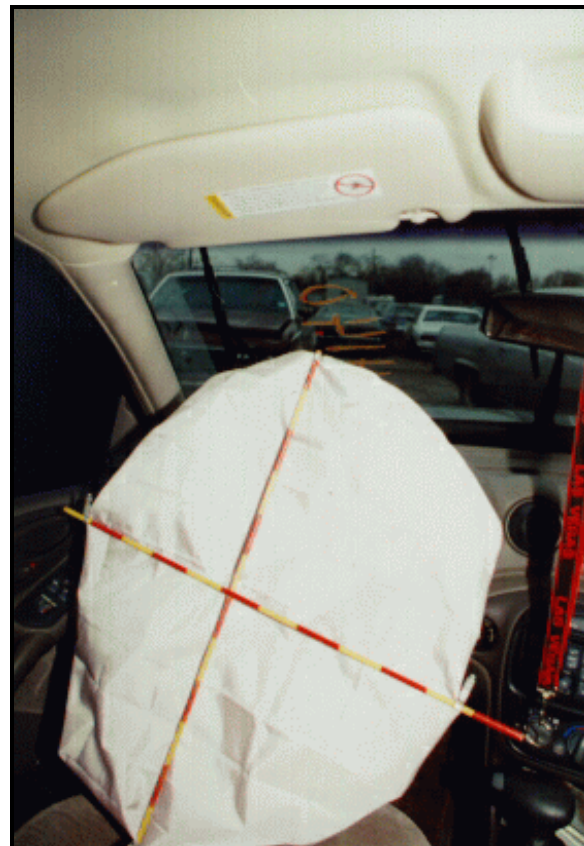
Figure 14: Case vehicle's driver seating area showing no contacts to left "A"-pillar, roof, or sun visor and no obvious evidence of contact to deployed air bag (case photo #30)

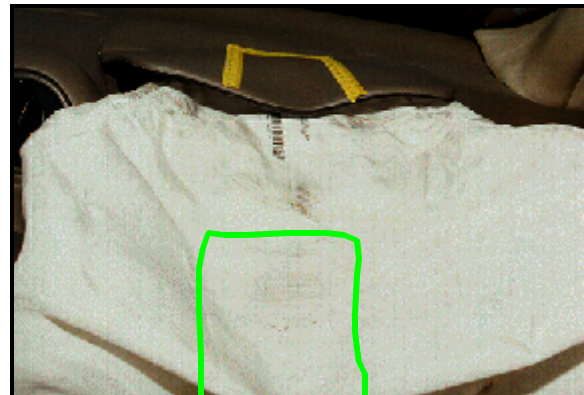
The front right passenger's air bag was located in the top of the instrument panel. There was a single, asymmetrical, modular cover flap. The cover flap was made of a thick vinyl over a thick metal type frame. The flap's dimensions were: 28 centimeters (11.0) at the forward horizontal seam, 34 centimeters (13.4 inches) at the rear (i.e., toward the windshield) horizontal seam, and 13 centimeters (5.1 inches) along both vertical seams. The profile of the case vehicle's instrument panel/dash resulted in a 7 centimeter (2.8 inch) setback of the leading edge of the cover flap relative to the protruding right instrument panel. An inspection of the front right passenger air bag module's cover flap and air bag revealed that the cover flap opened at the designated tear points, and there was significant intra-modular contact evidence (e.g., black streaks) to the top and front portions of the front right passenger's air bag and a large contact (e.g., scuff and deformation/indentation with skin transfer) to the cover flap from the front right passenger's chin (**Figure 15**).

The indentation/skin transfer was 8 centimeters (3.1 inches) wide and 8 centimeters (3.1 inches) deep and was located 9 centimeters (3.5 inches) from the left edge of the cover flap and 11 centimeters (4.3 inches) in from the right edge. The front right passenger's air bag was designed with two tethers, each 2.75 centimeters (1.1 inch) wide. Both tethers were sewn to the interior face of the air bag and were located approximately 10 centimeters (3.9 inches) inwards from the edges and was 47 centimeters (18.5 inches) down from the top edge. The front right passenger's air bag had no vent ports. The deployed front right passenger's air bag was rectangular with a height of approximately 74 centimeters (29.1 inches) and a width of approximately 51 centimeters (20.1 inches). There was contact evidence readily apparent [e.g., a blue and red streak (cloth transfer) and skin and oil transfers] on the front right passenger's air bag. Examination revealed a large transfer of skin to the top and front portions of the air bag (**Figure 16**). The skin transfer started approximately 27 centimeters (10.6 inches) down from the exhaust module of the air bag and extended downwards onto the front portion a total of 65 centimeters (25.6 inches). The skin transfer was

Figure 15: Close-up of contact evidence on case vehicle front right air bag module's cover flap and skin transfer to top of air bag (case photo #36)

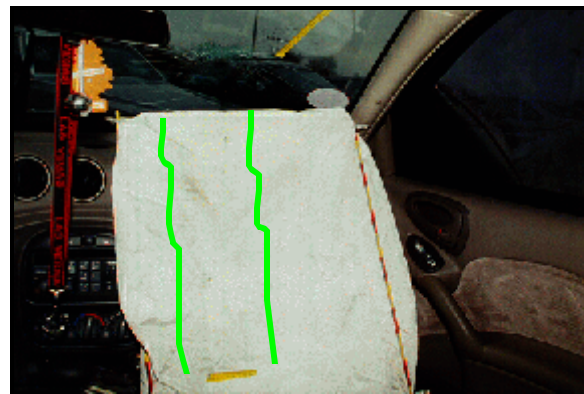
Figure 16: Skin evidence on front portion of case vehicle's front right passenger air bag (case photo #38)

approximately 15 centimeters (5.9 inches) wide and started 11 centimeters (4.3 inches) in from the left edge.

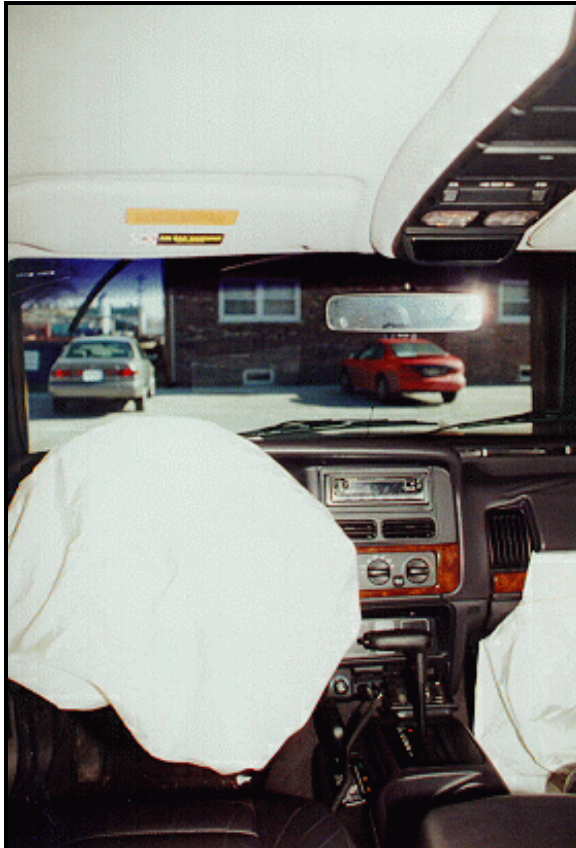
Figure 17: Vehicle #2's driverseating area showing no evidence of contact to greenhouse area or deployed driver air bag (case photo #57)

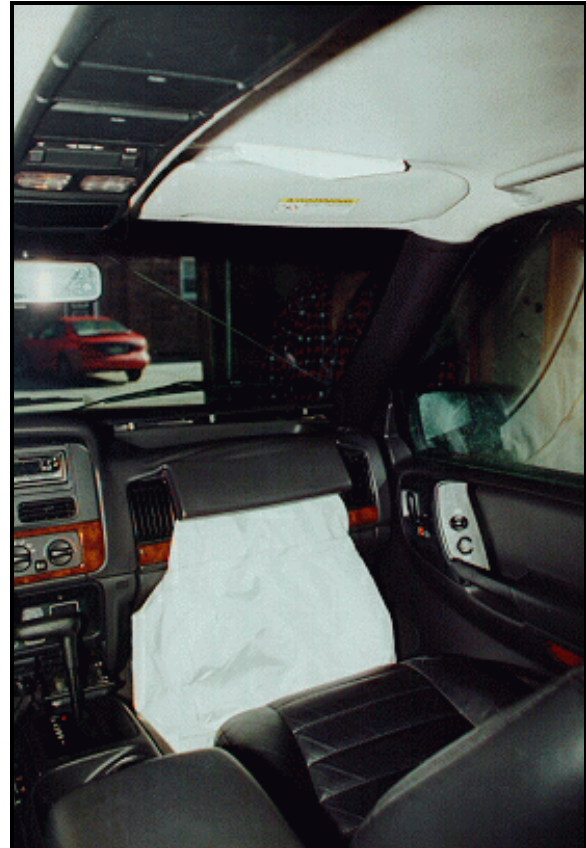
Figure 18: Vehicle #2's front right seating area showing no evidence of occupant contact to greenhouse area or deployed front right passenger air bag (case photo #59)
