School Bus Crash Investigation  
Dynamic Science, Inc.  
**Case 99002**  
Contract DTNH22-94-D27058  
Task 131  
Maryland  
March, 1999

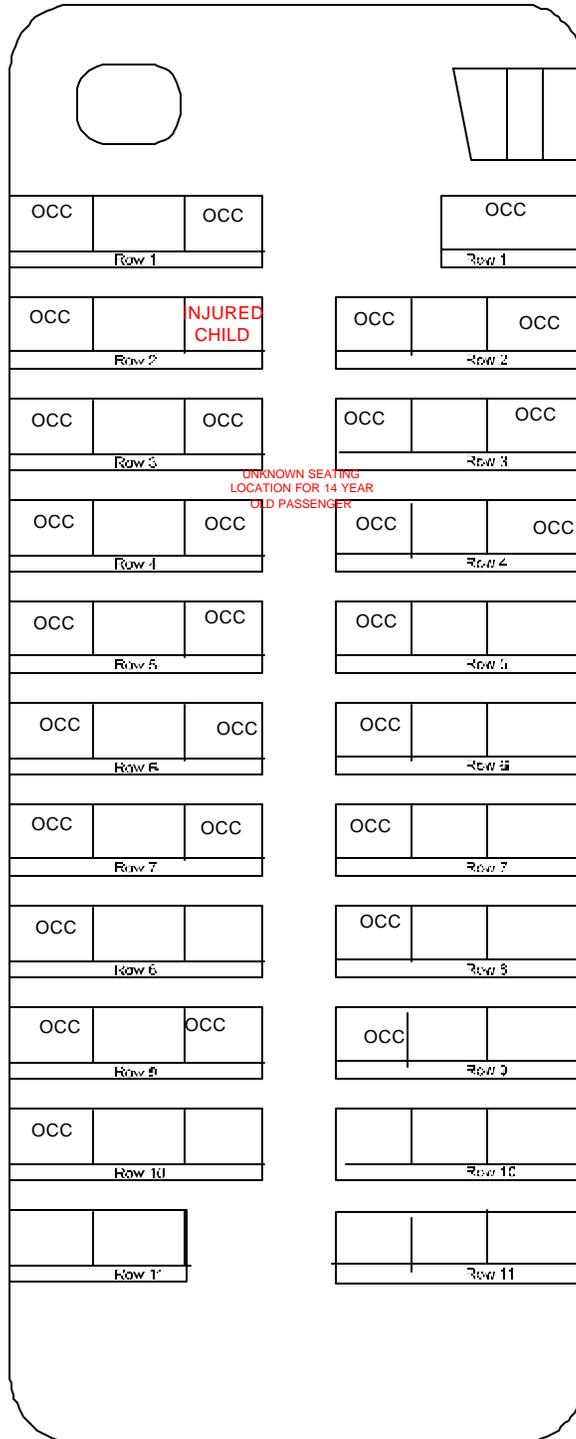
CASE 9902

The school bus has a seating capacity of 64 passengers. It was transporting 33 children between the ages of 11 and 17, and the bus driver. There were 11 rows of seats in the bus, as depicted in figure 1, with the left side seats having 3 designated seating positions and the right side seats having 3 designated seating positions.
