School Bus Crash Investigation  
Dynamic Science, Inc.  
**Case 99004**  
Contract DTNH22-94-D27058  
Task 131  
Ohio  
April, 1999

## Background

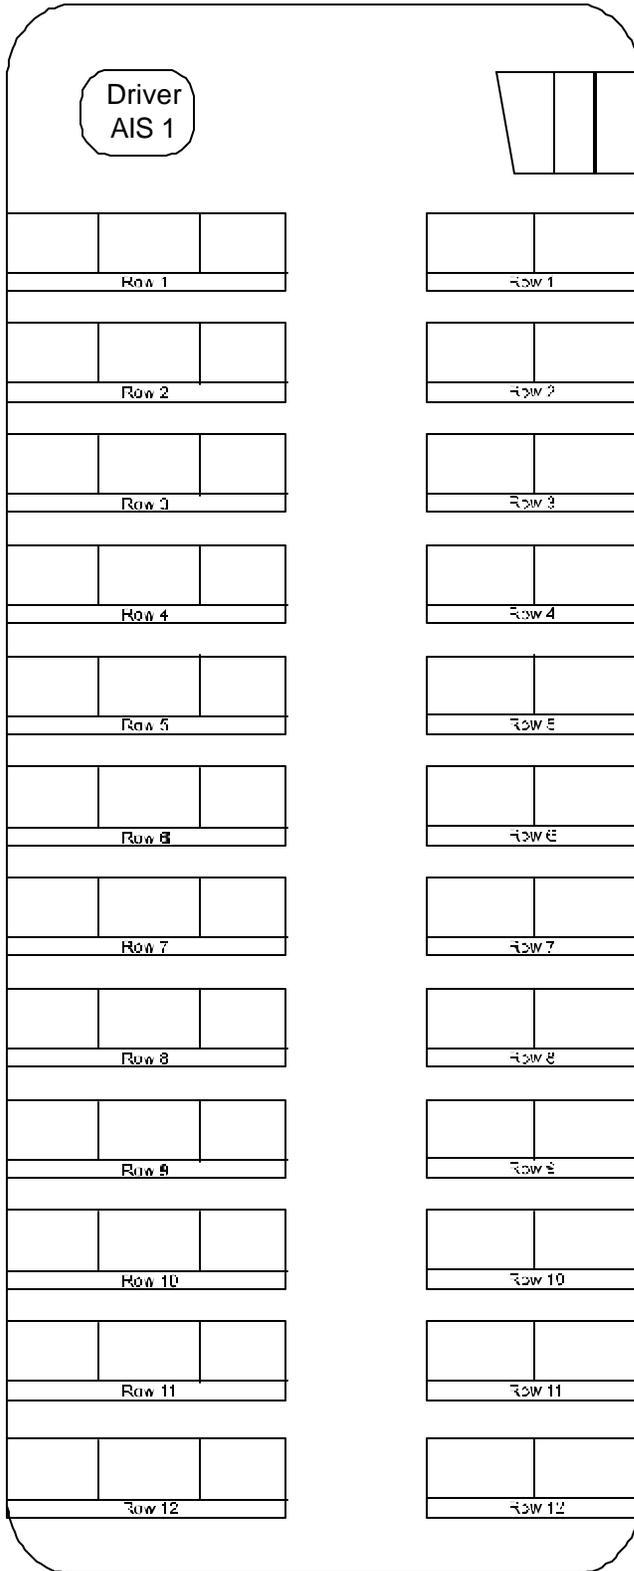
There were 35 occupants, the precise seating positions are unknown. All occupants allegedly received AIS 1 injuries
