**ON-SITE REDESIGNED AIR BAG DEPLOYMENT INVESTIGATION**

**VERIDIAN CASE NO. CA99-05**

**VEHICLE - 1998 HONDA ACCORD**

**CRASH DATE - APRIL 1999**

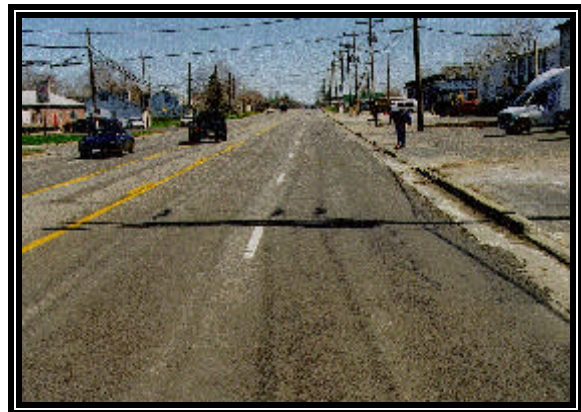
The crash occurred during daylight hours of April, 1999 on a five lane east/west suburban roadway. The road was straight and level and configured with two travel lanes for each direction and a center turn lane. The asphalt road surface was wet due to a combination of mixed precipitation and freezing temperatures at the time of the crash. A two lane road intersected from the north approximately 28 m (92 ft) east of the point of impact, forming a three leg intersection. The speed limit in the area of the crash was 64 km/h (40 mph). **Figure 1** is an eastbound trajectory approaching the point of impact.

**Figure 1:** Eastbound trajectory view of the 1998 Honda Accord.

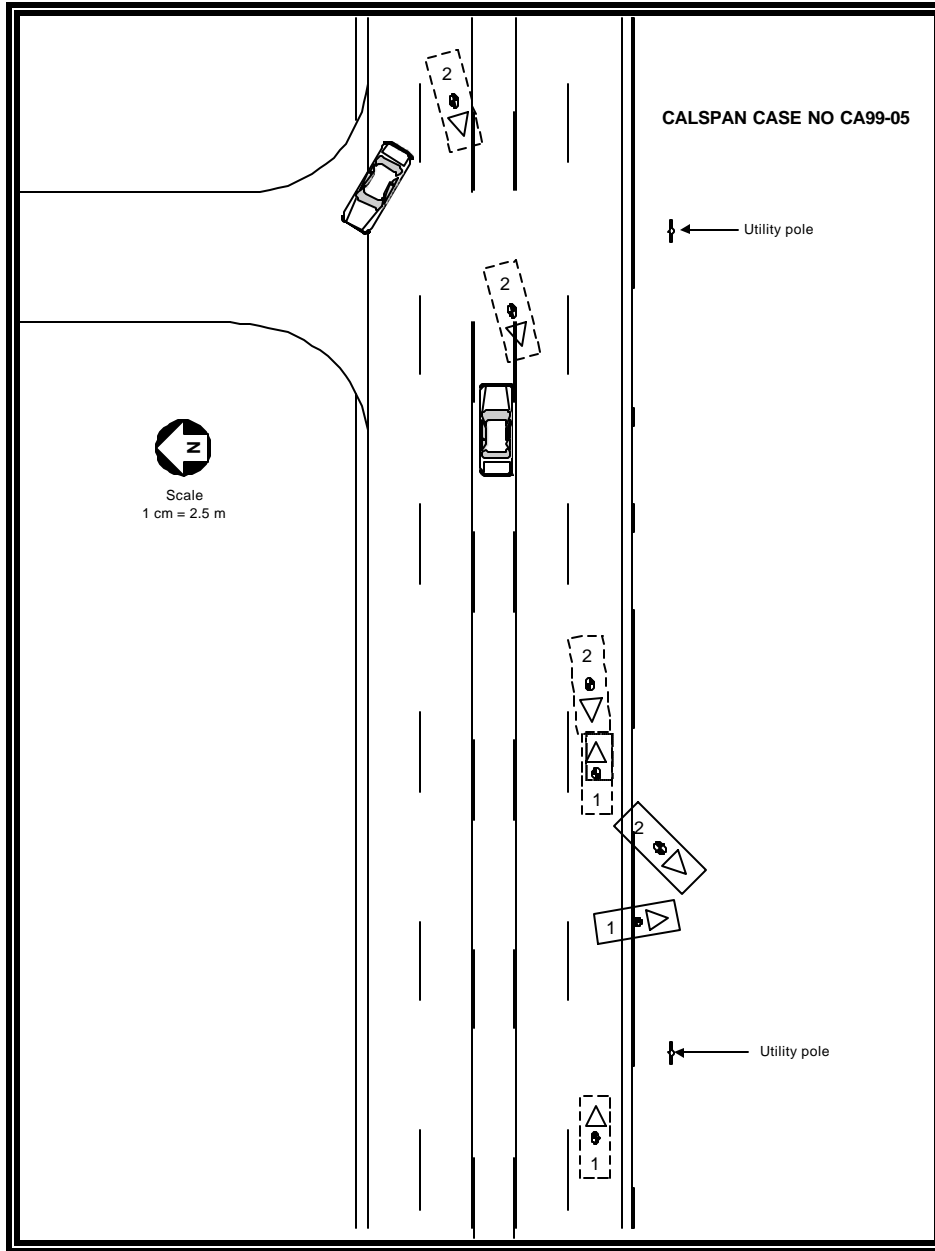
Figure 2: Crash Scene Schematic.

The Oldsmobile continued into the outboard eastbound travel lane where the impact occurred. The full frontal area on the Oldsmobile impacted and partially overrode the full frontal area of the Honda. The westward momentum of the Oldsmobile stopped and redirected the direction of the eastbound Honda to the west. The Honda slid westward approximately 9 m (30 ft) and rotated 90 degrees clockwise. The vehicle came to rest facing south, straddling the south roadside curb. The 12 o'clock direction of the impact force caused the deployment of the Honda's redesigned Supplemental Restraint System. Reconstruction analysis indicated the delta V of the Honda was 69 km/h (43 mph). Upon disengagement with the Honda, the Oldsmobile slid approximately 10 m (33 ft) southeastward. The vehicle came to rest facing southwestward, just off the south side of the road. The barrier equivalent delta V of the Oldsmobile was 80 km/h (50 mph). Refer to the crash schematic **Figure 2**.

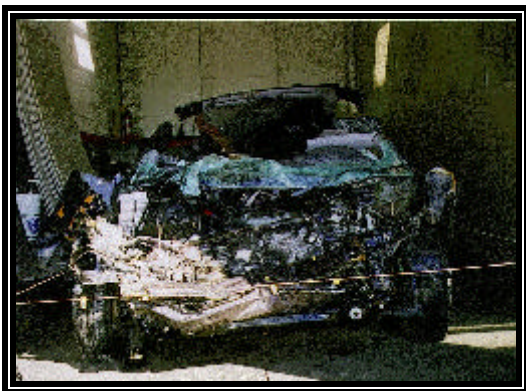
**Figures 3 and 4** are the front and left lateral views of the Honda. The vehicle sustained direct contact damage across the entire 147 cm (58 in) frontal end width. The crush profile measured at the elevation of the front bumper was as follows: C1=68.3 cm (26.9 in), C2=71.6 cm (28.2 in), C3= 76.7 cm (30.2 in), C4=69.9 cm (27.2 in), C5=49.5 cm (19.5 in), C6=46.7 cm (18.4 in). The energy of the impact was managed by the vehicle's primary structures forward of the instrument panel. The left and right wheelbases were fore-shortened 33.3 cm (13.1 in) and 25.7 cm (10.1 in), respectively. The left door was buckled and jammed shut by deformation. The right door remained close and was operational. The roof and left door were removed during the extrication of the occupants. The Collision Deformation Classification (CDC) of the vehicle was 12-FDEW-4. The Barrier Equivalent Speed (delta V) calculated by the barrier model of the WINSMASH program of the Honda was approximately 69 km/h (43 mph). The longitudinal and lateral components were -69 km/h (-43 mph) and 0 km/h, respectively.

**Figure 3:** Front view of the Honda.

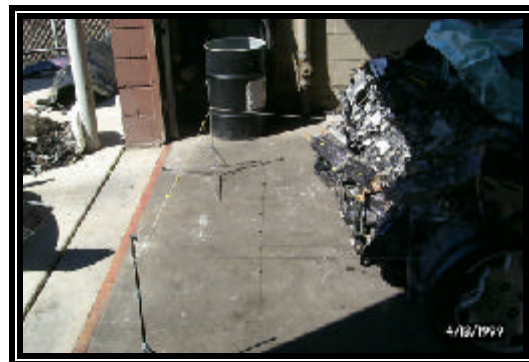
**Figure 4:** Left lateral view of the Honda.

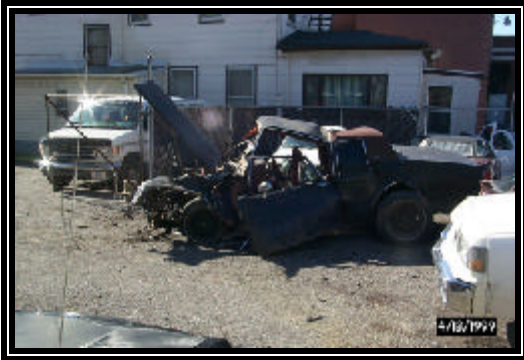
**Figures 5 and 6** are the left and right side views of the 1982 Oldsmobile Delta 88, 2-door. The Oldsmobile was identified by the Vehicle Identification Number (VIN): 1G3AN37Y1CM (production sequence deleted). The vehicle's power-train consisted of 5.0 liter, V8 engine linked to a 3-speed automatic transmission. The odometer read 273,504 km (169,952 miles) at inspection. The front restraint system consisted of 3-point lap and shoulder belts for the outboard positions.

The vehicle sustained direct damage across the entire 165 cm (65 in) frontal end width. The front bumper was displaced from the vehicle by the force of the impact. The crush of the left and right frame rails measured approximately 107 cm (42 in) and 127 cm (50 in) respectively. The left and right wheelbases were foreshortened (19.5 in) and (21.8 in), respectively. The force of the impact deformed the forward third of the vehicle rearward and buckled the roof. The vehicular damage extended rearward to the rear axle. The rear wheel well openings were deformed and the body was displaced from the frame. The left side of the rear axle was dislodged from the differential. The CDC of the damage was 12-FDEW-4. The

barrier equivalent speed (delta V) calculated by the barrier model of the WINSMASH program was approximately 80 km/h (50 mph).

**Figure 5:** Left side view of the Oldsmobile.

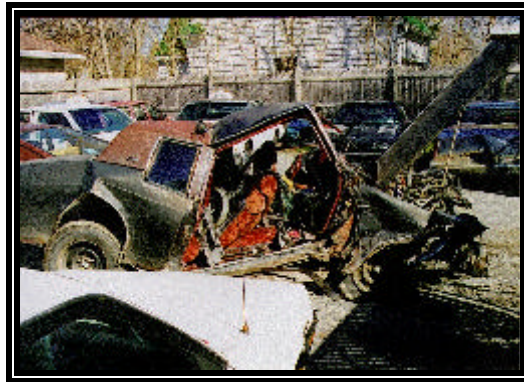
**Figure 6:** Right side view of the Oldsmobile.

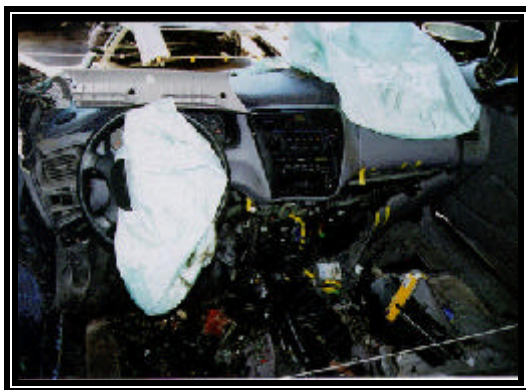
The occupant compartment and interior of the Honda Accord sustained moderate damage as a result of the external crash forces, **Figure 7**. The integrity of the occupant compartment was maintained during the crash, however the rescue operations required extrication of the occupants. The roof and left door were removed from the vehicle. Several interior occupant contacts were also identified during the course of the inspection.

**Figure 7:** View of the Honda interior.

The front seating system consisted of cloth covered, reclining bucket seats. Both seat backs were reclined rearward to their maximum positions. Presumably, the seat backs were adjusted during the rescue of the occupants. The left front seat track was adjusted to a position 5.3 cm (2.1 in) forward of full rear. The front right seat was adjusted to the full rear position. Two contacts were identified on the right knee bolster attributed to contact from the front right passenger's lower extremities. The contacts were located 24.1 cm (9.5 in) and 41.1 cm (16.2 in) right of vehicle centerline. Refer to **Figure 7**.

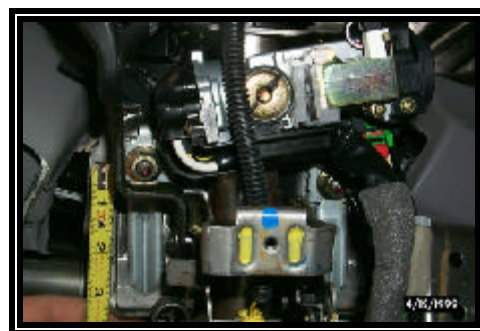
The steering assembly consisted of a 4-spoke, tilt steering wheel. The steering wheel was rotated 90 degrees clockwise at inspection. There was no deformation of the steering wheel rim. Displacement of the steering column's shear capsules measured 6.9 cm (2.7 in), **Figure 8**.

**Figure 8:** View of the shear capsule displacement.
