**VERIDIAN ON-SITE FRONTAL AIR BAG
ASYMMETRICAL DEPLOYMENT INVESTIGATION
VERIDIAN CASE NO. CA99-006
VEHICLE: 1997 BUICK SKYLARK
LOCATION: NEW JERSEY
CRASH DATE: MARCH 1999**

14. <i>Sponsoring Agency Code</i>	
15. <i>Supplementary Notes</i> On-site investigation of a severe offset, head-on crash with a guardrail end that involved a 1997 Buick Skylark. The frontal air bag system deployed asymmetrically, deploying the passenger air bag. The belted driver expired due to chest injuries.

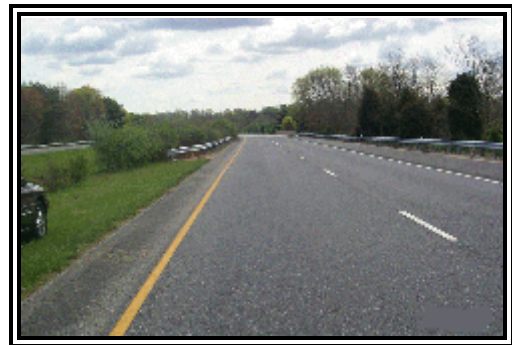
Prior to the crash, the 1997 Buick Skylark was traveling eastbound presumably in the left lane of a four lane divided (two lanes in each direction), negative 1.7 percent slope, straight, dry asphalt, interstate roadway with a posted speed limit of 105 km/h (65 mph). The weather was clear with good visibility reported by the investigating officer the tow truck operator. The solid yellow left roadway edge line and the broken white lane lines were in good condition (**refer to Figure 1**).

Figure 1- Approach trajectory of the Buick at 30 m from the point of impact (POI)

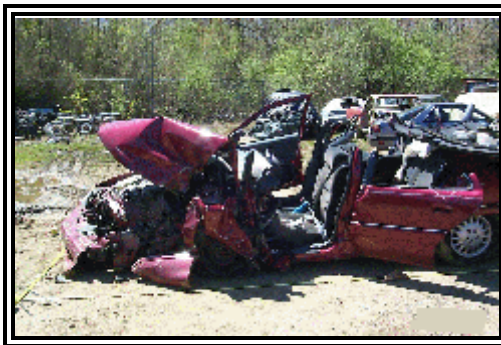
Figure 2- Damage resulting from the impact with the guardrail end

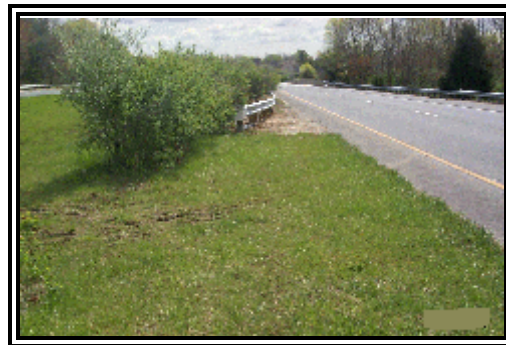
Scene evidence and damage to the front of vehicle indicated that the vehicle departed the roadway at a shallow angle, traveled parallel to the roadway and struck the guardrail end. The deformation pattern to the frontal plane of the vehicle was also indicative of a longitudinal impact configuration. The left front bumper corner was displaced rearward 42.5 cm (16.75") while the left axle was displaced 49.3 cm (19.4") rearward with no lateral displacement (**refer to Figure 2**). There were two 10.5 m (34') rolling tire prints leading to the guardrail end. The left tire print was directly in line with the barrier end and parallel to the roadway edge (**refer to Figure 3**). The driver possibly fell asleep or experienced a medical condition that resulted in loss of control of the vehicle prior to the roadway departure. In analyzing the scene evidence and vehicle damage, it appeared that the vehicle drifted off the roadway and struck the guardrail end without the driver initiating avoidance actions.

Figure 3- Trajectory of the Buick prior to the POI with the guardrail end

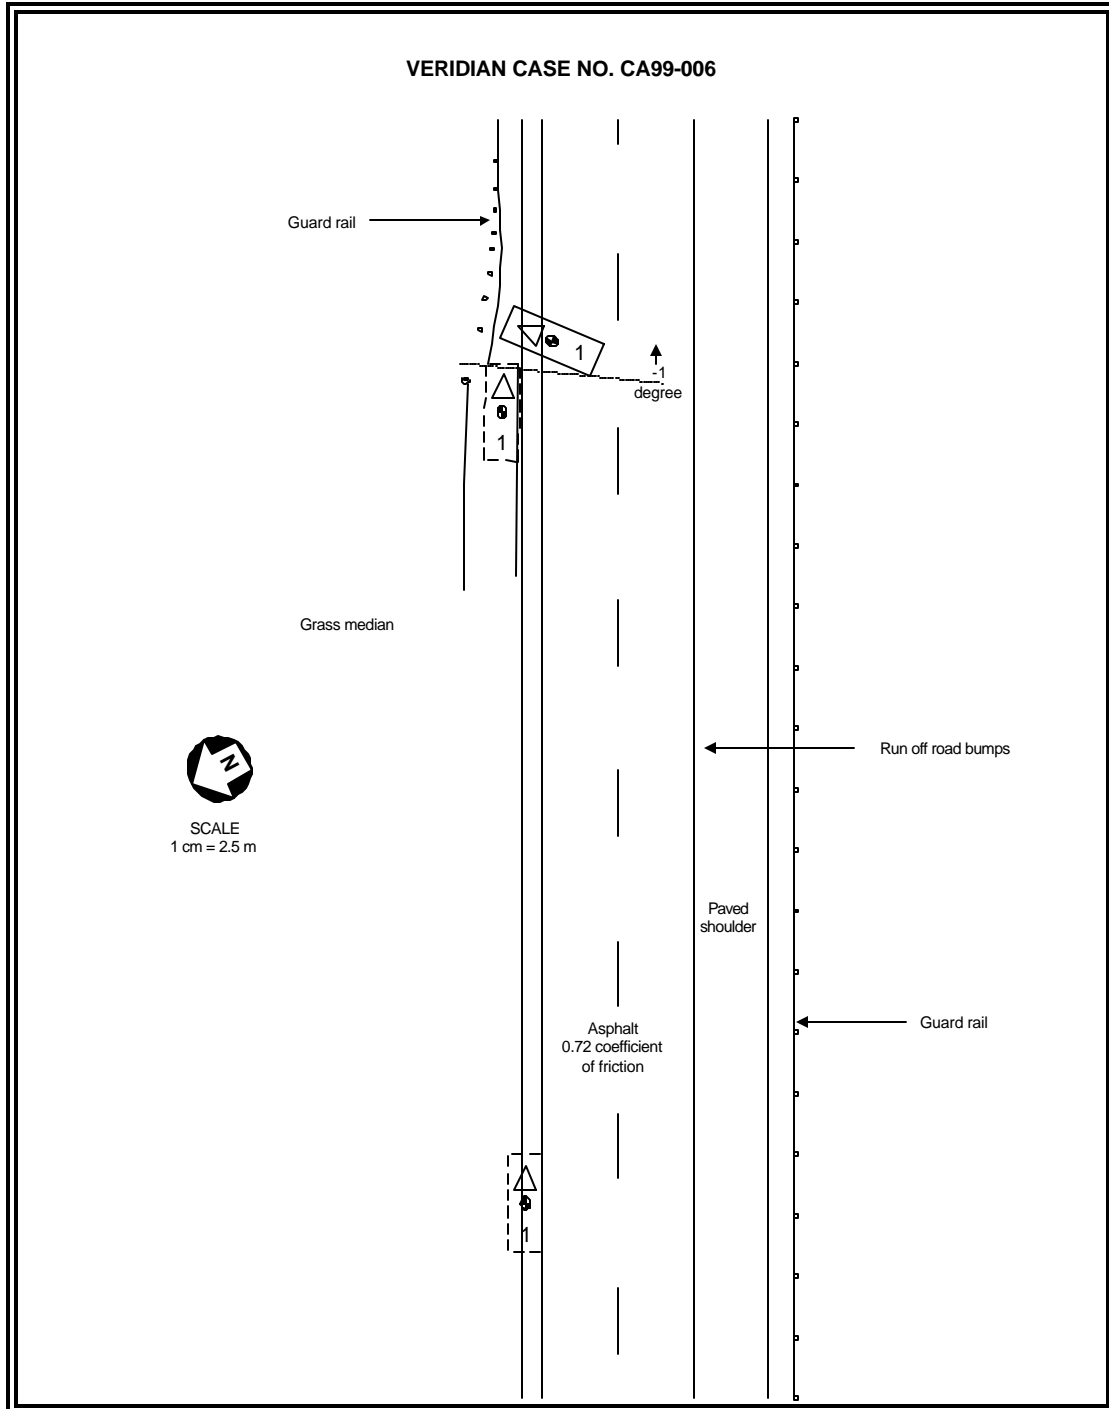
As the Buick crushed to maximum engagement, the vehicle rotated approximately 70 degrees in a counterclockwise direction and traveled approximately 3.5 m (11.5') in a southeasterly direction before coming to rest straddling the inboard shoulder, facing in an easterly direction. **Figure 4** is a schematic of the crash scene.

Figure 4- Scaled scene schematic

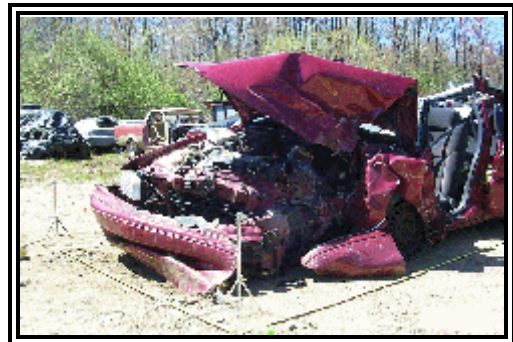
The 1997 Buick Skylark sustained severe exterior damage that involved the front bumper, the hood, the left front fender, radiator, left front wheel and axle, left A-pillar, left front door, left front door glazing and windshield (**refer to Figure 5**). Maximum crush was 42.5 cm (16.75") located at the left front bumper corner. The direct contact damage began at the front left bumper corner and extended 22.9 cm (9.0") inboard. The combined induced and direct contact damage (Field L) was 124.5 cm (49.0") which involved the full frontal width. The contact continued along the left front fender resulting in an overall contact extent of 124.5 cm (49.0"). The left side wheel base was displaced rearward 49.2 cm (19.4"). The crush profile is listed in the following table: $C_1 = 124.5$ cm (49.0"), $C_2 = 12.1$ cm (4.75"), $C_3 = 6.4$ cm (2.5"), $C_4 = 3.5$ cm (1.4"), $C_5 = 0$ cm, $C_6 = 0$ cm.

Figure 5 - Left front corner view of the Buick Skylark

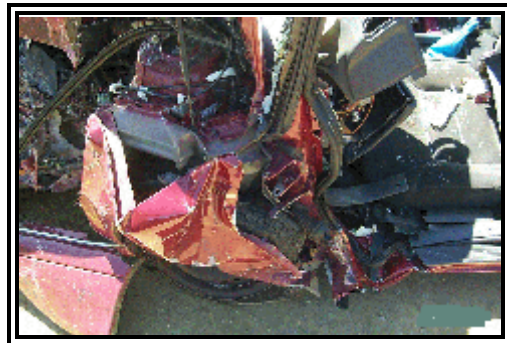
The degree of steering column intrusion could not be determined due to the relocated position of the column by rescue. The left lower A-pillar, however, had a longitudinal intruded value of 40.6 cm (16.0"). The left instrument panel intrusion measured 21.6 cm (8.5"), however, this value was considered to be an altered minimum value due to the 20 cm (8"0) forward spreading by rescue personnel (**refer to Figure 6**).

Figure 6- View of the left lower A-pillar and left sill showing the area cut and spread by rescue

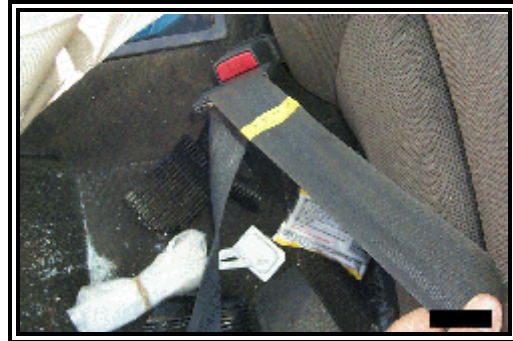
The driver's 3-point lap and shoulder belt exhibited witness marks (**refer to Figure 7**) that could support usage during the crash. There was a small disruption of the lap belt weave which measured 6.4 mm (0.25"). This small area was located over the seat cushion area and could have resulted from contact by some artifact in the driver's clothing (e.g., zipper, belt buckle, etc). There was a subtle striated abrasion pattern noted along the surface of the shoulder belt where it entered the vinyl cutout along the upper B-pillar. The determination of belt usage was confounded by the degree of steering wheel rim deformation and the total separation of the shear capsules. The degree of deformation and column movement generally represents a loading pattern by an unrestrained driver. Given the extreme rearward movement of the instrument panel and steering column from the impact, it appeared likely that the driver may have started to move forward and began to load the shoulder belt when the steering wheel contacted his chest. The belt restraint were not cut by rescue personnel during extrication activities.

Figure 7- View of the small disruption of the lap belt webbing

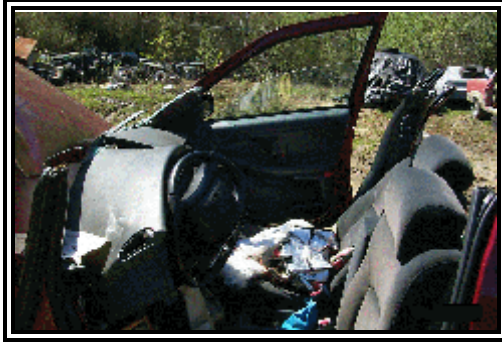
Figure 8- View showing the undeployed front left driver air bag module.

The front left air bag module was removed from the steering wheel mounting assembly and inspected for wiring continuity. While attempting to remove the air bag module, it was discovered that there were two anti-theft air bag locking bolts holding the unit in place. The head of the locking bolt was designed with a depressed irregular key lock type pattern. The outer edge (perimeter) of the bolt head was tapered which prevented the use of clamping tools for bolt removal.

After 30 minutes of effort, a mechanic was able to remove one of the mounting bolts from the front left air bag module which was then tilted on end to inspect the wiring. The typical yellow electrical connector and yellow wire appeared to be properly attached to the back of the inflator unit. Additionally, the yellow wire appeared to be properly routed through the steering wheel hub and connected to the steering wheel mounted clock spring. The wire was tensioned to check for wire connectivity with no abnormality noted. Visually, there did not appear to be any obvious problem with the unit.

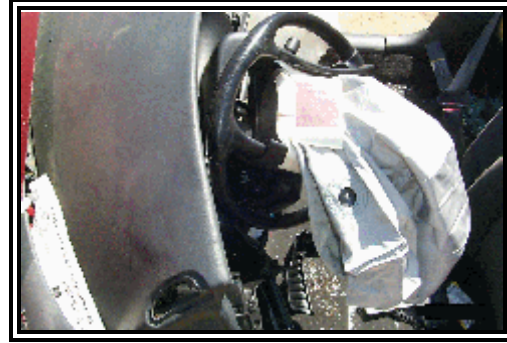
Figure 9- View of the front left driver air bag after it was mechanically removed from the air bag module

The front left air bag module cover was mechanically (cut) opened along the “T” configured module cover flaps. The overall air bag module surface measured 10.2 cm (4.0") vertically and 12.7 cm (5.0") horizontally. The nontethered air bag was folded in a normal pattern and did not appear to have any imperfection of the fabric. It had two vent ports in the 2 o'clock/10 o'clock positions which measured 2.5 cm (1.0") in diameter. The following identification number was noted on the air bag:

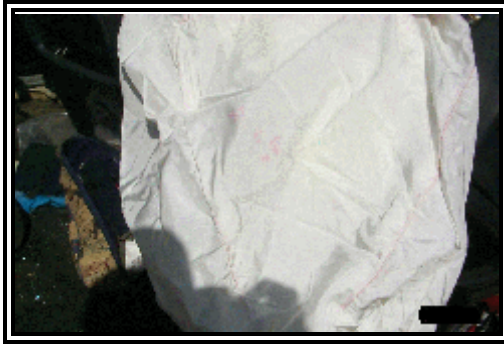
The inboard lateral surface of the front right air bag exhibited two small linear red transfers that were associated with lipstick marks (**refer to Figures 10 and 11**). The marks measured 2.5 cm (1.0") in length and were 7.0 cm (2.75") apart. The marks were located 17.8 cm (7.0") from the frontal vertical seam line and 22.9 cm (9.0") below the tether stitched seam line.

Figure 10- Overall view of the inboard lateral surface of the front right passenger air bag showing the red lip stick transfer marks

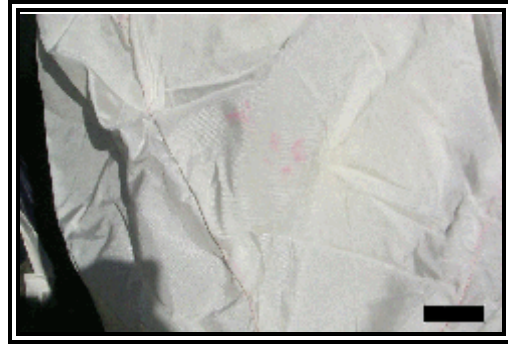
Figure 11- Close-up view of the red lipstick transfers on the inboard lateral surface of the front right passenger air bag
