School Bus Crash Investigation  
Dynamic Science, Inc.  
Case 99009  
Contract DTNH22-94-D27058  
Task 131  
Alabama  
June, 1999

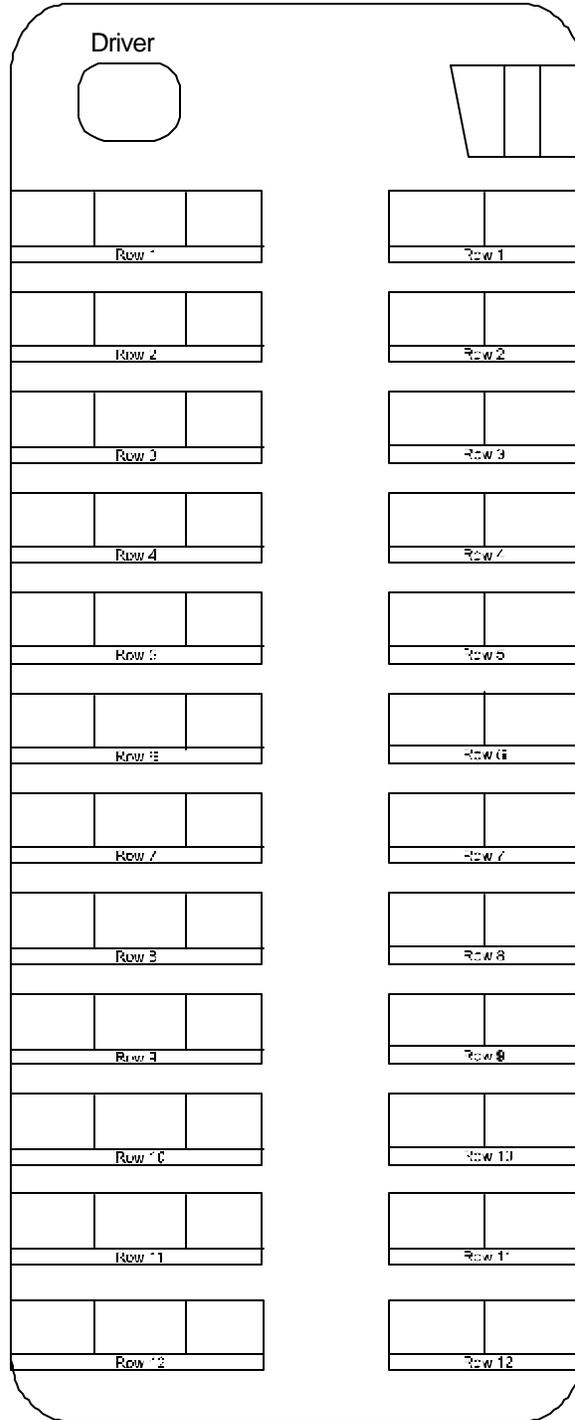
15 year old student injured  
in unknown seating  
position
