**VERIDIAN REMOTE AIR BAG RELATED ADULT PASSENGER  
FATALITY INVESTIGATION  
VERIDIAN CASE NO. CA99-011  
VEHICLE: 1997 PONTIAC TRANS SPORT  
LOCATION: PENNSYLVANIA  
CRASH DATE: OCTOBER 1998**

| <p>15. <i>Supplementary Notes</i><br/>On-site investigation of an intersection crash that resulted in frontal air bag deployment and the death of a 90 year old female front right passenger.</p> | | | |

**VERIDIAN REMOTE AIR BAG RELATED  
ADULT PASSENGER FATALITY INVESTIGATION  
VERIDIAN CASE NO. CA99-011  
VEHICLE: 1997 PONTIAC TRANS SPORT  
LOCATION: PENNSYLVANIA  
DATE OF CRASH: OCTOBER 1998**

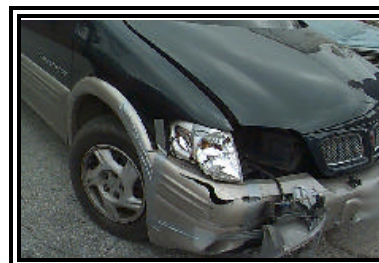
**Figure 1. Frontal damage to the Pontiac Trans Sport.**

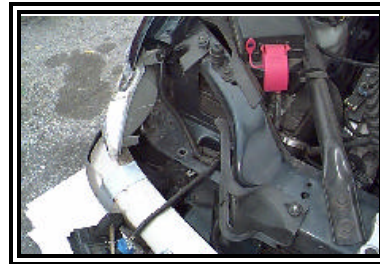
**Figure 4. Right corner area of the upper radiator support and fractured headlamp.**

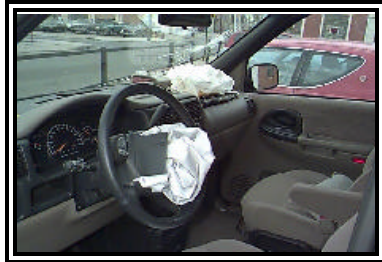
The 1997 Pontiac Trans Sport was equipped with frontal air bags for the driver and front right passenger positions (**Figure 5**). The system utilized a single point Sensing and Diagnostic Module (SDM) that was located under the front right seat. This SDM had event data recording (EDR) capabilities, however, due to the remote nature of this investigation, the EDR was not downloaded.

**Figure 5. Overall view of the deployed frontal air bag system.**

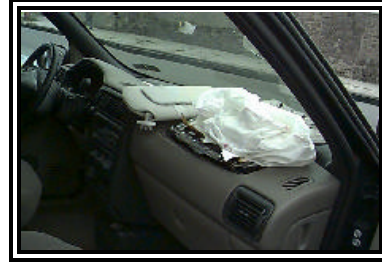
**Figure 6. Top mounted front right passenger air bag module.**

The front right passenger air bag module was mounted in the right instrument panel in a top mount configuration (**Figure 6**) and concealed by a single cover flap. The flap opened in an upward direction toward the windshield. A fracture point to the windshield was located above the passenger module location and was attributed to cover flap contact. Again, due to the remote nature of this investigation, it was unknown if the passenger air bag was tethered. The front right air bag module appeared to have been removed from the top instrument panel prior to photographic documentation by the insurance company. In addition, the right sun visor is visible on the top of the right instrument panel (**Figure 6**). It was unknown if the visor had separated as a result of the crash (air bag deployment) or was removed prior to inspection by the insurance company.

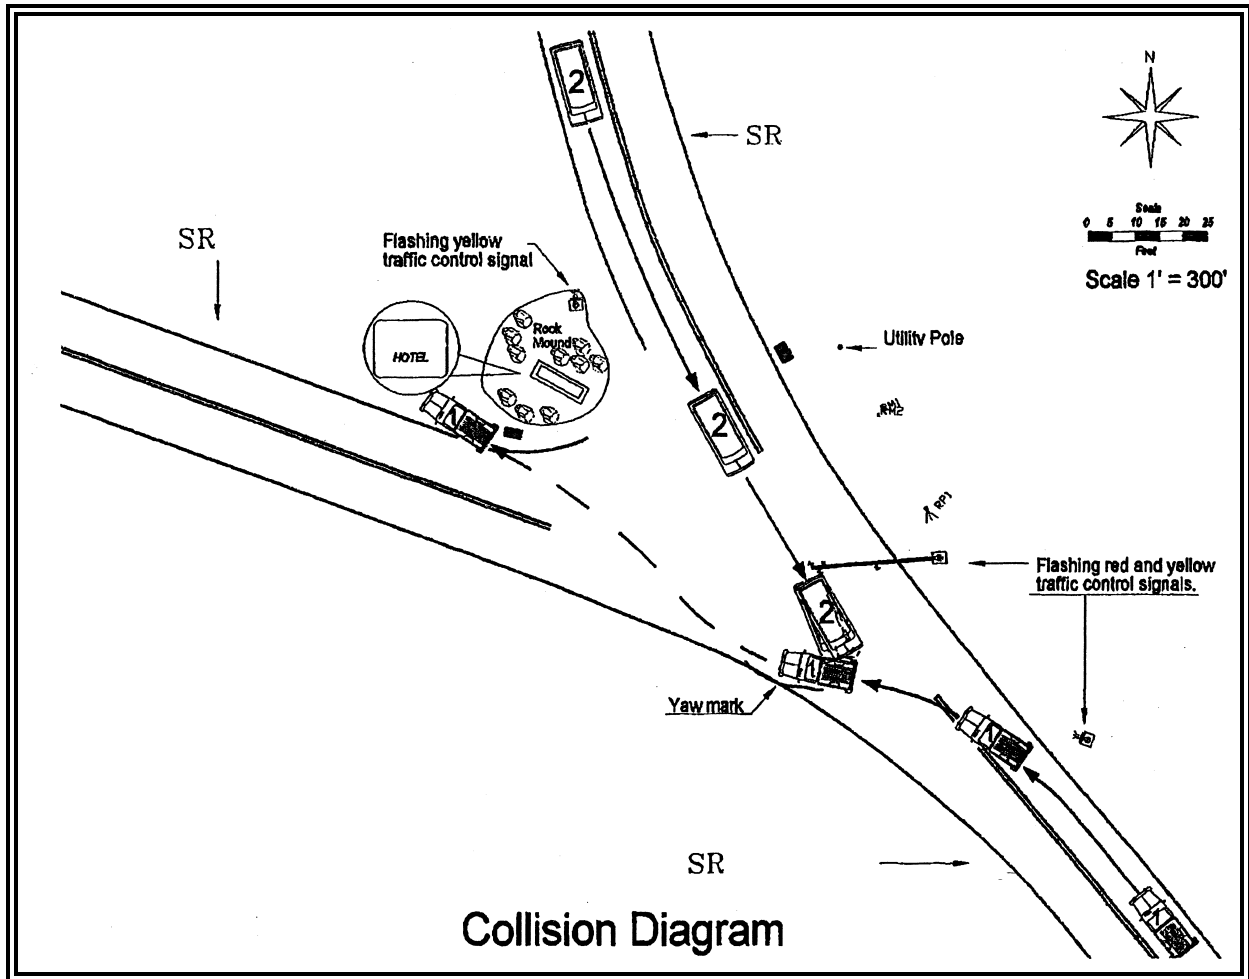
Figure 7. Police Crash Schematic

The police schematic indicated the Pontiac was deflected in a slight clockwise (CW) direction prior to coming to rest near the point of impact. The Toyota was impacted on the right rear axle area which rotated

the vehicle CW. The Toyota continued along the intersecting roadway and departed the right side of the roadway where it came to the final rest adjacent to the road edge.
