**REMOTE AIR BAG DEPLOYMENT INVESTIGATION**

**VERIDIAN CASE NO. CA99-013**

**FRONT RIGHT AIR BAG RELATED INJURY**

**VEHICLE #1 - 1994 PLYMOUTH GRAND VOYAGER MINIVAN**

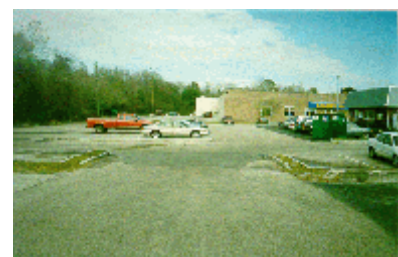
Prior to the crash, the 1994 Plymouth Grand Voyager was traveling north on a local roadway within a public parking lot which was designed to provide access between several businesses within a shopping area. The roadway appeared to have provided two way travel with an implied travel lane in each direction (**refer to Figure 1**). The straight, level, wet asphalt roadway was designed with a jog to the right (northbound) as it appeared

**Figure 1** - Trajectory of the Plymouth approaching the concrete barrier curb parking lot divider

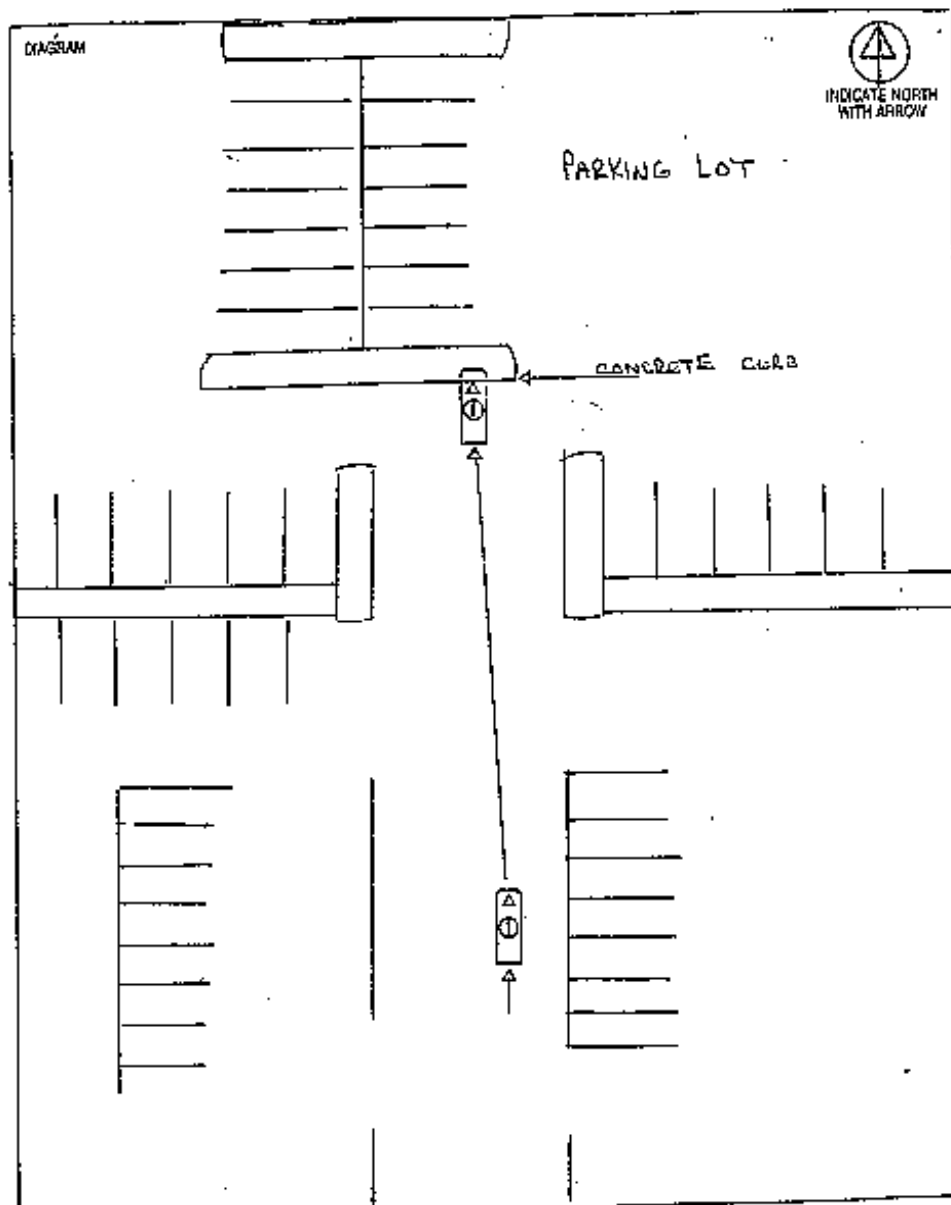
to intersect with another east/west parking lot roadway. The jog to the right was accomplished by a concrete barrier curb parking lot divider which was located at the northwest corner of the intersection and was oriented in an east/west direction. From the driver's perspective, the curbed divider occluded approximately two thirds of the roadway's northbound travel at the point of the jog. There were no traffic controls at the intersection of the two roadways (**refer to Figure 2**).

**Figure 2-** Police crash report scene sketch

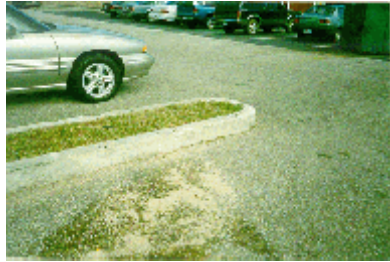
The height of the barrier curb parking lot divider visually appeared to be approximately 15.2 cm - 17.8 cm (6.0"-7.0"). Impact type evidence to the top and vertical surfaces of the curb were associated with contact by the lower frontal surface of the Dodge (**refer to Figure 3**).

**Figure 3-** View of the curb showing impact evidence with the lower frontal area of the Plymouth

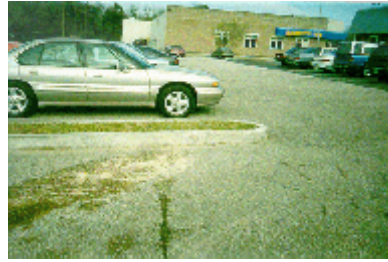
Leading up to the curb, there appeared to be a faint tire skid mark which was associated with the right front tire. It appeared to be at least 1.5 m (5.0') in length (refer to **Figure 4**) with an overall length not known due to the limited scope of the photographs provided by the attorney. The vehicle came to the final rest position (FRP) with the front wheels against the curb face and the vehicle's heading angle perpendicular to the curb.

**Figure 4-** View of the Plymouth's trajectory showing a faint right front skid mark

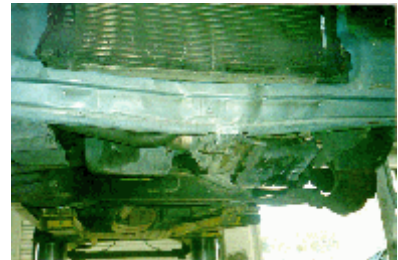
The center engine mounting bracket of the Plymouth as well as the lower radiator support bracket contacted the curb during the impact sequence as noted in **Figure 5**. Although the rearward deformation of the lower radiator support appeared to be minor (2.5 cm - 5.0 cm), the contact sequence to the stiffer engine mounting bracket apparently resulted in a sufficient delta V to have triggered the supplemental restraint system (SRS) deployment sequence.

**Figure 5-** Close-up view of the contact damage to lower radiator support and center engine mount bracket

An exemplar vehicle revealed that the clearance between the bottom of the center engine mounting bracket and the ground measured 21.6 cm (8.5") while the ground clearance between the transmission and engine oil pans was 15.9 cm (6.25"). Although these static dimensions were higher than the estimated 15.2 cm - 17.8 cm (6.0"-7.0") vertical height of the curb, the front of the vehicle more than likely pitched downward due to pre-impact braking and placed the lower portion of the frontal plane below the top edge of the curb. A fluid deposit at the scene which was located adjacent to the barrier curb indicated that either the engine or transmission oil pan also sustained damage during the crash.

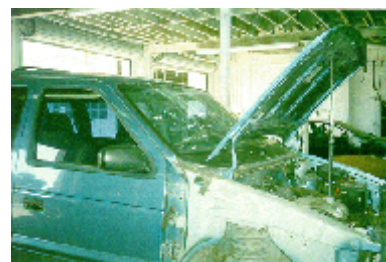
**Figure 6-** View of the damaged windshield glazing from contact with the expanding front right air bag

Interior damage data of the 1994 Plymouth Grand Voyager was not available for this report. From a supplied photograph, it was noted that the windshield glazing was fractured with a focused fracture pattern located in the upper third of the glazing and aligned with the right front seat area. The fracture pattern appeared to be the result of contact by the expanding front right air bag (as observed in other similar type deployment related crashes). The lap and shoulder restraint belts for the front seat occupants were visible in the photographs (refer to **Figure 6**).

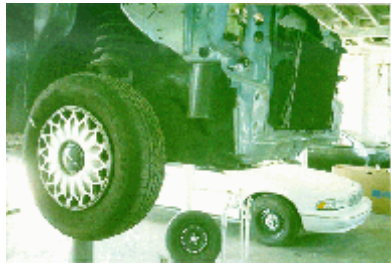
Crush values were visually determined from photographs and are contained in the following table (**refer to Figures 7 & 8**).

<b>Vehicle #1 Crush</b>			
Impact with barrier curb	$C_1 = \text{cm}$	$C_2 = 2.5 \text{ cm (1.0")}$	$C_3 = 5.1 \text{ cm (2.0")}$
	$C_4 = 5.1 \text{ cm (2.0")}$	$C_5 = 2.5 \text{ cm (1.0")}$	$C_6 = 0$

**Figure 7-** View of the frontal damage from the right side

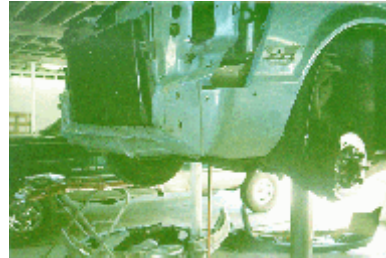
**Figure 8-** View of the damage from the left side of the vehicle
