REMOTE AIR BAG DEPLOYMENT REPORT

CASE NUMBER - IN99-014

VEHICLE - 1998 CHRYSLER CIRRUS

CRASH DATE - June 1998

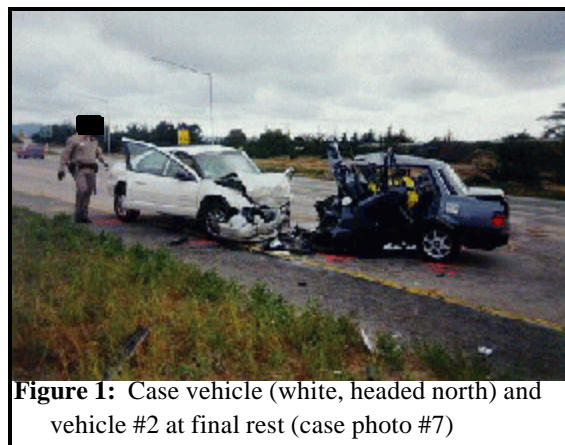
The crash occurred in the inside southbound lane. The front of the case vehicle impacted the front of vehicle #2, causing the case vehicle's driver and front right air bags to deploy. The impact was slightly offset to the left, but was essentially head-on (**Figure 1**). Both vehicles rotated a few degrees counterclockwise and came to rest in the inside southbound lane close to the point of impact, with the case vehicle headed due north and vehicle #2 headed slightly east of due south.

Figure 1: Case vehicle (white, headed north) and vehicle #2 at final rest (case photo #7)

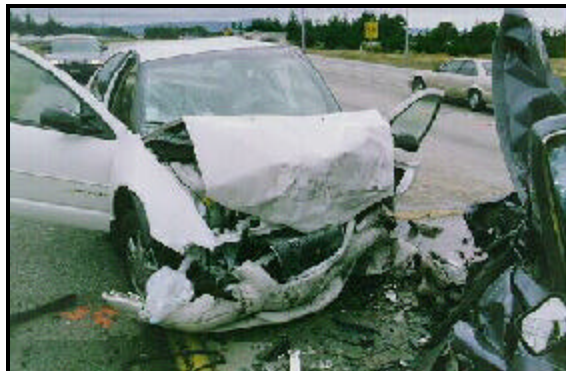
The case vehicle sustained very heavy direct contact damage across almost the entire front. The bumper and grille were pushed downward and rearward, with the engine hood bent down and folded over the damaged front area (**Figure 2**). Both headlight assemblies were broken away. The left side of the engine compartment was crushed against the cowl and the left front wheel assembly was pushed rearward against the lower left A-pillar (**Figure 3**). The left A-pillar was displaced rearward, causing the left roof side rail and windshield header to buckle, with stress cracks across the entire width of the windshield. The left front door opening was distorted and the door came open. There was substantial intrusion into the driver's seating area, including the instrument panel, steering column and the floor pan. Some of the rigid plastic components on the interior of the driver's door were shattered and there is a blood stain on the left side of the driver's air bag (**Figure 4**). The CDC for the case vehicle, estimated from on-scene photographs, is **12-FDEW-4**, with principal direction of force 0 degrees. The WinSMASH reconstruction program was used to calculate Delta V based on a CDC-only estimated crush profile. These CDC-only calculations provide a borderline reconstruction but the results appear reasonable. The Total, Longitudinal and Lateral Delta Vs are, respectively: 89 km.p.h. (55 m.p.h.), -89 km.p.h. (-55 m.p.h.) and 0 km.p.h. (0 m.p.h.).

Figure 2: Front of case vehicle; Note, left door came open during crash, right door opened by rescue workers (case photo #10)

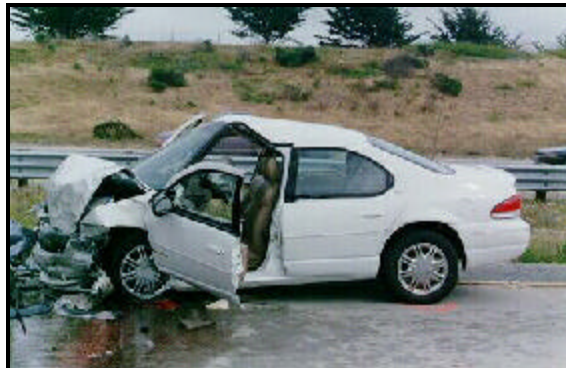
Figure 3: Left side of case vehicle (case photo #12)

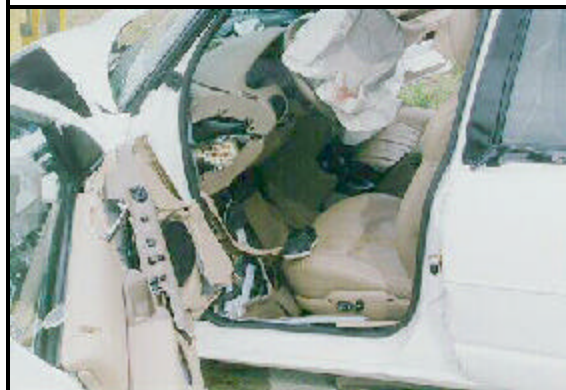
Figure 4: Case vehicle driver's seating area; Note, floor pan intrusion and displaced steering column (case photo #16)

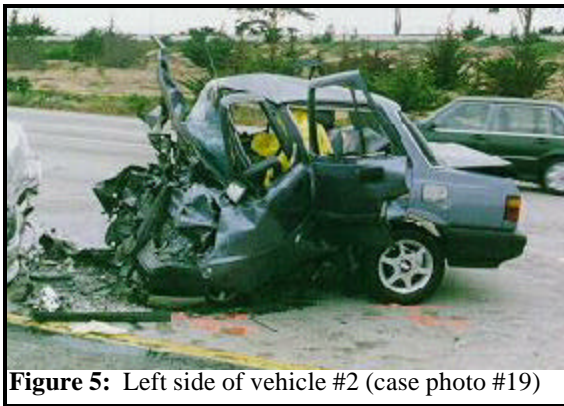
Vehicle #2 sustained massively destructive direct contact damage across the entire front. The entire front bumper was crushed straight back into the cowl, with the left and right wheel assemblies crushed against the lower left and right A-pillars, respectively (**Figure 5, below**). The cowl was pushed rearward and both A-pillars were bent backwards, with the windshield header bent down and the roof buckled across the entire width. The movement of the A-pillars caused both front doors to be pushed rearward, displacing both B-pillars and resulting in all four doors coming open (**Figure 6**). The available photographs do not show the interior, but it is apparent that the front seat row sustained massive intrusion across the entire width. The CDC for vehicle #2, estimated from on-scene photographs, is **12-FDEW-6** with principal direction of force 0 degrees. The WinSMASH reconstruction program was used to calculate Delta-V based on a CDC-only estimated crush profile. These CDC-only calculations provide a borderline reconstruction but the results appear reasonable. The Total, Longitudinal and Lateral Delta-Vs are, respectively: 128 km.p.h. (79 m.p.h.), -128 km.p.h. (-79 m.p.h.) and 0 km.p.h. (0 m.p.h.).

Figure 5: Left side of vehicle #2 (case photo #19)

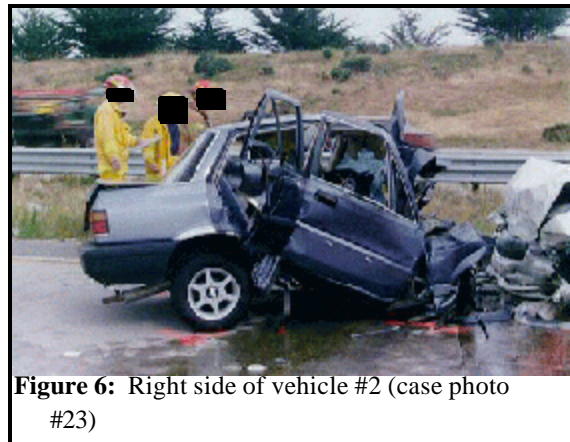
Figure 6: Right side of vehicle #2 (case photo #23)
