Remote Investigation / Vehicle to Vehicle
Dynamic Science, Inc. / Case Number: DS99021
1995 Dodge Caravan
California
May, 1998

1. Report No. DS99021		2. Government Accession No.		3. Recipient Catalog No.	
4. Title and Subtitle In-Depth Accident Investigation				5. Report Date March 26, 2000

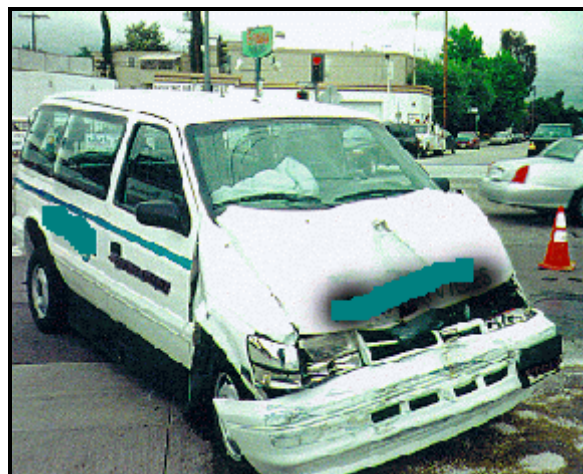
Figure 2. Exterior, Vehicle 1. Vehicle at final rest position.

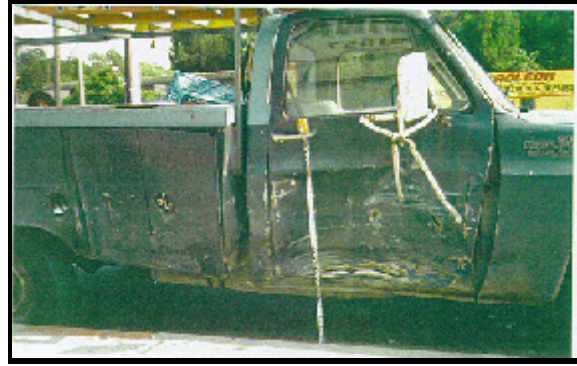
Figure 3. Exterior, Vehicle 2.

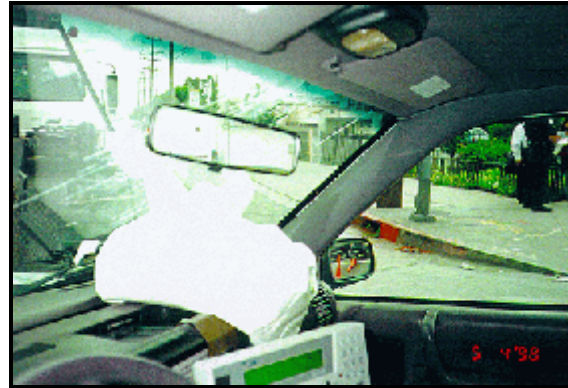
Figure 4. Interior, Vehicle 1.

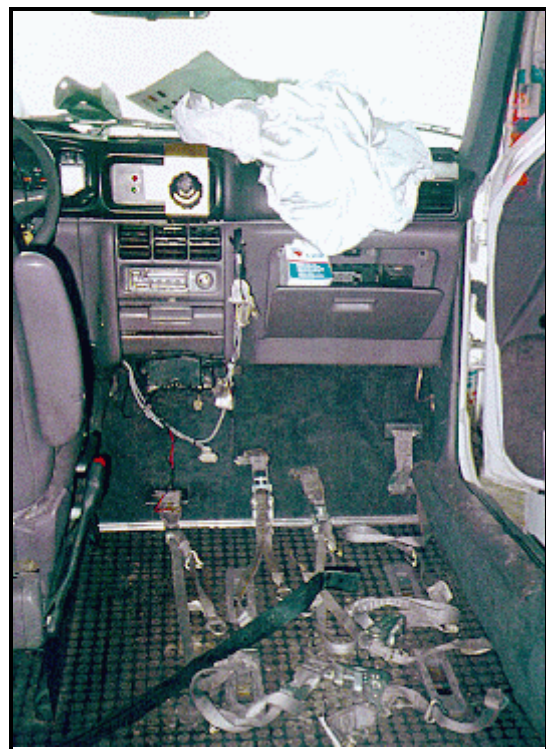
Figure 5. Front right seating position.

Some of the major injuries to the front right occupant are related to the air bag deployment. It appears that the wheelchair was not completely secure on the right side (based on occupant statements). As the driver of Vehicle 1 began braking, the wheelchair came out of the floor slots on the right side. This occupant indicated that she saw the impending crash and a logical response would have been to put her right hand/arm out in front of her. As the braking continued, the wheelchair then pivoted to a small degree in a counterclockwise direction—making the occupant lead with her right side. At impact, she pitched forward and to the left—exacerbating the right side lead. As the air bag deployed, the bag itself and possibly the cover struck the underside of the right forearm, forcing it upward into the windshield—causing the fracture; the air bag continued its deployment and struck the right side of her face—causing the abrasions. It appears that this occupant struck the lower instrument panel with her left knee—causing the effusion. This strike also caused the femur fracture as the knee was loaded against the instrument panel.

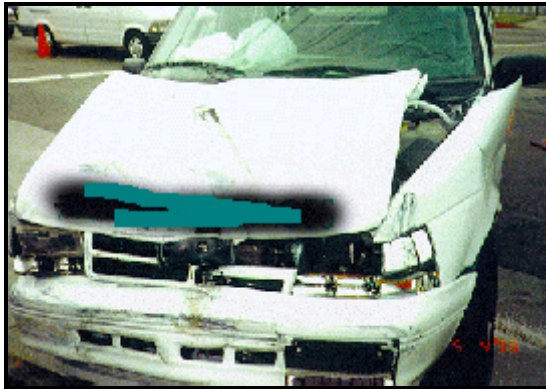
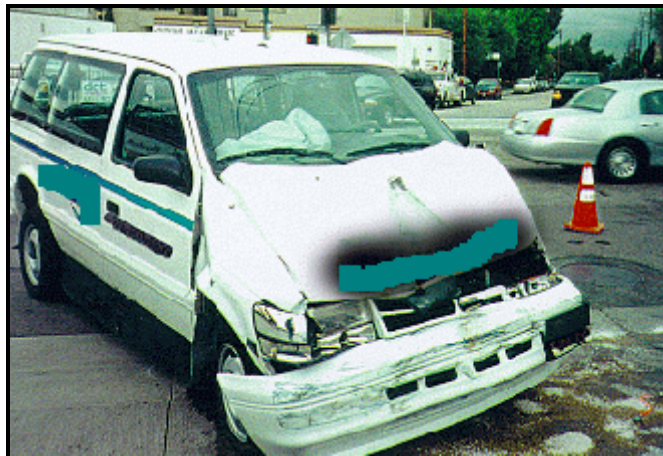
Description:	1995 Dodge Caravan	
VIN:	Unknown	
Odometer:	Unknown	
Engine:	Unknown	
Reported Defects:	None noted	
Cargo:	Wheelchair, wheelchair lift	
Damage Description:	Moderate frontal crush with movement from left to right.	
CDC:	11FDEW1	
Delta V:	Total	19.2 km/h (12.0 mph)
	Longitudinal	-18.1 km/h (-11.2 mph)
	Latitudinal	6.6 km/h (4.1 mph)
	Energy	22,419 joules (16,542 ft-lbs)

Figure 7. Exterior, Vehicle 1.

Figure 8. Exterior, Vehicle 1.

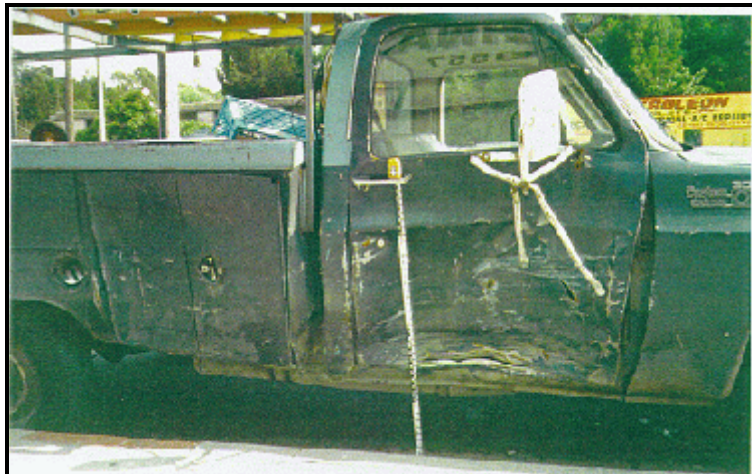
Description:	1977 Chevrolet C-30 utility pickup truck	
VIN:	Unknown	
Odometer:	Unknown	
Engine:	Unknown	
Reported Defects:	None noted	
Cargo:	Unknown	
Damage Description:	Minor to moderate crush to right front door area. Vehicle driven from scene.	
CDC:	02RZEW2	
Delta V:	Total	7.9 km/h (4.9 mph)
	Longitudinal	-3.9 km/h (-2.4 mph)
	Latitudinal	-6.8 km/h (-4.2 mph)
	Energy	18,813 joules (13,894 ft-lbs.)

Figure 9. Exterior, Vehicle 2.
