## REMOTE AIR BAG DEPLOYMENT REPORT

CASE NUMBER - IN99-025

VEHICLE - 1998 DODGE NEON

CRASH DATE - June 1998

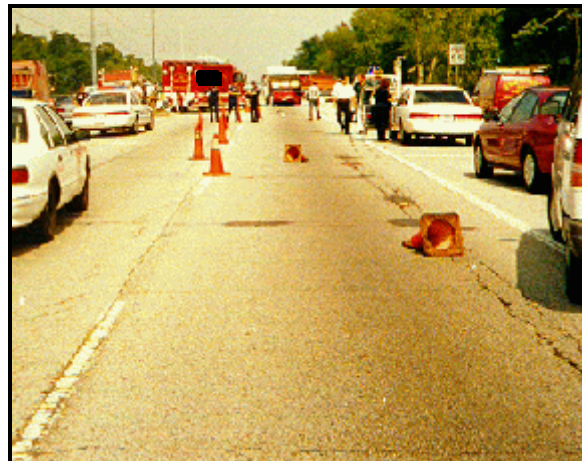
**Figure 1:** Westbound approach view for the case vehicle; Note: overturned safety cones and distance case vehicle traveled prior to impact with vehicle #2 (case photo #01)

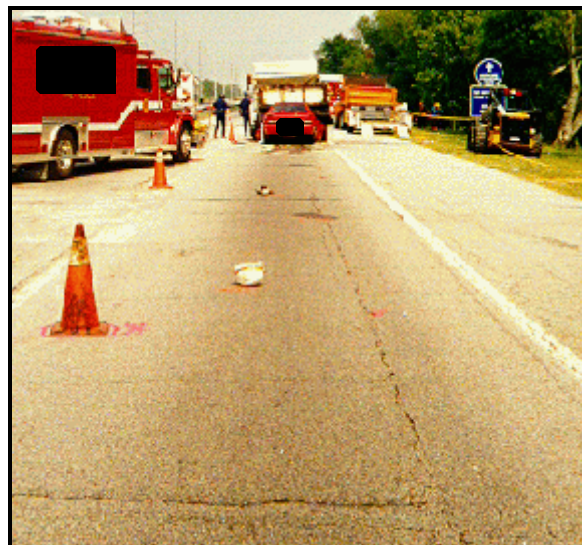
**Figure 2:** Case vehicle driver's westbound approach view; Note: highway worker's hard hat and shoe on pavement (case photo #02)

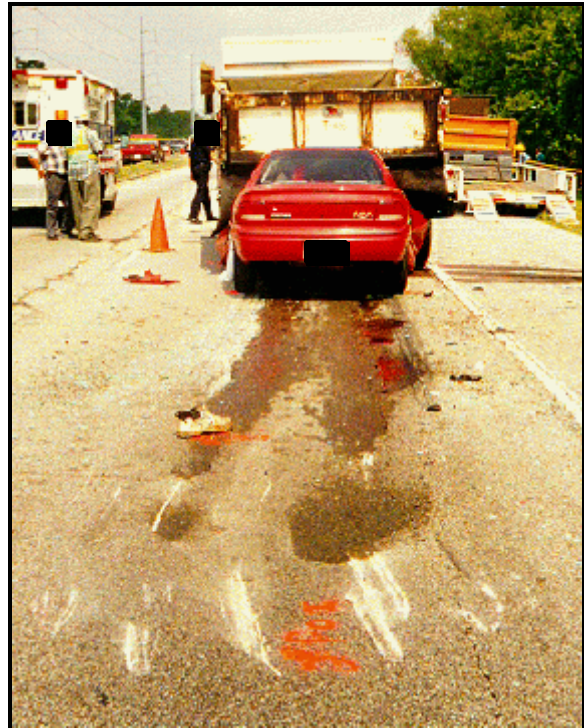
**Figure 3:** Case vehicle-to-dump truck impact area and final rest positions; Note: at-impact pavement gouges (case photo #04)

The front of the case vehicle impacted and underrode the rear plane of vehicle #2's dump bed, causing the case vehicle's driver and front right passenger air bags to deploy. The case vehicle's front bumper seems to have contacted both the inside left rear and inside right rear dual wheels of vehicle #2, shoving vehicle #2's rear axle forward sufficiently to dislodge the drive shaft at its forward universal joint. Investigating officers measured the post-impact travel of the case vehicle at 11.1 meters (36.5 feet). Underride penetration on the case vehicle reached rearward of the B-pillars on the roof. No post-impact rotation by the case vehicle was discovered (**Figure 4**).

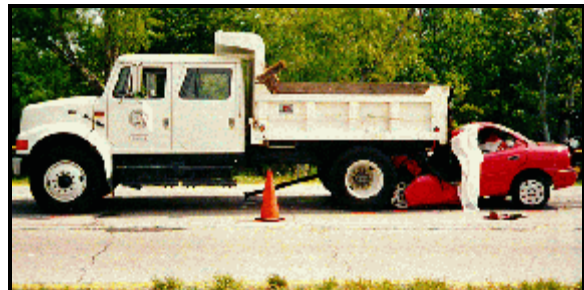
**Figure 4:** Final rest positions of the case vehicle and vehicle #2; Note: depth of underride by the case vehicle (case photo #05)

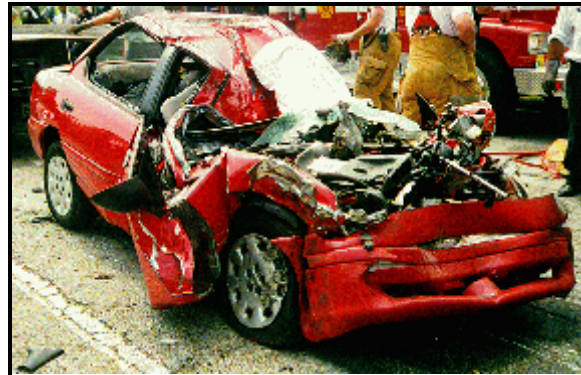
The case vehicle sustained direct contact across the entire width of its front end. The front bumper and fascia were shoved rearward and torqued at an angle, with the top further rearward than the bottom. Missing was the front grille and both headlamp assemblies. Both front fenders were displaced rearward, with the rear portions of the fenders buckling outward and forward, and the mounting plates to the lower A-pillars pulled forward with the front door seams still partially attached. The front engine compartment brackets were shoved rearward (**Figures 5 and 6**). When the case vehicle was pulled from under vehicle #2, the case vehicle's hood was jammed under the dump bed and atop its right rear dual tires. Engine components atop the block were scraped rearward. The top of the cowlings was pushed rearward and caused the instrument panel to be compressed against the driver. Both A-pillars were displaced rearward and buckled as the forward roof header was deflected downward, almost to the top of the instrument panel. The bottom of vehicle #2's dump bed contacted the case vehicle's roof to the halfway mark of the rear passenger doors. The windshield was splintered, folded, and mostly laying atop the back of the engine compartment. All four door glazings were shattered (kernelized), but the doors remained shut. Both B-pillars were bent rearward. Both roof side rails were bent downward.

**Figure 5:** Case vehicle's frontal damage as viewed from the front right corner; Note: direct contact to roof rearward of the B-pillar (case photo #15)

Based on police photographs, the CDC for the case vehicle-to-dump truck collision (event #4) is estimated as: **12-FDAA-9**, with a principal direction of force of 0 degrees. This crash is out-of-scope for the WinSMASH reconstruction program. The crash severity for the case vehicle was high [greater than 40 km.p.h. (25 m.p.h.)].

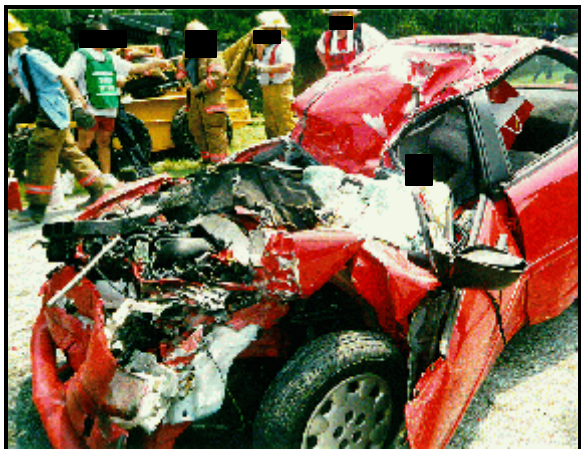
**Figure 6:** Case vehicle's front damage as viewed from the front left corner; Note: location of the front roof header (case photo #10)

Heavy intrusion into the case vehicle's passenger compartment occurred. The instrument panel and steering wheel pinned the driver in his seat, while the front roof header was deflected downward to near the top of the instrument panel. The left upper A-pillar was pushed rearward and downward into the driver's seat area and the right upper A-pillar was shoved rearward and downward, with the forward right corner of the front roof header/upper right A-pillar crushed within a few centimeters (inches) of the right upper B-pillar.

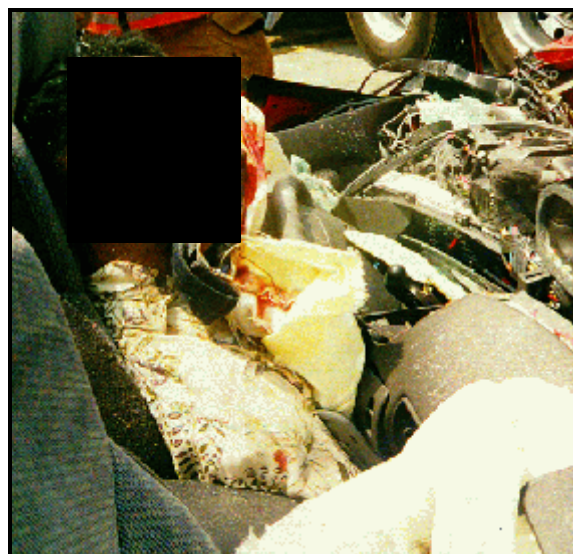
The impact with worker #3 probably did not caused any significant movement by the driver and there is no evidence that any avoidance actions were attempted. Thus, pre-impact body movements by the case vehicle’s driver are not likely. As the case vehicle impacted the back of vehicle #2's dump bed and undercarriage, the driver continued forward and began to load his three-point safety belt and deploying air bag. Intrusion by the instrument panel and steering assembly forced him back into his seat. The Police Crash Report indicates that the major autopsy findings were: laceration of the aorta with bilateral hemothoraces and laceration of the pulmonary artery, probably caused by his contact with the steering wheel hub and spokes. In addition, he sustained lacerations of the liver with hemoperitoneum, probably caused by contact with the lower steering wheel rim. A small laceration is visible on his forehead . It seems likely that he sustained other significant injuries as well.

**Figure 7:** Case vehicle driver’s post-impact position; Note: location of steering column/wheel and instrument panel (case photo #16)

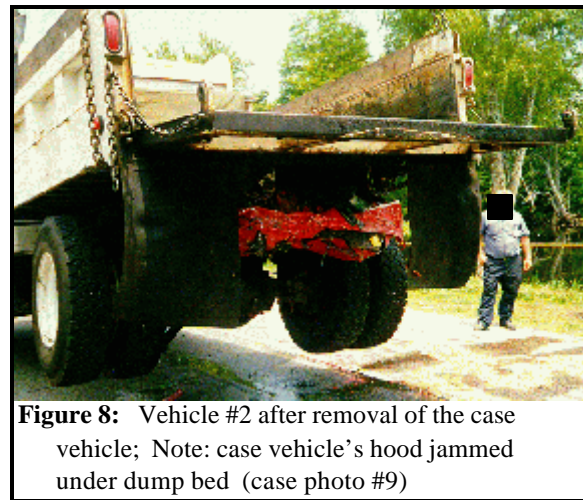
Vehicle #2 was a rear wheel drive, 1998 International 4700 Series, 4x2, steel extended cab, dump truck (VIN: 1HTSCABR4WH-----). Vehicle #2 was towed from the scene due to disabling damage. An estimated TDC for vehicle #2 is: **06-BDLR-A**, with a principal direction of force of 180 degrees. Vehicle #2 had to be lifted with a crane to permit removal of the case vehicle. The case vehicle's hood was lodged in the undercarriage (**Figure 8**).

**Figure 8:** Vehicle #2 after removal of the case vehicle; Note: case vehicle's hood jammed under dump bed (case photo #9)
