## REMOTE AIR BAG DEPLOYMENT REPORT

CASE NUMBER - IN99-029

LOCATION - Ohio

VEHICLE - 1998 PONTIAC SUNFIRE SE

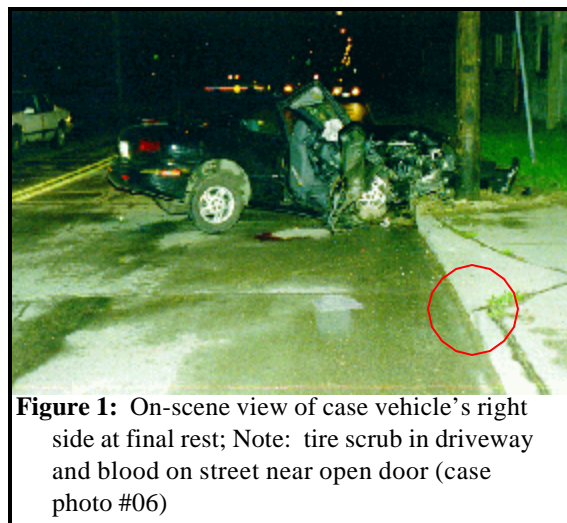
The crash occurred off the road on the right (south) side (**Figure 1**). The front right corner of the case vehicle impacted a large wooden utility pole, causing the driver and front right passenger supplemental restraints (air bags) to deploy. The right front wheel and suspension snagged against the pole, and the case vehicle pitched and rotated approximately 80 degrees clockwise, coming to rest with all four wheels in the roadway. The front right door came open as a result of the impact damage, and the front right passenger fell out of the open door onto the roadway. She was declared dead at the scene and was transported directly to the morgue. The case vehicle's driver fled the scene on foot and has not been identified. The crash severity for the case vehicle was high [greater than 40 km.p.h. (25 m.p.h.)].

**Figure 1:** On-scene view of case vehicle's right side at final rest; Note: tire scrub in driveway and blood on street near open door (case photo #06)

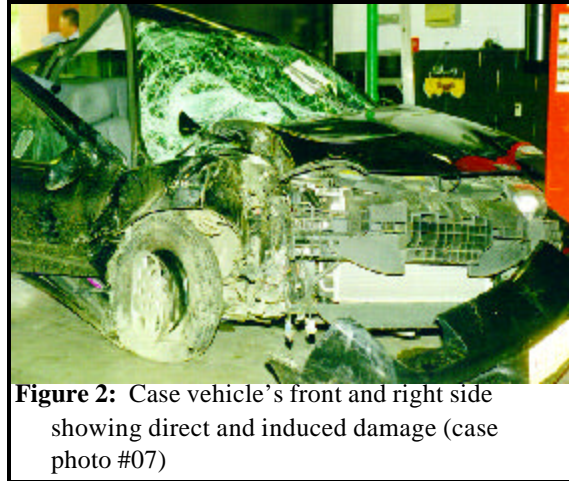
The case vehicle was in a slight counterclockwise yaw (approximately -20 degrees) when it hit the pole. The impact with the pole was at the apex of the front right corner and was assigned to the front plane. The impact was slightly off horizontal due to the front right wheel ramping up the side of the driveway. The front bumper beneath the bumper fascia was not contacted (**Figure 2**). The pole crushed the soft components of the right front fender rearward and inward and pushed the engine hood rearward. The back edge of the hood was forced into the windshield, causing fractures of the windshield. The right front wheel and suspension snagged against the pole (pocketing engagement), causing the wheel to be crushed rearward into the right "A"-pillar and inducing clockwise rotation. The "A"-pillar was displaced rearward, resulting in buckling of the right roof rail, roof, door sill, and floor and further fracturing of the windshield. The damage to the floor caused the front right bucket seat to tilt to the right (**Figure 1** above and **Figure 4**). The leading edge of the front right door was damaged, the door opening was distorted, and the door came open. The left side of the case vehicle and the driver's seating area were essentially undamaged (**Figures 3 & 4**). The CDC, estimated from police photographs is: **01-FRES-5**, with principal direction of force 20 degrees. The WinSMASH reconstruction program, Barrier algorithm with CDC-only estimated crush profile, was executed. This WinSMASH run provides a borderline reconstruction, and the results appear to be low. The total, longitudinal and lateral delta Vs are, respectively: 41 km.p.h (25 m.p.h), -39 km.p.h (24 m.p.h), and -14 km.p.h (-9 m.p.h).

**Figure 2:** Case vehicle's front and right side showing direct and induced damage (case photo #07)

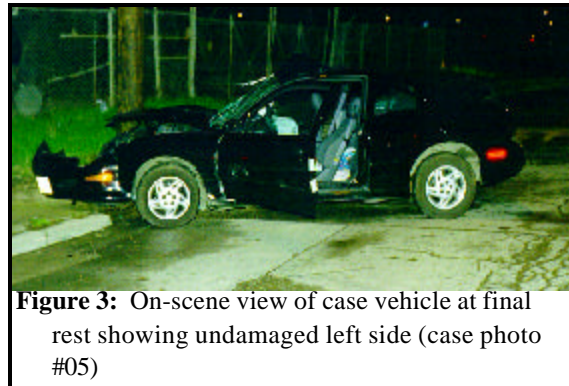
**Figure 3:** On-scene view of case vehicle at final rest showing undamaged left side (case photo #05)

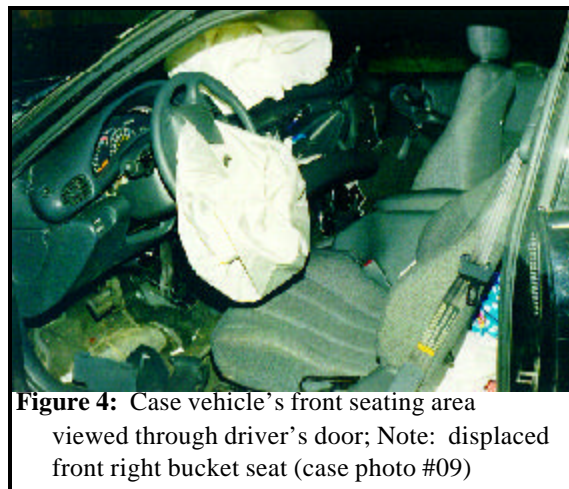
**Figure 4:** Case vehicle's front seating area viewed through driver's door; Note: displaced front right bucket seat (case photo #09)

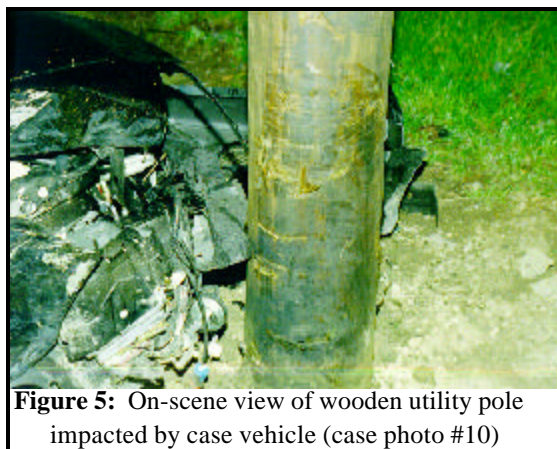
The case vehicle hit a timber utility pole that was approximately 40 - 45 centimeters (16 - 18 inches) in diameter (**Figure 5**). The pole was set in the cement concrete of the sidewalk, approximately 30 centimeters (12 inches) into the sidewalk from the curb. There was gouging on the surface of the pole, but there was no evidence that the pole fractured or that the foundation was disturbed.

**Figure 5:** On-scene view of wooden utility pole impacted by case vehicle (case photo #10)
