# Remote, Redesigned Air Bag Special Study **FOR NHTSA'S INTERNAL USE ONLY**

Dynamic Science, Inc., Case Number (DS99029) 1998 Buick Century California June, 1998

This remote investigation focused on the redesigned air bag system deployment of a 1998 Buick Century. The case was generated through the Fatal Accident Reporting System. The driver and the rear left seat occupant in the case vehicle were fatally injured in this single vehicle crash. The case was conducted as a remote investigation. This crash occurred during the late evening hours in June, 1998. The crash occurred on a sharply curved, two-lane, two-way undivided roadway. The curve has a critical curve speed of 11.4<sup>1</sup>. The speed limit in this area is 40 km/h (25 mph). The roadway was lit by streetlights and light from nearby businesses.

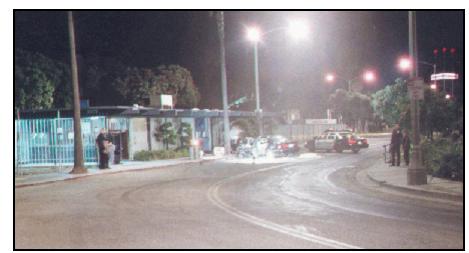
Figure 1. Final rest, case vehicle

of the case vehicle began accelerating through the curves. The Buick Century passed a non-contact vehicle on the left. As the Buick entered the right hand curve, the driver lost control and the vehicle began a slight clockwise yaw. The Buick struck and over-rode the curb on the left side of the roadway and, according to the police, struck a metal air vent. The vehicle continued onward until striking a large palm tree with the front left of the vehicle (12FYEW5). The Buick sustained a longitudinal delta v of -58.4 km/h (-36.3 mph) and a latitudinal delta v of 5.1 km/h (3.2 mph)<sup>2</sup>. The vehicle rotated about the tree in counterclockwise direction and came to rest in the street facing north.

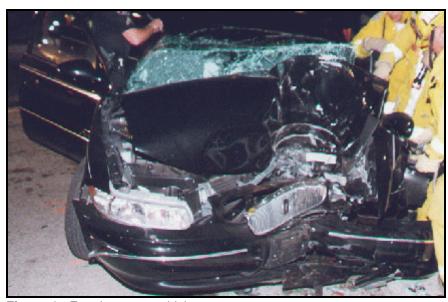
Figure 2. Exterior, case vehicle

Model year, make and model	1998 Buick Century
VIN	2G4LUS52MXWXXXXX
CDC	12FYEW5

Plane of Impact	Field L cm/in.	C1 cm/in.	C2 cm/in.	C3 cm/in.	C4 cm/in.	C5 cm/in.	C6 cm/in.
Bumper					400 (40: )		
	Not availa	ble, however	police indicate	that there was the front end.	106 cm (42 in.)	of indentation	n (crush) to
