Remote, Redesigned Air Bag Special Study
FOR NHTSA'S INTERNAL USE ONLY
Dynamic Science, Inc., Case Number (DS99033)
1999 Dodge Neon
California
November/1998

This remote investigation focused on the redesigned air bag system deployment of a 1999 Dodge Neon four-door. The case was generated through the Fatal Accident Reporting System. The front right occupant of the Dodge Neon was fatally injured. The case was conducted as a remote investigation.

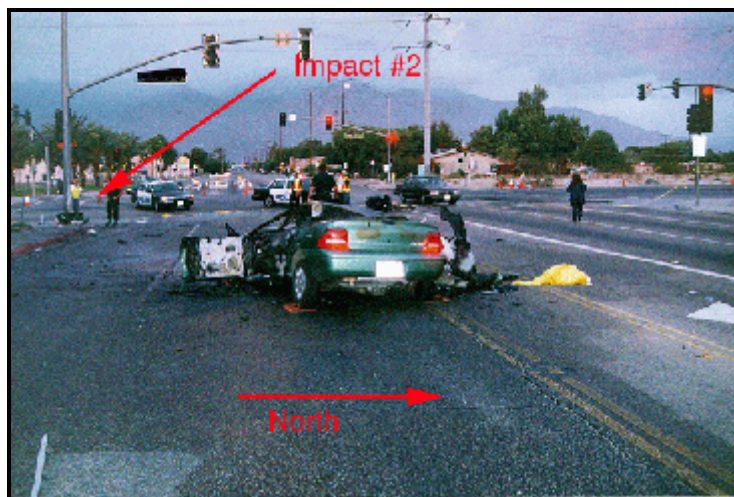
Figure 1. Final rest, Case vehicle. Facing west.

The case vehicle rotated about the pole in a clockwise fashion and returned to the roadway. The case vehicle continued to rotate as it traveled eastbound. The front right door came off approximately 10 m (33 ft) east of the intersection. The case vehicle then came to rest facing southwest in the second eastbound lane.

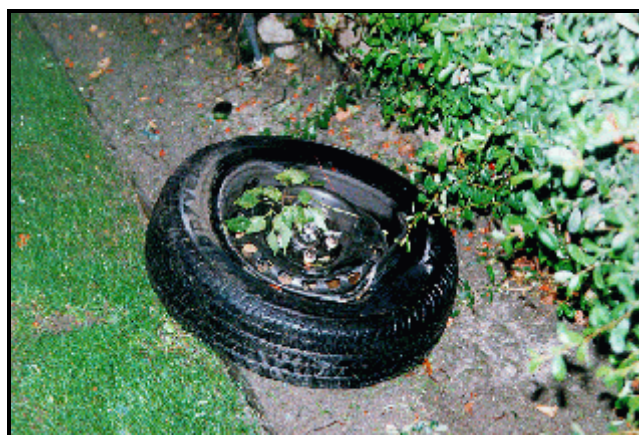
The case vehicle, a 1999 Dodge Neon four-door driven by an unrestrained 16-year-old male (173 cm/68 in., 57 kg/125 lbs.), was traveling eastbound in the first lane adjacent to the right turn lane (possibly in the right turn lane to some extent) approaching the intersection. The front right seat was occupied by an unrestrained 16-year-old female (147 cm/58 in., 45 kg/100 lbs.). As the case vehicle entered the intersection it possibly hit a dip in the roadway. The driver appears to have lost control at this point and veered slightly to the right. The Dodge Neon departed the roadway on the right side and struck the curb on the southeast corner (12FRWN3).

Figure 2. Right front tire, damaged from impact with curb and pole.

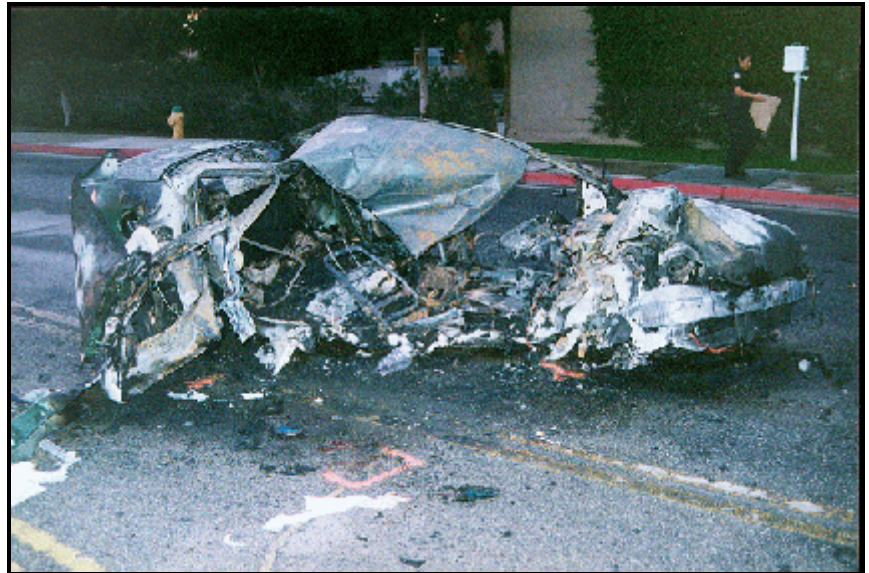
The case vehicle continued on and struck a metal pole with its front right (12FREE6). The case vehicle sustained an estimated longitudinal Δv of -57.5 km/h (-35.7 mph) and a lateral Δv of -5.0 km/h (-3.1 mph)¹ from this impact. Both front air bags likely deployed at this point. Prior to a fire consuming the vehicle, a witness stated that both air bags had indeed deployed; the police indicated that the driver air bag was visibly deployed.

Figure 3. Front right of case vehicle

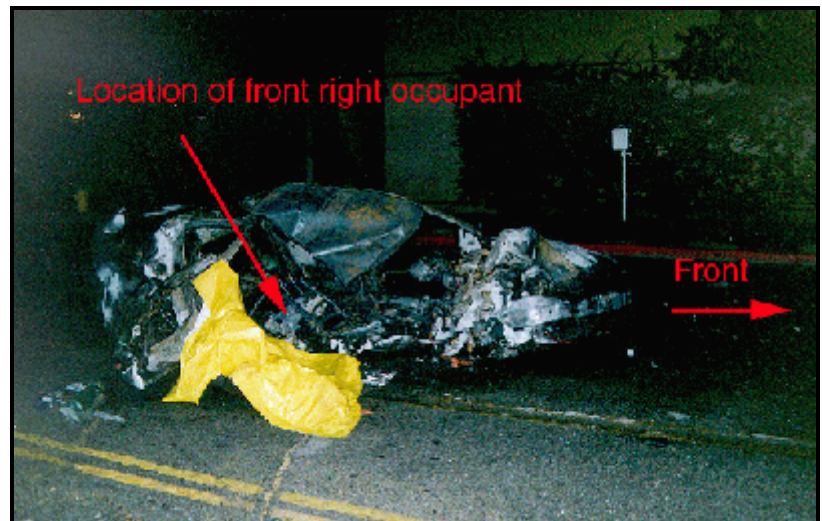
Figure 4. View showing location of front right occupant after the vehicle came to rest. Moved approximately one foot from the vehicle by witnesses.

The front right occupant was found outside of the right side of the case vehicle. Witnesses approached the vehicle and attempted to move the occupant away from the vehicle, but were unable to move her more than a foot before being driven away by the extreme heat. Both the police and the witnesses indicated the occupant had already expired before becoming involved in the vehicle fire. She sustained a lacerated aorta, comminuted, depressed and basal skull fractures of the frontal, temporal and sphenoid bones. There were bilateral fractures of ribs 1 and 2, bilateral femoral fractures, and compound fractures of the left distal tibia and fibula.

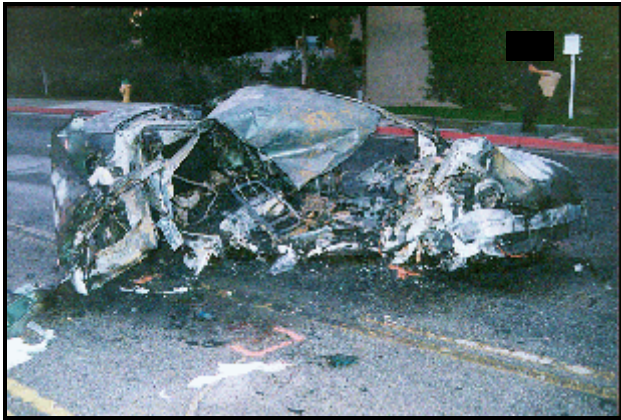
Figure 5. Exterior, case vehicle. Right side.

This vehicle sustained heavy damage to the right side. The right front door was torn off and fell onto the roadway. There was substantial right side intrusion from the A-pillar, front right instrument panel, right toe pan, right floor rail, and right roof. All the glazing in the vehicle was missing. The front right side glass and the rear right side glass were likely disintegrated due to the impact. The windshield would also have sustained damage due to the impact. The remaining windows likely sustained damage due to the fire.

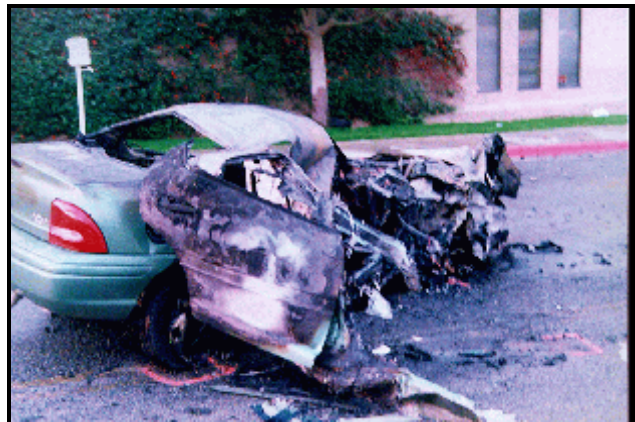
Figure 6. Exterior, case vehicle. Right rear.
