**REMOTE REDESIGNED AIR BAG DEPLOYMENT INVESTIGATION  
SCI TECHNICAL SUMMARY REPORT**

**VERIDIAN CASE NO. CA99-034**

**RABSS VEHICLES - 1998 CHEVROLET MONTE CARLO LS  
1998 FORD WINDSTAR**

**CRASH DATE - JULY 1998**

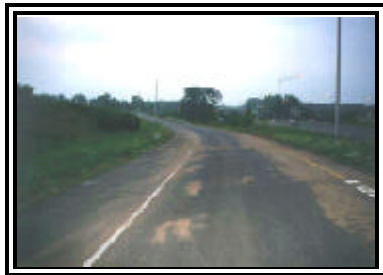
The 46-year-old male driver of the Chevrolet Monte Carlo was operating the vehicle the wrong way on the northbound entrance ramp at a high rate of speed when he failed to detect the approaching Ford Windstar (**Figure 1**). The 37-year-old male driver of the Ford Windstar was operating the vehicle northbound on the entrance ramp to the northbound travel lanes of an interstate highway when he detected the 1998 Chevrolet Monte Carlo traveling the wrong way in the opposite direction at a high rate of speed (**Figure 2**). Upon recognition of the impending harmful event, the driver of the Ford Windstar braked and attempted to steer left. Although the 1998 Ford Windstar was equipped with 4-wheel ABS (anti-lock brakes), the investigating officer documented 13.1 m (43.0') of pre-impact skid marks left by the Windstar (**Figure 3**).

**Figure 1. Southbound approach for the 1998 Chevrolet Monte Carlo**

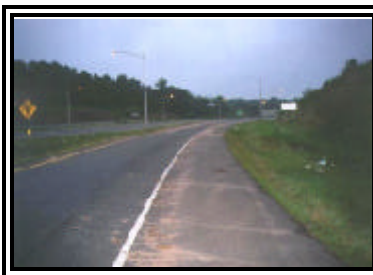
**Figure 2. Northbound approach for the 1998 Ford Windstar**

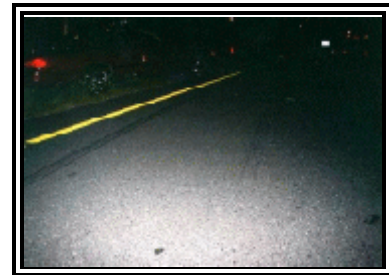
**Figure 3. Pre-impact skid marks from Ford Windstar**

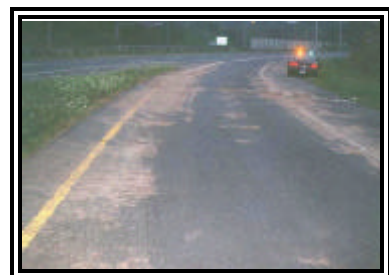
As the Monte Carlo continued south on the entrance ramp, the front right area of the Chevrolet Monte Carlo impacted the front right area of the Ford Windstar (**Figure 4**). Impact resulted in severe damage to both the Monte Carlo and the Windstar. The resultant directions of force were in the 12 o'clock sectors for each vehicle. The damage algorithm of the WinSMASH program computed total velocity changes of 80.1 km/h (50.0 mph) for the Monte Carlo and 68.6 km/h (42.9 mph) for the Windstar based on estimated crush profiles. The longitudinal and latitudinal components were -78.8 km/h (-49.3 mph) and -13.9 km/h (-8.7 mph), respectively for the Monte Carlo. The longitudinal and latitudinal components were -67.6 km/h (-42.3 mph) and -11.9 km/h (-7.4 mph), respectively for the Windstar. The impact induced deceleration was sufficient to deploy the frontal air bag systems in both vehicles. The Monte Carlo deflected off of the Windstar and rotated in a CW direction approximately 280 degrees while it traveled in a south direction onto the east

**Figure 4. Point of impact looking northbound**

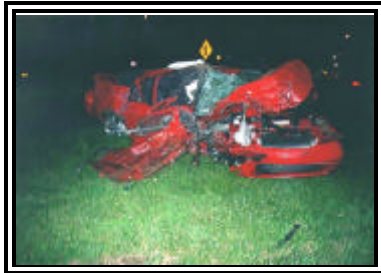
The 1998 Chevrolet Monte Carlo sustained severe frontal damage as a result of the impact with the Ford Windstar (**Figure 5**). The CDC for this impact to the Chevrolet Monte Carlo was 12-FREE-8. The direct contact damage began at the right bumper corner and extended approximately 36 cm (14") toward the center of the bumper. The direct damage for this corner impact extended down the right side of the vehicle, extending approximately 152 cm (60") rearward from the right front bumper corner and approximately 60

cm (24") vertically from the lower sill. The maximum crush was at the right bumper corner and estimated to be approximately 152 cm (60"). The CDC for the second impact was 00-RBHN-3. The direct contact damage for the second event (impact with the luminaire) began directly above the center of the right rear axle and extended approximately 38 cm (15") longitudinally toward the front of the vehicle. Direct damage and was approximately 20 cm (8") in depth laterally across the center of the backlight, which was disintegrated from impact forces (**Figure 6**). Paint transfers and deformation were noted on the luminaire (**Figure 7**). The CDC for the rollover was 00-TPDO-3. The direct contact damage attributed to the third event (rollover) included scratches and dents in the roof, vertical displacement of the roof, and lateral shift of both C-pillars to the right. Vertical abrasions and buckling were visible on both side planes of the vehicle. The vertical displacement of the roof was estimated to be approximately 10 cm (4"). The front axle fractured during the rollover sequence, resulting separation of the right front wheel. According to the police report, the fuel tank had ruptured due to the crash and was leaking.

**Figure 5. Frontal damage to Chevrolet Monte Carlo**

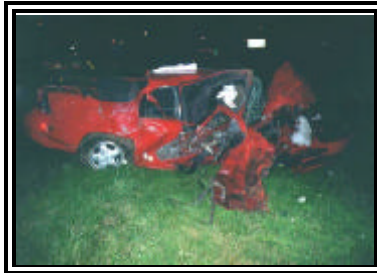
**Figure 6. Right side damage to Chevrolet Monte Carlo**

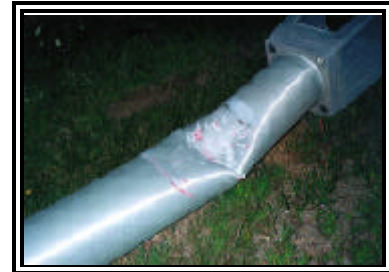
shoulder. The Monte Carlo impacted a luminaire with a frangible base approximately 20 cm (8") in diameter with the right rear quarter panel, above the right rear wheel, which caused the luminaire to fracture at the base. This impact caused the vehicle to tip onto its right side approximately 20 degrees. The Monte Carlo continued in a south direction through the luminaire and rotated an additional 350 degrees in a CW direction and subsequently rolled four quarter turns to final rest, which caused the front right wheel to fracture from the vehicle. The vehicle came to rest on the east shoulder facing east. The Windstar rotated approximately 100 degrees and came to rest on the on-ramp facing east.

**Figure 7. Fractured luminaire showing deformation and paint transfers**

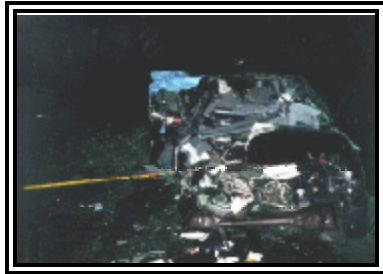
The 1998 Ford Windstar sustained severe front and right side damage as a result of the impact with the Chevrolet Monte Carlo. The direct contact damage to the frontal plane began at the right front bumper corner and extended approximately 38 cm (15") toward the center of the bumper (**Figure 8**). The Collision Deformation Classification (CDC) for this initial impact to the Ford Windstar was 12-FREE-9. The direct contact for this corner impact extended down the entire right side of the vehicle as evidenced by displaced and torn sheet metal (**Figure 9**). The direct contact damage along the right side extended vertically approximately 60 cm (24") from the lower sill. The combined direct and indirect damage involved the full frontal width of the Windstar. The maximum crush was located at the front right bumper corner, and

estimated to be approximately 200 cm (78"). The right front tire was deflated and restricted from rearward displacement. The windshield was cracked and all of the right side tempered glazing was shattered from impact forces.

**Figure 8. Frontal damage to Ford Windstar**

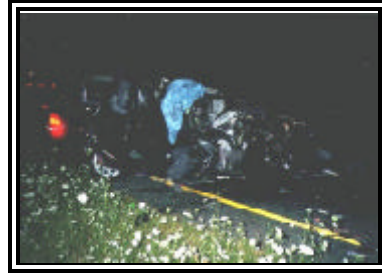
**Figure 9. Right side damage to Ford Windstar**
