VERIDIAN ON-SITE FAIL-TO-DEPLOY INVESTIGATION

VERIDIAN CASE NO. CA99-42

VEHICLE - 1999 GMC SIERRA PICKUP TRUCK

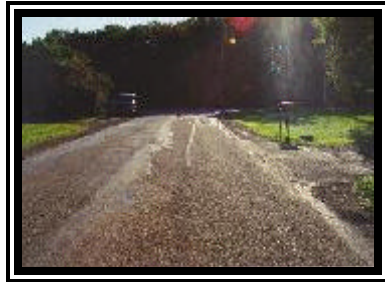
The 33 year old male driver of the 1999 GMC Sierra pickup truck was operating the vehicle eastbound (**Figure 1**) on a 2 lane rural roadway when he failed to detect a stop sign as he proceeded straight through a Y-intersection. As he approached the intersection, he steered right/braked and subsequently departed the east pavement edge.

Figure 1. Eastbound approach for the 1999 GMC Sierra pickup truck.

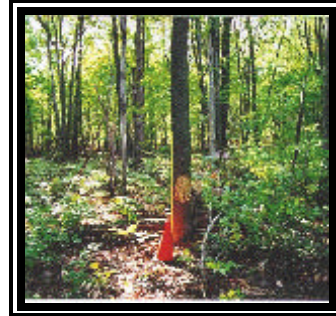
Figure 2. Struck tree (impact #5).

As the Sierra departed the east pavement edge of the 3-leg intersection, the frontal area struck a patch of vegetation (brush) resulting in superficial damage. The Collision Deformation Classification (CDC) for this initial impact was 12-FDEW-1. The pickup continued 5.0 meters (16.4 feet) into the wooded area as the left side surface sideswiped an 8.0 cm (3.1 in) diameter tree resulting in minor damage. The CDC for this secondary impact was 12-LDES-1. The left side surface subsequently sideswiped an 18.0 cm (7.1 in) diameter tree resulting in moderate damage. The CDC for this third impact was 12-LDAS-1. The Sierra impacted another patch of brush which also resulted in superficial frontal damage. The CDC for this fourth impact was 12-FDEW-1. The pickup traveled 7.0 meters (23.0 feet) where the front left area struck a 22.0 cm (8.7 in) diameter tree (**Figure 2**) which resulted in moderate damage. The CDC for this fifth impact was 12-FLEE-2. At this point, the pickup rotated counterclockwise 29 degrees as the front left area struck a 25.0 cm (9.8 in) diameter tree stump resulting in minor damage. The CDC for this sixth and final impact was 12-FYLN-1. The impact induced deceleration was insufficient to deploy the Sierra's air bag system. Although the impacts were classified as out of scope (overlapping damage), the WinSMASH damage algorithm computed a barrier equivalent velocity change of 20.6 km/h (12.8 mph). The specific longitudinal component was -20.6 km/h (-12.8 mph). This speed change was below the "must fire" threshold of 25.7 km/h (16.0 mph) required for air bag deployment. The Sierra came to rest against the final impact facing east.

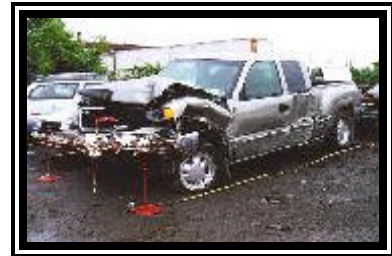
The Sierra sustained moderate frontal damage as a result of the impact with the tree cluster (**Figure 3**). The direct contact damage encompassed the full frontal width resulting in a combined direct and induced damage length (Field L) of

154.0 cm (60.6 in). Six crush measurements were taken at the level of the bumper: C1= 39.0 cm (15.4 in), C2= 9.0 cm (3.5 in), C3= 12.0 cm (4.7 in), C4= 5.0 cm (2.0 in), C5= 0 cm, C6= 0 cm. Damage was documented outside the left frame rail from the third tree impact (impact #5). The damage began 4.0 cm (1.6 in)

inboard of the front left bumper corner and extended 22.0 cm (8.7 in) to the right. This damage pattern restricted/deflated the left front wheel/tire. Damage was also documented inside the left frame rail from the tree stump impact (impact #6). The damage began 41.0 cm (16.1 in) inboard of the front left bumper corner and extended 24.0 cm (9.4 in) right. Brush transfers were noted which encompassed the full frontal width of the vehicle. Overlapping sideswipe damage was identified to the left side surface which began

13.0 cm (5.1 in) aft of the front left bumper corner and extended 445.0 cm (175.2 in) rearward. The lateral displacement from the sideswipes measured 7.0 cm (2.8 in) between the left B and C-pillars. The windshield was fractured at the lower left A-pillar from exterior impact forces. Minor induced buckling was found on the roof area at the left B-pillar.

Figure 3. Frontal and left side damage to the 1999 GMC Sierra pickup truck.

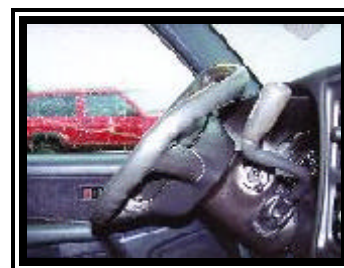
Interior damage to the Sierra pickup identified through the vehicle inspection was minor and was attributed to occupant contact (**Figures 4&5**). The upper portion of the steering wheel rim was deformed forward 6.0 cm (2.4 in) with the lower portion deformed 1.0 cm (0.4 in). The left sunvisor was displaced and scuffed with the inboard locking clip fractured. No deformation was found on the left or right knee bolsters. A 4.0 cm (1.6 in) longitudinal toe pan intrusion was documented to the driver space. A 28.0 cm (11.0 in) fabric transfer was identified to the shoulder portion of the front right

Figure 7. Steering wheel deformation.
