ON-SITE FATAL AIR BAG DEPLOYMENT INVESTIGATION

VERIDIAN ENGINEERING CASE NO. CA99-043

**VEHICLE #1 - 1996 CHRYSLER CONCORDE LX
VEHICLE #2 - 1995 HYUNDAI ELANTRA GLS**

Final Case Report
Veridian Engineering Case No. CA99-043
Front Right Air Bag Deployment Related Child Fatality
State of Georgia
September, 1999

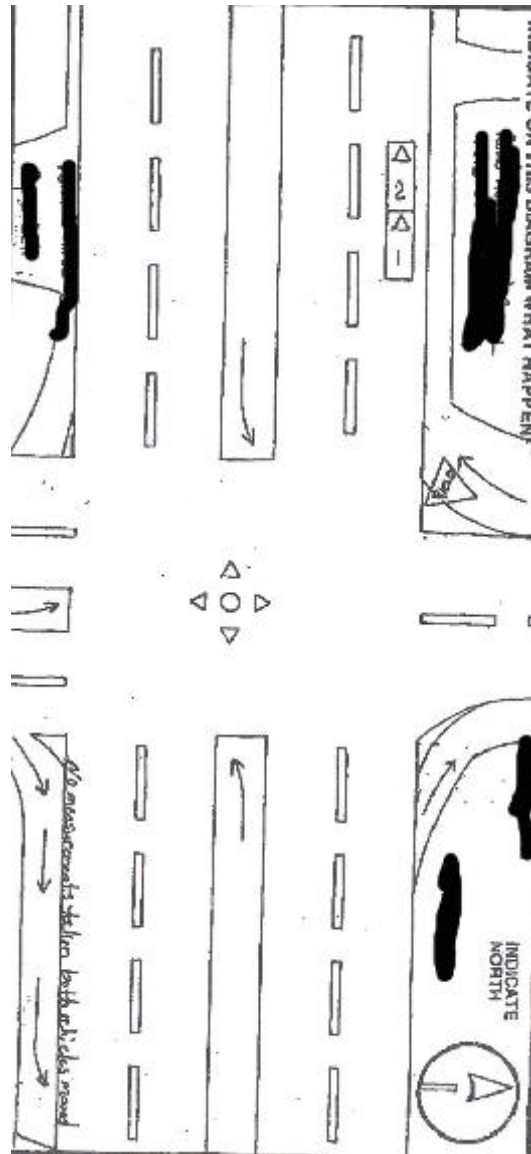
Figure 1 Police scene sketch

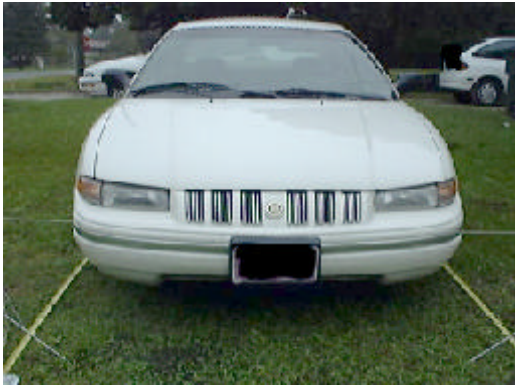
The crash deployed the Chrysler's supplemental restraint system (SRS) in a low delta V threshold type crash. The damage to the Chrysler was limited to 9.0 mm (0.375") displacement of the left bumper at the frame rail attachment bracket (**Figures 2 and 3**). The collision deformation classification (CDC) for this vehicle was: 12-FYEW-1. Using the damage routine of the WinSMASH speed reconstruction program, the delta V for the Chrysler was computed as 10.1 km/h (6.3 mph) and 14.4 km/h (8.9 mph) for the Hyundai.

Figure 3 Frontal view of the 1996 Chrysler Concorde LX

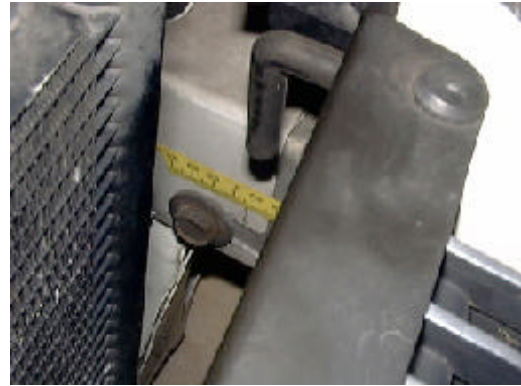
Figure 2 View of the left front bumper attachment bracket at the left frame rail showing 9.5 mm (0.375") of rearward displacement

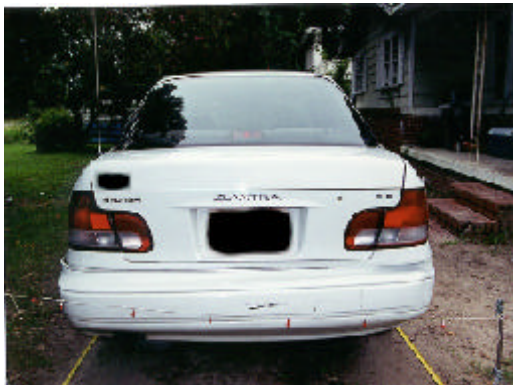
Damage to the rear of the Hyundai was located in the right rear bumper area. The maximum crush of 12.8 cm (5.0") was located at the right rear bumper corner (**Figures 4 and 5**). The assigned CDC for this vehicle was 06-BZEW-1.

Figure 4 View of the rear plane of the 1995 Hyundai Elantra GLS

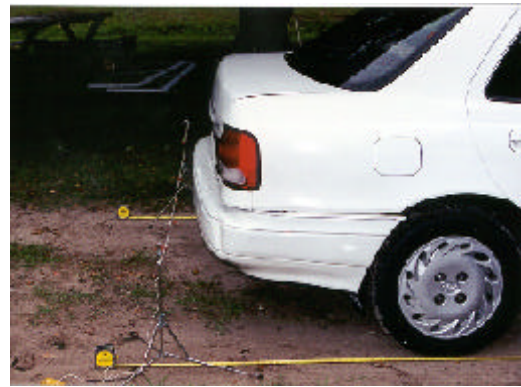
Figure 5 Lateral view of the right rear side plane showing the extent of damage (Note: string line set 3 cm long)

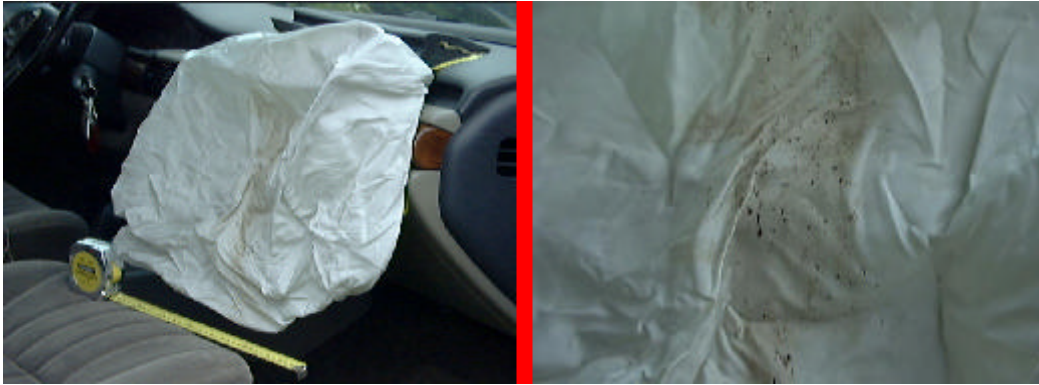
During pre-crash braking, the child moved forward and was within close proximity to the instrument panel at the time of air bag actuation. The front right air bag contacted the child's neck and facial area which resulted in abrasions and contusions of the left anterior neck and a complete separation fracture of C1 from the base of the skull. These medically diagnosed injuries were correlated with the heavy concentration of body tissue noted on the surface of the air bag which measured 10.2 cm (4.0") wide and 48.3 cm (19.0") long

(Figure 6). The child was subsequently propelled rearward and contacted her mother’s face with her head. The mother reported that she had suffered two fractures of the left “cheek” bone, nerve damage along the left side of her face, a blood clot adjacent to the left eye, and impaired vision of the left eye.

Figure 6 Overall and close-up view of the front right air bag showing the body tissue transfer related to contact with the child’s neck and facial area.

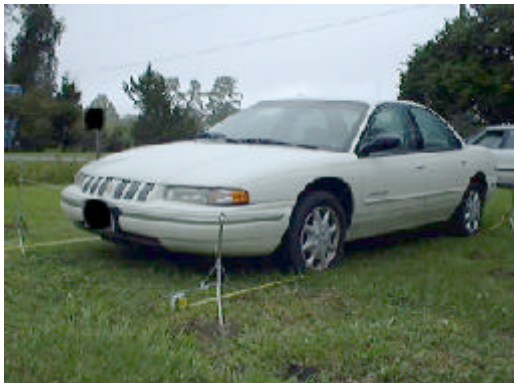
The Chrysler was equipped with a dual frontal air bag system which deployed as the result of the impact with the rear plane of a 1995 Hyundai Elantra GLS. Exterior damage was limited to the left front bumper corner (**Figures 7 & 8**) which was displaced rearward 9.5 mm (0.375"). Direct contact to the front bumper measured 68.6 cm (27.0") wide which began at the vehicle centerline and extended to the left bumper corner. The only measurable crush was located at the left frame rail where the displacement of the bumper mounting bolt measured 9.5 mm (0.375"). Crush values are listed in the following table:

Figure 7 View of the left front corner

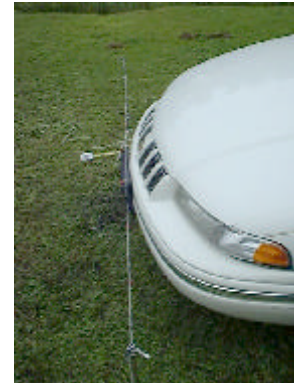
Figure 8 Lateral view of the frontal plane showing the extent of rearward displacement

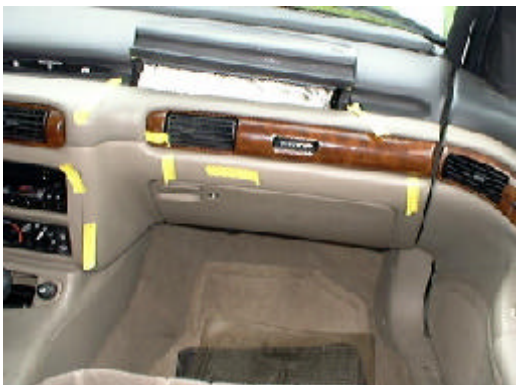
Interior damage to the 1996 Chrysler Concorde LX was confined to minor scrapes along the surfaces of the front right instrument panel area, tissue transfer along the right windshield header and the associated disruption of the interior from the deployment of the air bag system. Two abraded marks which measured 11.4 cm (4.5") and 5.1 cm (2.0") in length were located on the intermediate horizontal level of the front right instrument panel adjacent to the top mounted air bag module cover, respectively. These were attributed to contact by the front right air bag during the deployment sequence (**Figure 9**). There was a 1.9 cm (0.75") diameter smudge on the vertical surface of the front right instrument panel just above the glove compartment door and 27.9 cm (11.0") right of the vehicle centerline which was attributed to contact by the child occupant during the impact sequence.

Figure 9 View of contact evidence along the front right instrument panel

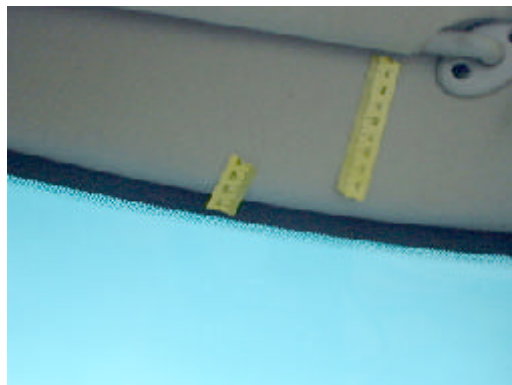
Figure 10 View of scattered tissue transfer along the right windshield header area

The leading edge of the windshield header, roof liner, and right sunvisor contained small dot like artifacts which were attributed to tissue transfers related to the neck and facial soft tissue injury suffered by the front right child occupant (**Figure 10**). These artifacts were located 40.6 cm (16.0") right of the vehicle centerline and concentrated over a field width of 5.1 cm (2.0").

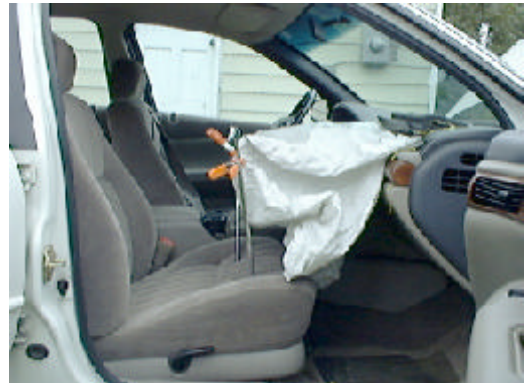
The front right bucket seat was found adjusted in a full rear position, but moved forward 5.1 cm (2.0") during the inspection to the approximate position described by the front right occupant prior to the crash (**Figure 11**). The front right seat adjustment range measured 21.6 cm (8.5"). The front right seat back support measured 21 degrees rearward from vertical. At this position, the seat back support measured 78.7 cm (31.0") rearward from the front right air bag module cover at a height of 140.6 cm (16.0") above the junction of the seat cushion. The leading edge of the seat cushion vertically was 30.5 cm (12.0") above the floor and 14.0 cm (5.5") rearward from the vertical plane of the instrument panel. The seat cushion had a 21 degree incline. The seat cushion measured 55.9 cm (22.0") wide and 50.8 cm (20.0") in length.

Figure 11 Lateral view of the front seat area showing the relative seat adjustment location and front right air bag excursion

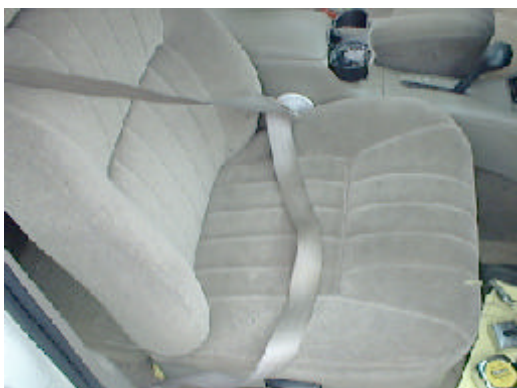
The front restraint belts were a manual three point continuous loop lap and torso belt (**Figure 12**). The front left adjustable D-ring was in the full down position while the front right was located 2.5 cm (1.0") above full down over a 10.2 cm (4.0") vertical adjustment range. Both front belts exhibited heavy usage with score type witness marks on the latch plates (**Figure 13**). Both the driver and adult front right occupant indicated that they were wearing the restraint belts at the time of the crash. There was no visible evidence on the front restraint system related to usage during the crash. Given the low severity of the crash, the lack of crash related loading evidence was considered within normal expectations.

Figure 12 View of the front right continuous loop lap and torso restraint belt

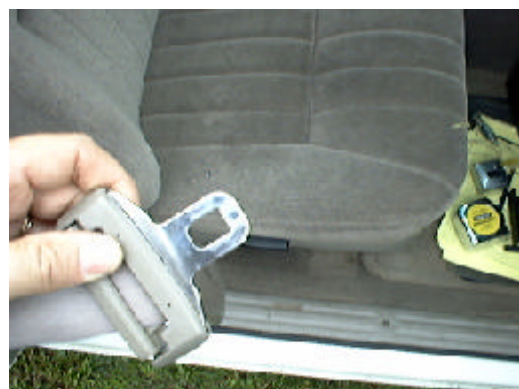
Figure 13 View of usage related score marks on the front right restraint belt latch plate

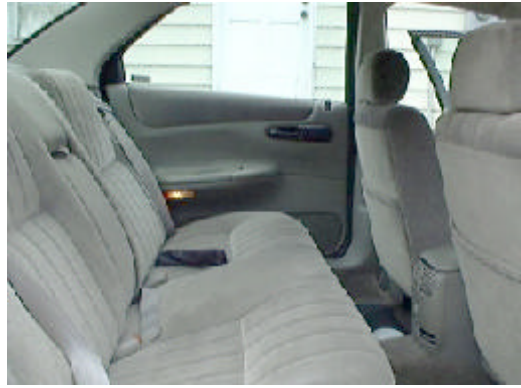
The rear seat area was equipped with lap and torso belts in the outboard seat positions and a single lap belt in the rear center. The driver and front right occupant indicated that three of the children were using the restraint while the fourth child seated in the rear center left was unrestrained. Inspection of the belt system indicated that the center lap belt was tucked behind the seat back support and not available at the time of the crash (**Figure 14**). The latch plates on the outboard restraint belts exhibited score marks which were related to frequent belt usage. There was no visible evidence of crash related occupant contact points to the rear surfaces of the front seat back supports.

Figure 14 View of the rear seat area of the Chrysler showing the availability of the outboard lap and torso belts and the non availability of the center lap restraint belt

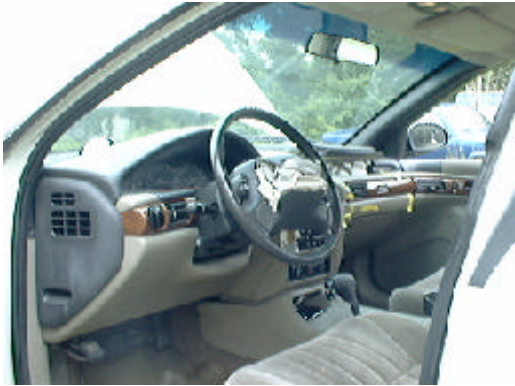
The front left driver module cover opened in the usual symmetrical “H” configuration pattern (**Figure 15**). The flaps measured 16.5 cm (6.5") laterally with a vertical dimension of 7.0 cm (2.75") for the top flap and 5.7 cm (2.25") for the bottom flap. The 1.9 mm (3/16") thick soft vinyl flaps did not exhibit any driver contact evidence.

Figure 15 View of the front left instrument panel and air bag module cover

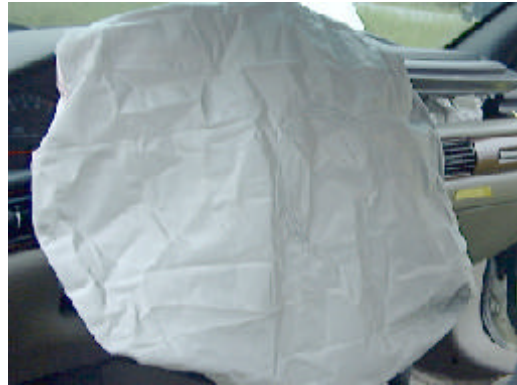
The air bag measured 64.1 cm (25.25") in diameter with a 15.9 cm (6.25") stitched center tether attachment circle (**Figure 16**). The air bag contained two tethers in the 3 and 9 o'clock positions and did not have any visible vent ports. The front surface of the air bag was made of a fine gray mesh heavy denier nylon fabric while the rear surface was made of a white mesh with a lighter weight denier. There was no visible driver contact evidence noted on the surface of the air bag. The air bag identification number was located on a tag which was stitched into the rear surface of the air bag which read as follows:

Figure 16 View of the front left air bag

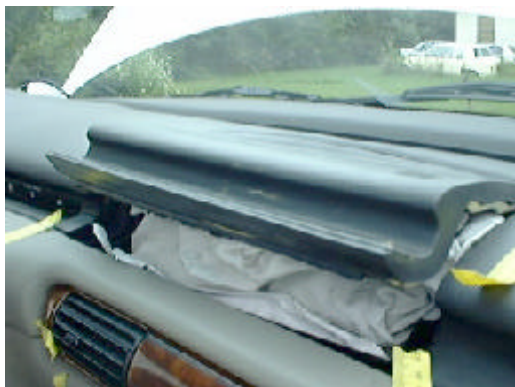
The front right air bag module cover was a top mount design which was hinged along the windshield seam edge. The cover was designed with a step up profile (**Figure 17**) where the leading edge was located 4.4 cm (1.75") below the top surface and had a step width of 3.8 cm (1.5"). The overall longitudinal length of the cover measured 17.5 cm (6.9") and was recessed 6.4 cm (2.5") from the vertical plane of the instrument panel (**Figure 18**) and 35.6 cm (14.0") from the base of the windshield. The lateral width of the cover measured 34.9 cm (13.9") along the leading edge and 36.2 cm (14.25") along the hinge edge. The cover appeared to be composed of a 15.9 mm (5/8") thick pliable vinyl material. There were no obvious occupant contact evidence on the cover.

Figure 17 View of the front right air bag module cover (artifacts shown in the photograph along the leading edge were related to post crash activities)

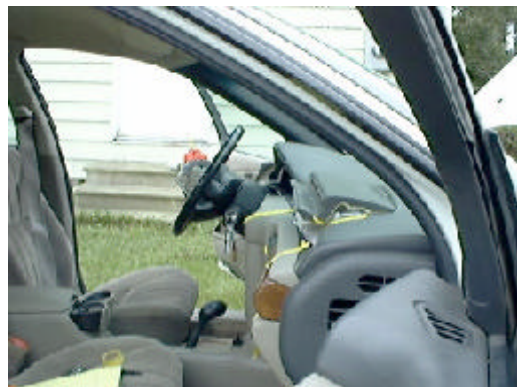
Figure 18 Lateral view of the right instrument panel highlighting the location of the front right air bag module cover to the leading edge of the instrument panel

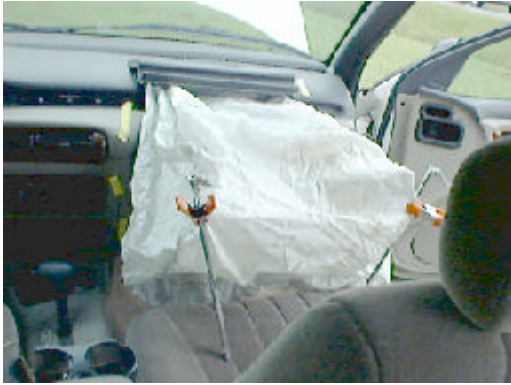
The air bag had a single full width tether and lacked visible vent ports. The width of the air bag measured 55.9 cm (22.0") and had a static longitudinal excursion (**Figure 19**) of 40.6 (16.0") with a vertical height of 58.4 cm (23.0"). The front surface of the air bag exhibited a heavy concentration of bodily tissue which was concentrated in a 10.2 cm (4.0") wide band that extended 48.3 cm (19.0") in length. The tissue

Figure 19 View of the front right air bag showing the relationship between the air bag excursion and the leading edge of the seat cushion

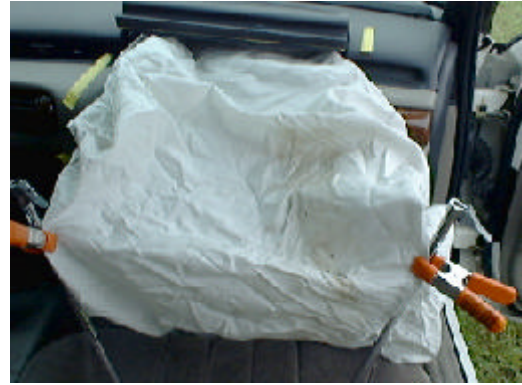
artifact field began 24.1 cm (9.5") from the instrument panel and 12.7 cm (5.0") inboard from the right side of the air bag.

Figure 20 View of the bodily artifact tissue field located 12.7 cm (5.0") inboard from the right seam line

The pattern and length of the tissue transfer field indicated that the child was within close proximity to the air bag module cover at the time of the air bag deployment sequence. This transfer correlated with the medically described abrasion of the left anterior neck area.

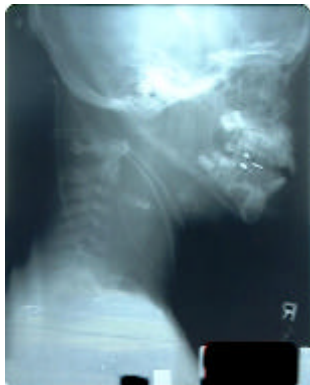
The child suffered a complete fracture separation of C1 from the base of the skull with complete spinal cord transection (AIS-6). This injury was determined by the coroner after analyzing x-ray film and noting the wide gap between C1 and C2 (**Figures 21 & 22**).

Figure 21 Right lateral x-ray view of the girl's neck and head showing the complete separation of C1 from base of the skull

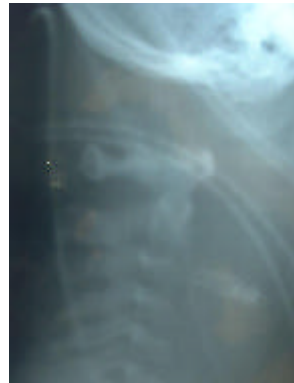
Figure 22 Close-up view of the atlanto-occipital fracture dislocation
