**VERIDIAN ON-SITE AIR BAG RELATED
CHILD PASSENGER FATALITY INVESTIGATION
VERIDIAN CASE NO. CA99-046
VEHICLE: 1996 VOLKSWAGEN GOLF GL
LOCATION: VIRGINIA
CRASH DATE: SEPTEMBER 1999**

Contract No.
DTNH22-94-D-07058

U.S. Department of Transportation
National Highway Traffic Safety Administration
Washington, D.C. 20590

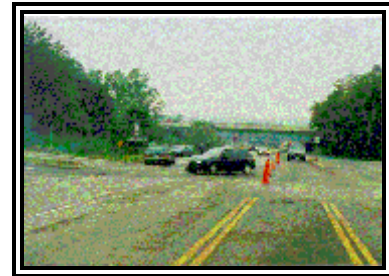
Figure 1. Overall on-site view of the crash scene.

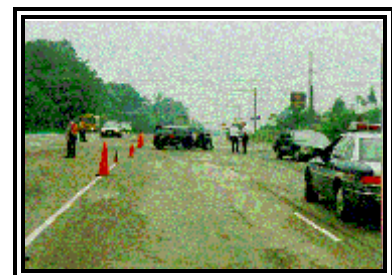
The Volkswagen driver detected the Buick as it turned across its path of travel. She braked with sufficient force to lock the front wheels of the Golf as it skidded on the worn asphalt surface to impact (**Figure 2**). The investigating officer documented front wheel skid marks of 14 m (46') for the left tire and 19.2 m (63.0') for the right front tire. This

Figure 2. Trajectory and final rest of Volkswagen.

pre-crash braking resulted in an equivalent velocity loss due to braking of 60.5 km/h (37.6 mph). There were no avoidance actions initiated by the Buick driver.

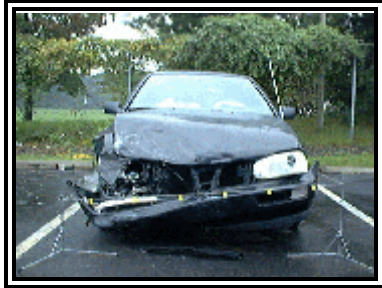
The 1996 Volkswagen Golf sustained moderate frontal damage as a result of its intersection crash with the 1996 Buick Roadmaster. The direct contact damage on the bumper fascia began 18.4 cm (7.25") left of center and extended 93.3 cm (36.75") to the right bumper corner (**Figure 3**). The off-set frontal damage pattern displaced the full width of the frontal structure resulting in a combined induced and direct contact damage length (Field L) of 143.8 cm (56.6"). Maximum crush was 30.5 cm (12.0") located at the right corner of the front bumper. A crush profile was documented at bumper level (**Figure 4**) and was as follows: C1 = 2.2 cm (0.875"), C2 = 3.2 cm (1.25"), C3 = 11.1 cm (4.375"), C4 = 11.7 cm (4.6"), C5 = 16.5 cm (6.5"), C6 = 30.5 cm (12.0").

The damage pattern resulted from an 11 o'clock impact force with a Collision Deformation Classification (CDC) of 11-FZEW-2. The undeformed end width of the frontal plane was 146.1 cm (57.5"). The baseline dimension (base of windshield to front bumper) was 106.7 cm (42.0"). The left wheelbase was not deformed, however, the right wheelbase was reduced in length by 1.7 cm (0.7").

Figure 3. Frontal damage pattern to the Volkswagen Golf.

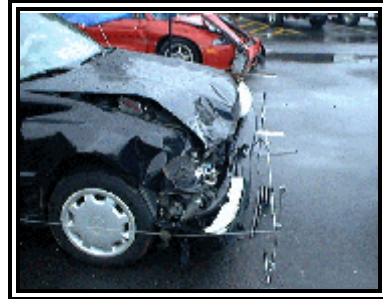
Figure 4. Profile view documenting the extent of crush.

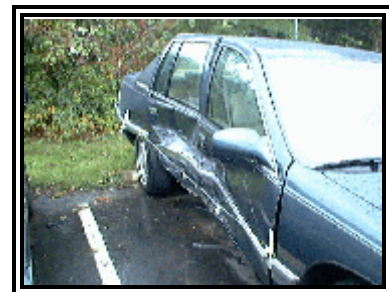
The right passenger compartment area of the 1996 Buick Roadmaster was impacted by the frontal area of the Volkswagen. The direct contact damage began 10.2 cm (4.0") forward of the right rear axle position and extended 168.9 cm (66.5") forward to the mid point of the right front door. The induced damage (Field L) began on the right rear quarter panel 22.9 cm (9.0") rearward of the referenced axle position and extended 267.0 cm (105.1") forward to the leading edge of the right front door. Maximum crush was 22.2 cm (8.75") located 21.6 cm (8.5") rearward of the right B-pillar. The crush profile

Figure 5. Right side damage to the Buick Roadmaster.

documented at mid door level (**Figure 5**) at six equidistant points along the Field L was as follows: C1 = 0 cm , C2 = 7.9 cm (3.1"), C3 = 21.6 cm (8.5"), C4 = 20.0 cm (7.875"), C5 = 9.5 cm (3.75"), C6 = 0 cm . The CDC for this impact was 02-RPEW-3.

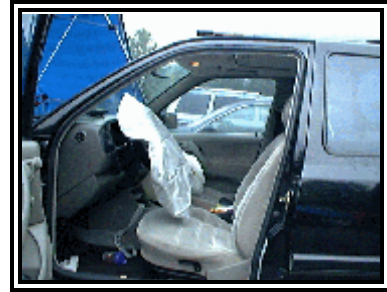
The driver air bag deployed from a typical mount within a four spoke steering wheel rim with the spokes located at the 3/9 and 5/7 o'clock positions. The air bag unit was concealed within an H-configuration module cover with symmetrical cover flaps. The upper flap was 7.0 cm (2.75") in height while the lower flap was 6.4 cm (2.5"). The width of both flaps at the horizontal tear seam was 16.8 cm (6.6"). The flaps were hinged with rigid sheet metal hinges that resulted in the flaps remaining fully opened against the wheel rim post-crash. **Figure 6** is a profile view of the deployed front left air bag.

Figure 6. Overall view of the driver's seated position and the deployed front left air bag.

The driver air bag was vented by two 3.2 cm (1.25") diameter ports located at the 10 and 2 o'clock positions, centered 7.0 cm (2.75") forward of the internally sewn peripheral seam. The bag measured 67.3 cm (26.5") in diameter in its deflated state and was tethered internally by four straps sewn to the face of the bag with a 8.9 cm (3.5") diameter reinforcement. In addition to the internal tethers, the two panels of the bag were sewn together at the 6 o'clock sector. This stitching separated during deployment which probably controlled the deployment path and expansion of the bag. The two rows of stitching were 19.1 cm (7.5") in length and at the mid point, located 14.0 cm (5.5") above the peripheral seam. This stitch pattern was similar to an energy management loop on a seat belt webbing. There was no driver contact evidence (i.e., make-up, tissues transfers) on the deployed driver air bag.

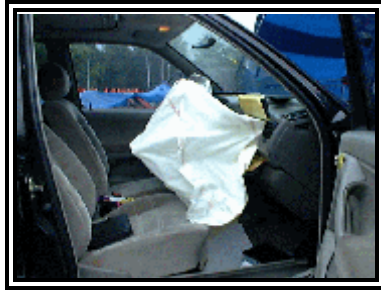
The front right passenger air bag deployed from a mid instrument panel mounted module assembly (**Figure 7**). The module was configured with H-configuration cover flaps that opened horizontally. The flaps were constructed of the vinyl outer skin with a rigid foam backer panel. The maximum thickness of the flaps was 2.5 cm (1.0"). The upper flap measured 7.3 cm (2.9") in height while the lower flap was 9.5 cm (3.75"). Both flaps had a maximum width of 37.1 cm (14.6") at the center tear seam. The upper flap contained several small tissue fragments at the mid point which extended 4.6 cm (1.8") above the tear seam (**Figure 8**). The tissue fragments resulted from contact against the chin of the child passenger. The upper flap contained a label with the following identification:

Figure 7. View of the deployed front right passenger air bag.

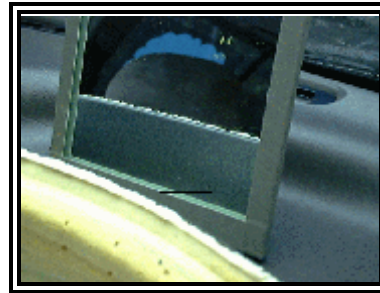
Figure 8. Small tissue fragments on the face of the upper module cover flap.

Front right occupant contact evidence to the air bag system consisted of a tissue transfer to the mid point of the upper module cover flap and a large tissue transfer to the bag membrane. The vertically oriented flap transfer was located 17.5-19.1 cm (6.9-7.5") left of the right edge of the cover flap and extended 4.6 cm (1.8") above the horizontal tear seam.

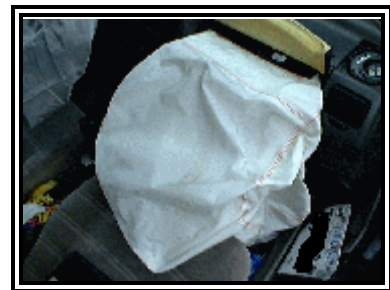
A large vertically oriented tissue transfer originated on the top panel of the passenger air bag membrane and extended onto the face of the bag as the membrane expanded against the child passenger. The transfer began on the top panel, 17.8 cm (7.0") forward of the bag face and 17.8-20.3 cm (7.0-8.0") left of the right side seam. The transfer continued across the upper apex of the bag onto the face of the membrane (**Figure 9**). At the apex, the transfer was 14.0 cm (5.5") in width and tapered to 5.1 cm (2.0") in width at its termination point which was located 20.3 cm (8.0") below the referenced apex point. It should be noted that larger fragments of tissue were scattered throughout this area with a vertical streaking of the transfers (**Figure 10**). There was no tearing or other damage to the bag membrane.

Figure 9. Vertically oriented tissue transfer on the front right air bag.

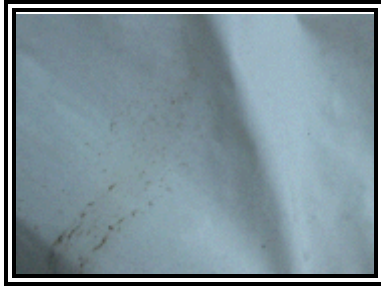
Figure 10. Close-up view of the tissue transfer.

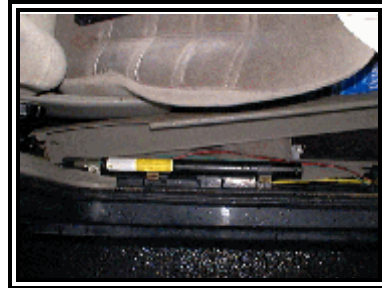
Figure 11. Front right pretensioner.

In this off-set front right crash, the right passenger pretensioner detected a sufficient frontal pulse to deploy the pyrotechnical device while the off-side (from the impact) driver unit did not deploy. Although the front right passenger was not wearing the manual belt system, the pretensioner fired and spooled the belt taut against the right B-pillar and locked the retractor in this position. The front left belt system (also not worn) remained in its pre-crash state which allowed the retractor to spool-out and retract the shoulder belt webbing.

A Volkswagen representative noted that a "tell-tail" sign of pretensioner deployment involved a physical inspection of the forward end cap on the unit's tube. If the plastic end cap is separated/displaced from the tube, then the system deployed. This end cap had separated from the front right unit while the cap remained intact within the tube of the front left unit.

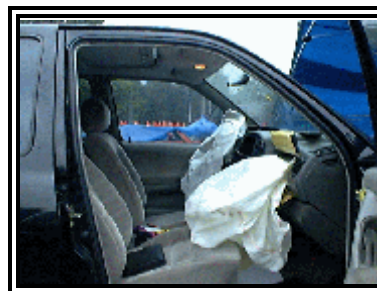
At impact with the Buick, the Golf's frontal air bag system deployed. The upper module cover flap contacted the chin of the forward positioned child passenger (**Figure 12**). The child passenger sustained a fracture of the left mandibular ramus with a contusion over the fracture site from flap contact. This contact sequence was confirmed by faint tissue transfers on the mid point of the cover flap. The flap was not deformed. This contact sequence probably began to rotate the head in an upward and rearward direction which exposed the anterior neck to the deploying air bag membrane. The subsequent expansion of the frontal air bag against the child resulted in a large triangular continuous abrasion and contusion pattern that extended across the anterior neck from ear-to-ear and vertically from the chin to the 1st intercostal space of the sternum. A large tissue transfer was present on the top surface of the air bag. In addition, she sustained an abrasion over the left ear. The expanding air bag hyper-extended the child's head which resulted in a traumatic fracture/dislocation of the atlanto-occipital joint and transection of the spinal cord at the level of the pons.

Figure 12. Occupant trajectory and deployment path of the front right air bag.

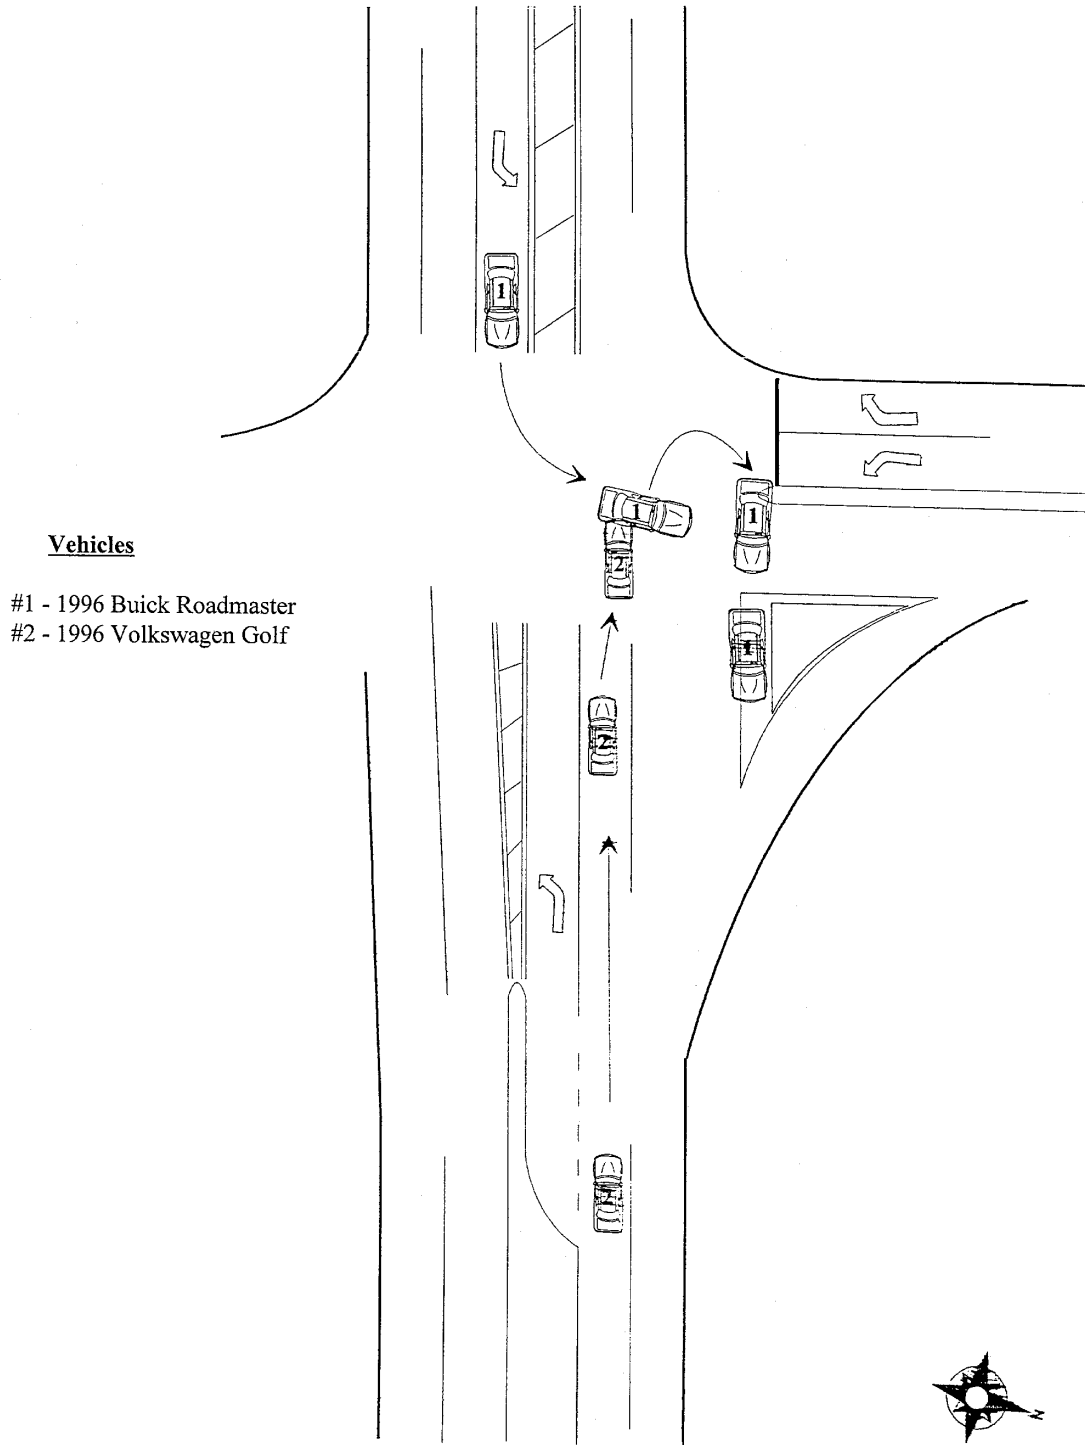
**CRASH SCHEMATIC
VERIDIAN CASE NO. CA99-46**

Figure 13. Crash Schematic
