On-scene Investigation / Vehicle to Vehicle
Dynamic Science, Inc. / Case Number: DS99048
1993 Jeep Grand Cherokee
Oregon
December 1995

1. Report No. DS99048		2. Government Accession No.		3. Recipient Catalog No.	
4. Title and Subtitle In-Depth Accident Investigation				5. Report Date February 5, 2000

Dynamic Science, Inc.
Accident Investigation
Case Number: DS99048

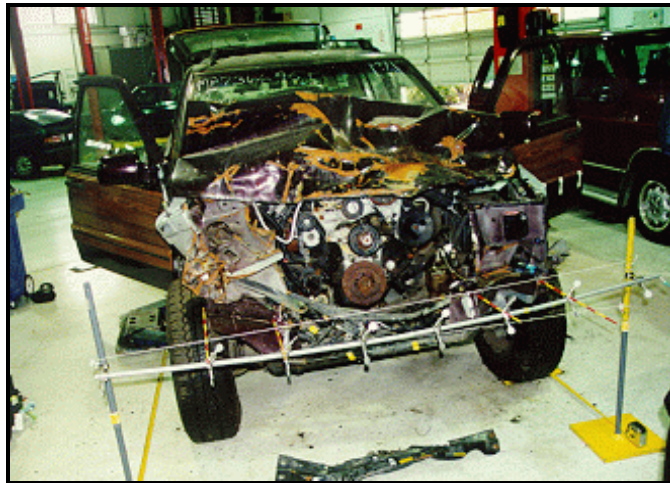
Figure 1. Exterior, Vehicle 1

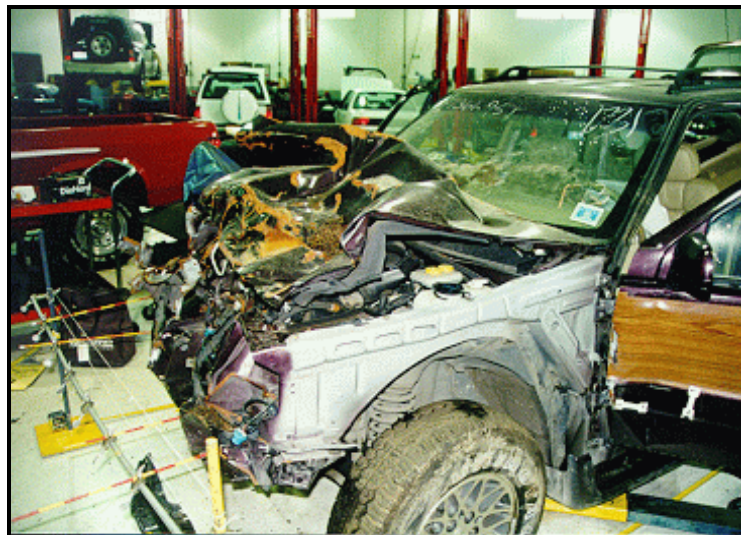
Description:	1993 Jeep Grand Cherokee 4x4 SUV	
VIN:	1J4GZ8846PCxxxxxx	
Odometer:	82,102 km (51,016 miles)	
Engine:	5.2L 8 cylinder	
Reported Defects:	None	
Cargo:	Lap top computer	
Damage Description:	Moderate frontal crush	
CDC:	12FDEW2	
Delta V:	Total	26.5 km/h (16.4 mph)
	Longitudinal	-26.1 km/h (-16.2 mph)
	Latitudinal	4.6 km/h (2.9 mph)
	Energy	43,219 joules (31,899 ft-lbs.)

Figure 3. Exterior, case vehicle

There was no intrusion nor any integrity loss.

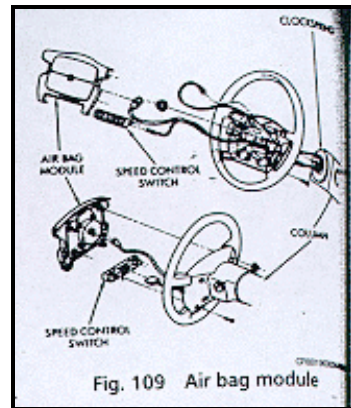
The case vehicle was equipped with a single, driver's frontal air bag which deployed during impact. The circular air bag had a diameter of 58 cm (22.8 in.) and there were 6 vertical folds. There were two vent holes just to the right and left of the 12 o'clock position on the back of the air bag. There were no tethers. The air bag module was housed in the steering wheel and the cover had an "H" configuration opening pattern. There was no contact to the cover flap. There was no damage to either the air bag or the module cover flaps.

Figure 4. Air bag system

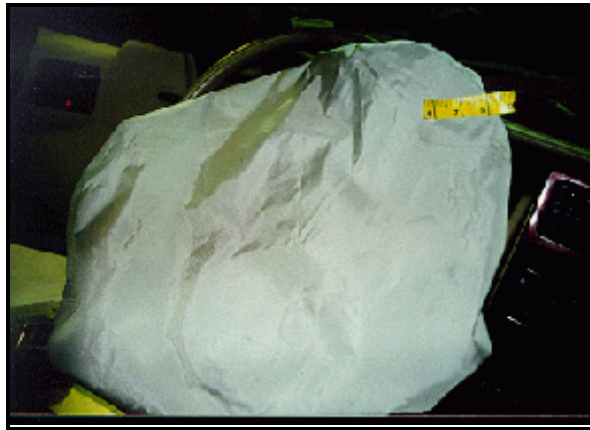
Figure 5. Driver's frontal air bag

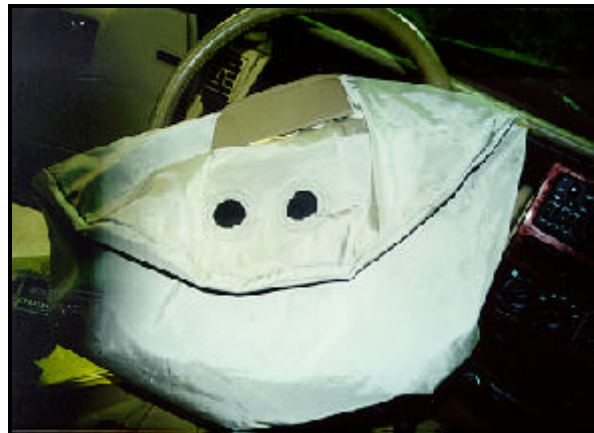
Figure 6. Driver's air bag—back

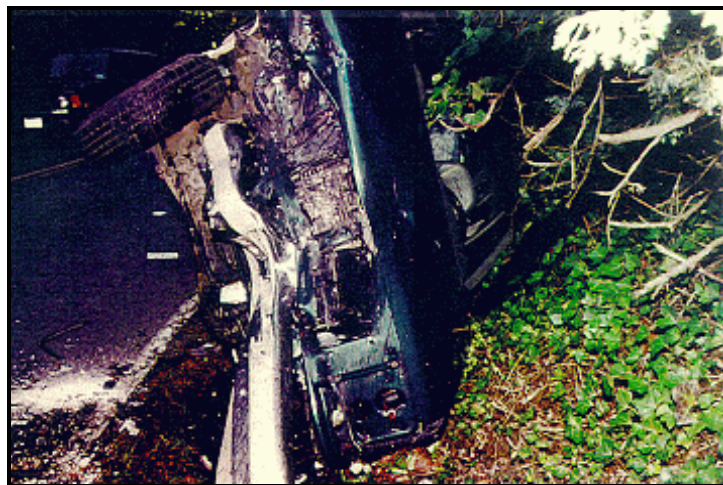
Description:	1991 Ford Explorer	
VIN:	Unknown	
Odometer:	94,957 km (59,004 miles) per police report	
Engine:	Unknown	
Reported Defects:	None noted	
Cargo:	Unknown	
Damage Description:	Moderate to heavy damage through front plane.	
CDC 1:	01FZEW2 (based on police photos)	
CDC 2:	00LDAO2	
Delta V:	Total	25.2 km/h (15.7 mph)
	Longitudinal	-24.1 km/h (-15.0 mph)
	Latitudinal	-7.8 km/h (-4.9 mph)
Energy	63,507 joules (46,844 ft-lbs.)

Figure 7. Exterior, other vehicle

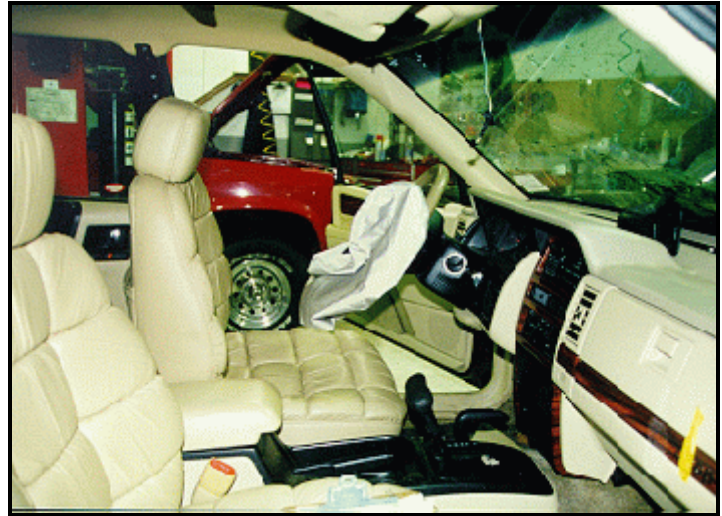
The case vehicle was equipped with an electric seat adjuster. The leather-covered front left seat was adjusted to a position where the leading edge of the seat cushion was forward of the steering wheel rim. The seat back was adjusted so that it was fully upright. There was 46 cm (18 in.) of clearance between the face of the air bag module and the seat back. The post-crash excursion of the air bag was 42 cm (17 in.). At impact, the driver of the case vehicle pitched forward and engaged the deploying air bag with her chest. This movement loaded the steering column causing 4 cm (1.6 in.) of compression. Given the proximity of the driver to the steering wheel, there would only be a minimal amount of belt loading prior to engagement. There was no contact with the air bag module cover nor was there any rim deformation. The driver continued forward and struck the lower instrument panel with her right knee. The driver's left hand came off the steering wheel and impacted the windshield. The driver's right foot likely struck the toe pan—causing the calcaneus fracture. High heels were found in the vehicle, but it is not known if they were being worn at the time of the crash. The driver sustained an abrasion to her right arm—probably due to contact with the deploying air bag.

Figure 8. Interior, case vehicle (seat in pre-crash position)

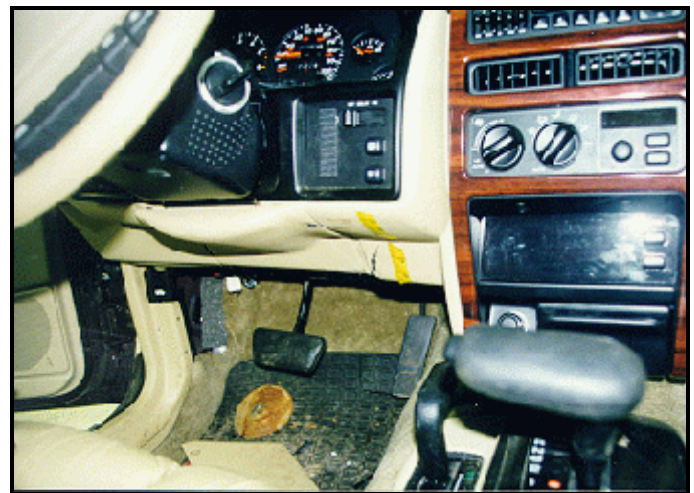
Figure 9. Front left—shows right knee contact

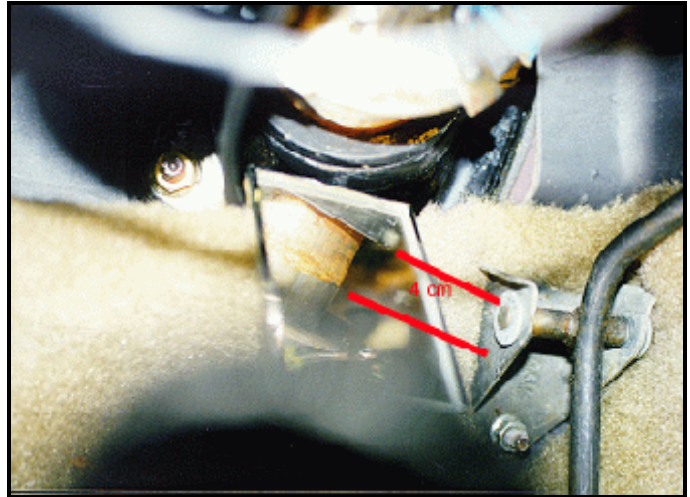
The driver's fatal chest injuries appear to have been caused by the deploying air bag and the subsequent loading of the steering wheel.

Figure 10. Under instrument panel view showing stroke from steering column compression.

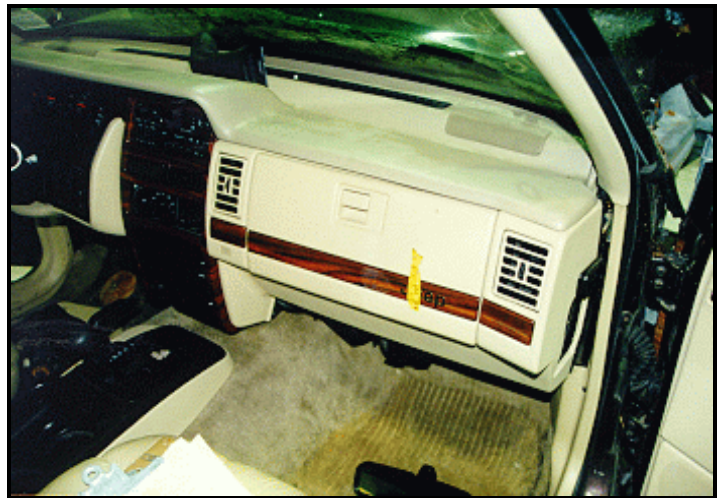
The front right occupant was wearing just the lap portion of the lap and shoulder belt. At impact, she pitched forward—rotating about the lap belt—and struck her head on the instrument panel. She sustained a minor contusion.

Figure 11. Right instrument panel–skin transfer
