**REMOTE REDESIGNED AIR BAG NON-DEPLOYMENT ADULT PASSENGER
FATALITY INVESTIGATION
SCI TECHNICAL SUMMARY REPORT**

VERIDIAN CASE NO. CA99-052

RABSS VEHICLE -1998 BUICK LESABRE

CRASH DATE - NOVEMBER 1998

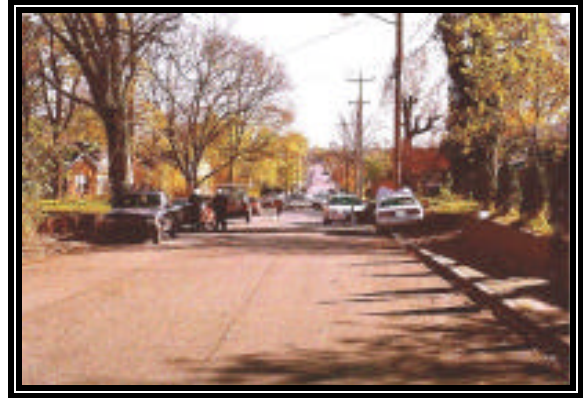
The 80-year-old male driver of the 1998 Buick LeSabre was operating the vehicle southbound on the residential roadway when he momentarily lost consciousness. During the episode, he relinquished control of the vehicle which caused it to veer to the right side of the roadway (**Figure 1**). The right front tire over rode the right curb edge and the vehicle rode up onto the sidewalk. The vehicle traveled south straddling the curb for approximately 23 m (75') prior to impact with the utility pole. There was no evidence within the vehicle's trajectory indicative of attempted driver avoidance maneuvers.

Figure 1. Southbound path of travel for the Buick LeSabre

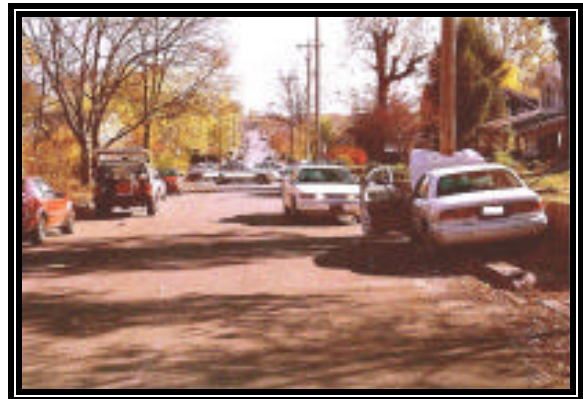
The front center area of the LeSabre impacted the utility pole. Impact resulted in moderate damage to the vehicle. The principal direction of force was within the 12 o'clock sector. The damage algorithm of the WinSMASH program computed a total velocity change of 34 km/h (21 mph) for the LeSabre based on the estimated crush profile. The impact induced deceleration was sufficient to deploy the redesigned frontal air bag system. The driver's air bag deployed, but the front right passenger air bag did not. The vehicle came to rest against the utility pole primarily on the west sidewalk with the left front and left rear wheels still on the roadway surface adjacent to the west curb (**Figure 2**).

Figure 2. Point of impact and final rest position against the utility pole

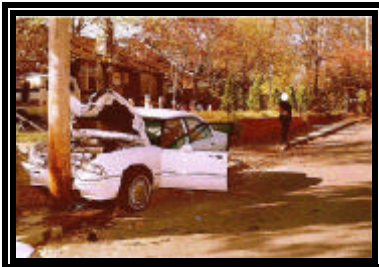
The 1998 Buick LeSabre sustained moderate frontal damage as a result of the impact with the utility pole (**Figure 3**). The Collision Deformation Classification (CDC) for this impact was 12-FCEN-2. The direct contact damage was estimated to begin approximately 15 cm (6") to the right of the center of the frontal plane and extended approximately 30 cm (12") left across the frontal plane (**Figure 4**). The combined direct and induced damage involved the full frontal width of the vehicle. Six crush measurements were estimated at the level of the bumper: C1 = 0 cm, C2 = 15 cm (6"), C3 = 50 cm (20"), C4 = 60 cm (24"), C5 = 20 cm (8"), C6 = 0 cm. The impact displaced the hood upward and rearward in addition to buckling at the designated fold points (**Figure 5**).

Figure 3. Frontal damage to the Buick LeSabre

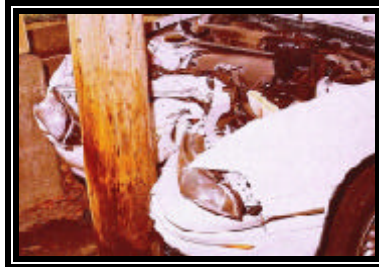
Figure 4. Close up of the frontal damage

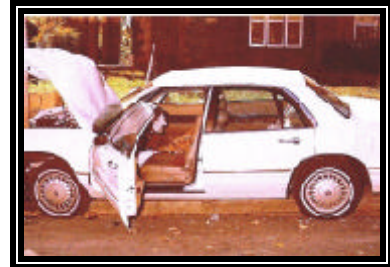
Figure 5. Left side view showing hood damage

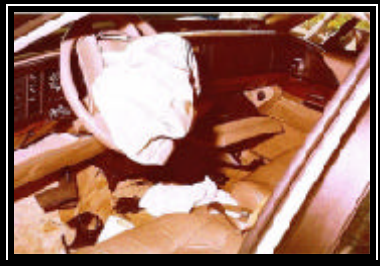
Interior damage to the Buick LeSabre was minor, and was attributed to occupant contact and passenger compartment intrusion. The knee bolster was displaced and the steering column appeared to have been compressed slightly (**Figure 6**). There was minor deformation to the driver's side rigid plastic knee bolster as evidenced by two depressions on either side of the steering column. A scuff mark was present on the mid instrument panel above the right corner of the glove compartment door estimated to be approximately 7 cm (3") in width and 4 cm (2") in height. The glove box door was open. The trim on the top of the right instrument panel was displaced upward approximately 3 cm (1") at the corner where it met the right door trim from occupant contact (**Figure 7**). The windshield on the right side was cracked in a spider web fashion from occupant contact. Intrusions included the left, center, and right toe pan areas, the center being the most intruded component (**Figure 8**).

Figure 6. Interior view showing damage to the knee bolster and steering column

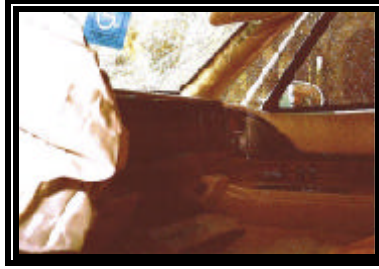
Figure 7. Interior view of the right instrument panel

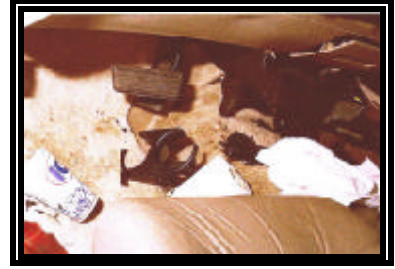
Figure 8. Interior view of the intruded toe pan and damaged knee bolster
