## REMOTE AIR BAG DEPLOYMENT REPORT

CASE NUMBER - IN99-060

VEHICLE - 1998 CHRYSLER CONCORDE LX

CRASH DATE - March 1998

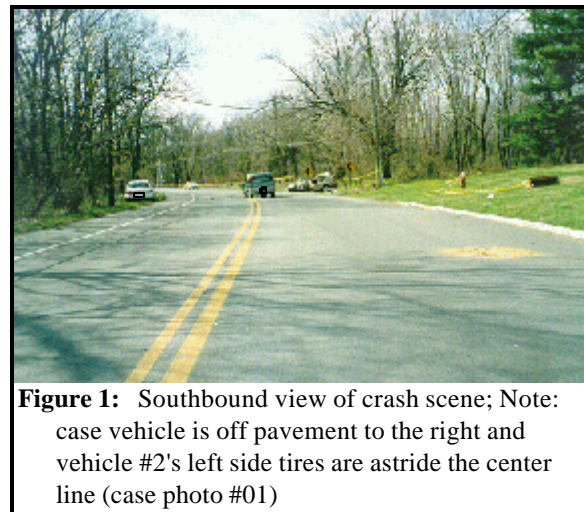
The case vehicle was traveling south in the southbound lane of a two-lane, two-way, undivided state highway (**Figure 1**). Vehicle #2 was traveling north in the northbound lane of the same state highway. It was daylight, with no adverse weather or roadway defects reported. The roadway was bituminous, dry, curved left (southbound), and level. The posted speed limit was 72 km.p.h. (45 m.p.h.). Traffic control devices present were four Chevron Alignment Signs (Manual on Uniform Traffic Control Devices, W1-8) for southbound traffic, a double solid yellow (no passing) center line, and single solid white edge lines delineating the east and west pavement verges. A diamond warning sign of indeterminate legend for southbound traffic is visible in the police photographs near the curve's northern tangent point. All traffic control devices were visible. Vehicle #2 drifted over the centerline into the southbound lane. The investigating officer indicated the case vehicle's driver braked and deposited pre-impact skidmarks. No indication of steering was reported. The crash occurred in the southbound lane of the roadway.

**Figure 1:** Southbound view of crash scene; Note: case vehicle is off pavement to the right and vehicle #2's left side tires are astride the center line (case photo #01)

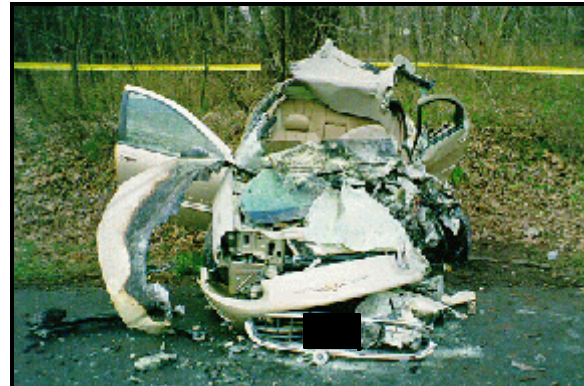
The case vehicle sustained direct contact damage to its front left corner (**Figure 2**). This direct damage consisted of rearward crush and displacement of the front bumper and fascia, the left side of the grille, the left headlamp assembly, all engine compartment components left of the left stub frame (including the left front fender), the left side steering assembly, the left front suspension system, and the left front wheel and tire shoved under the left lower A-pillar (**Figure 3**). Due to extrication efforts by rescue personnel that resulted in the complete removal of the case vehicle's left front door, the cutting of both upper A-pillars and B-pillars, and the roof peeled rearward, it is not known if direct damage extended to the left front A-pillar and the forward left front door seam. There was a minor post-impact engine compartment fire that further damaged the hood and windshield, masking their crash deformation. Indirect damage included the shortening and buckling of the left rocker panel, buckling of the left rear door, shattering of the left rear door glazing (kernelized), leftward pull of the right front fender, and a missing right front headlamp assembly. Based on available police photographs, the CDC for the case vehicle was estimated as: **12-FLAE-6** (direction of principal force 350 (-10) degrees). The WinSMASH reconstruction program, with CDC-only estimated crush profile, provided a borderline reconstruction, but the results appear reasonable. The case vehicle's estimated Total, Longitudinal, and Lateral Delta Vs are, respectively: 62.6 km.p.h. (38.9 m.p.h.), -61.6 km.p.h. (-38.3 m.p.h.), and 10.9 km.p.h. (6.8 m.p.h.).

**Figure 2:** Front left damage to case vehicle; Note: A- and B-pillars cut and roof peeled for extrication; fire damage to hood and windshield (case photo #07)

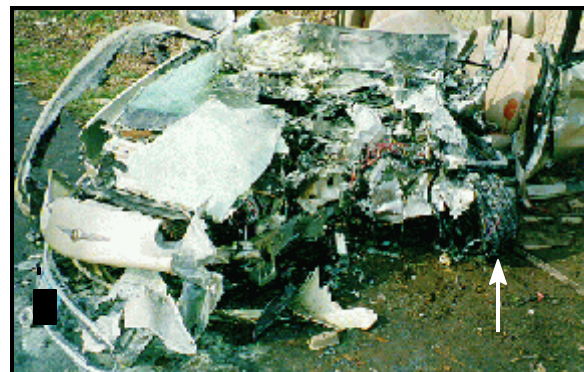
**Figure 3:** Close-up view of case vehicle's front left damage; Note: post-impact location (arrow) of left front wheel (case photo #08)

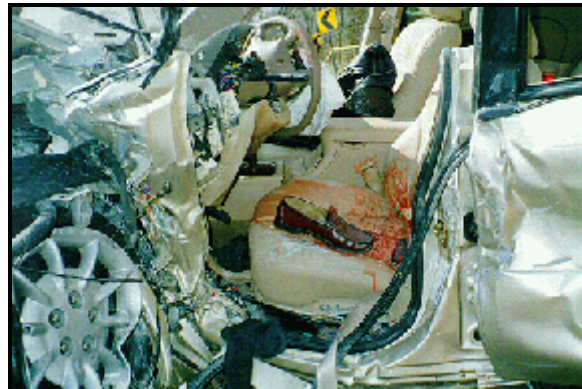
Intrusion to the case vehicle driver's area was substantial. The lower left A-pillar was displaced rearward and inward, as was the left corner of the instrument panel. The steering column and steering wheel were pushed rearward. Possible deformation to the driver's toe pan and foot well areas, as well as the upper A-pillar, windshield header, and the left roof rail cannot be determined.

**Figure 4:** Case vehicle driver's seat area intrusion and damage; Note: steering wheel and column displacement and reduced left front door exit area (Case photo #13)

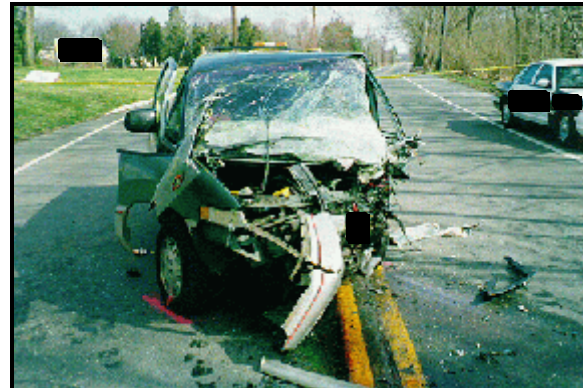
Vehicle #2 sustained direct contact damage to the left half of the front plane (**Figure 5**), including: the front left bumper and fascia displaced rearward; the front grille shattered and missing; the front hood deflected to the right, with the left half sheared off and its left side hinge missing; left half of the front engine compartment bracket housing displaced rearward; left half of the radiator shoved rearward; left front fender missing; left front wheel and tire displaced rearward under the lower A-pillar; the left front door glazing shattered and its sheet metal panel missing; the left upper A-pillar shoved rearward; and the left side of the windshield separated from the left A-pillar and splintered (**Figure 6**). Based on police photographs, the estimated CDC for vehicle #2 was: **12-FYAW-6** (direction of principal force 350 (-10) degrees). The WinSMASH reconstruction program, with a CDC-only estimated crush profile, provided a borderline reconstruction, but the results appear reasonable. Vehicle #2's estimated Total, Longitudinal, and Lateral Delta Vs are, respectively: 68.8 km.p.h. (42.8 m.p.h.), -67.7 km.p.h. (-42.1 m.p.h.), and 11.9 km.p.h. (7.4 m.p.h.).

**Figure 5:** Vehicle #2's front left damage (case photo #16)

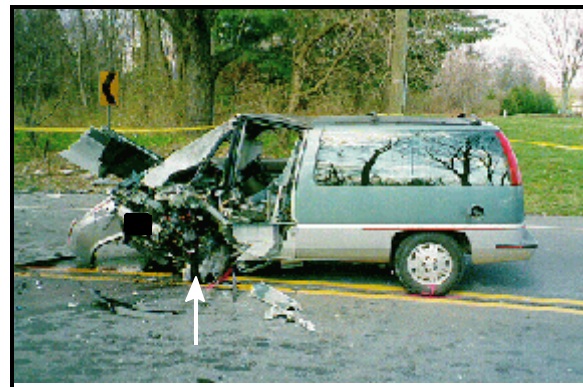
**Figure 6:** Left side view of vehicle #2's front left damage; Note: post-impact position of left front wheel (arrow) and reduced left front door exit area (case photo #19)
