**REMOTE REDESIGNED AIR BAG DEPLOYMENT INVESTIGATION  
SCI TECHNICAL SUMMARY REPORT**

**VERIDIAN CASE NO. CA99-063**

**RABSS VEHICLE - 1998 TOYOTA AVALON**

**CRASH DATE - AUGUST 1998**

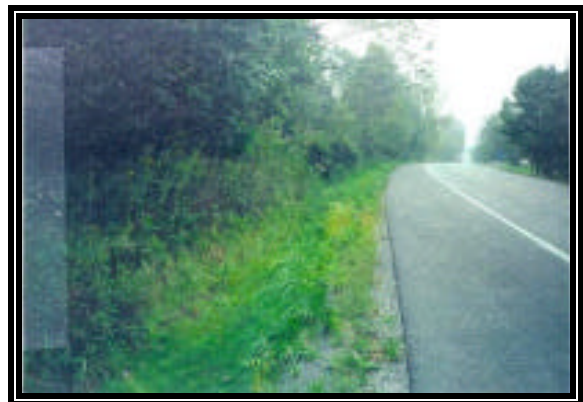
**Figure 1. East roadside with drainage ditch**

shoulders and a grassy drainage ditch on the east side of the roadway (**Figure 1**). The investigating officer reported the drainage ditch to be 1.5 m (5') below the grade of the roadway. The roadway was bordered by trees and vegetation on both sides.

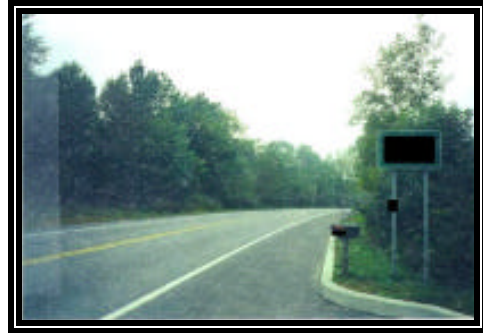
The 26-year-old female driver of the 1998 Toyota Avalon was operating the vehicle southbound on a 2-lane state roadway during a rainstorm (**Figure 2**). A non-contact vehicle traveling northbound splashed water onto the windshield of the Toyota, causing the driver's view to become obstructed. According to police, the driver reacted by steering right which caused the vehicle to travel onto the west shoulder. In an attempt to correct this maneuver, the driver steered left and lost control of the vehicle. The vehicle began to yaw in a counterclockwise (CCW) direction due to the slippery road conditions, crossed the centerline, and departed the roadway on the east side. The vehicle continued to yaw a police reported 27 m (89') along the east shoulder and into the grassy drainage ditch that bordered the east shoulder before impact.

**Figure 2. Southbound approach for the Toyota Avalon**

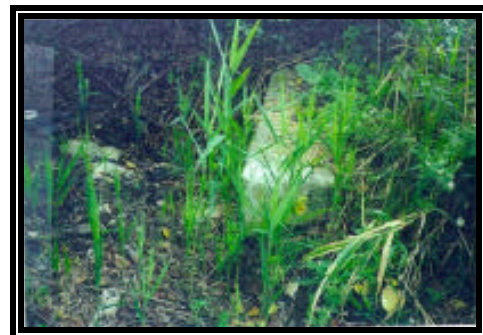
As the 1998 Toyota Avalon traveled down the slope into the bottom of the drainage ditch, it impacted a 0.5 x 3.4 m (1.6' x 11.0') concrete culvert (**Figure 3**) with the front right area. The principal direction of force was in the 1 o'clock sector. The damage algorithm of the WinSMASH program computed a velocity change of 35.6 km/h (22.3 mph) based on an estimated crush profile. The longitudinal and lateral components were -30.8 km/h (-19.3 mph) and -17.8 km/h (-11.1 mph) respectively. The impact induced deceleration was sufficient to deploy the redesigned frontal air bag system. The vehicle continued to travel in a forward direction over the culvert. It impacted the ground with the front left corner and struck the culvert with the lower right rear area before coming to rest in the ditch facing southeast.

**Figure 3. Concrete culvert**

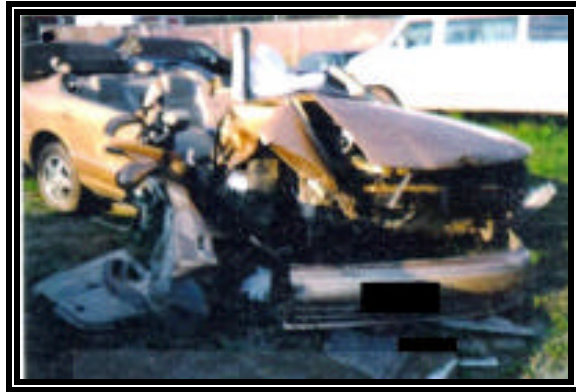
The 1998 Toyota Avalon sustained moderate frontal damage as a result of the impact with the concrete culvert. Insurance photos provided the basis for an analysis of the exterior damage of the vehicle (**Figure 4**). The roof and all glazing were removed by rescue personnel to extricate the occupants. The Collision Deformation Classification (CDC) for the frontal impact with the culvert was 01-FREE-4. Direct contact damage began at the front right bumper corner and extended laterally approximately 25 cm (10") toward the center of the vehicle. Direct contact damage was also noted longitudinally along the right front area forward of the A-pillar. The right front fender was displaced rearward and upward, and the hood was buckled at the designed fold points. The right front wheel was displaced rearward to the right A-pillar and was rotated clockwise (CW) at an approximate 50 degree angle relative to the vehicle. The bumper reinforcement bar was displaced rearward and the bumper fascia was separated from the vehicle. The combined direct and induced damage involved the entire frontal width of the vehicle. Six crush measurements were estimated at the level of the bumper reinforcement bar and were as follows: C1 = 5 cm (2"), C2 = 15 cm (6"), C3 = 30 cm (12"), C4 = 45 cm (18"), C5 = 60 cm (24"), C6 = 75 cm (30").

**Figure 4. Frontal damage to the Toyota Avalon**

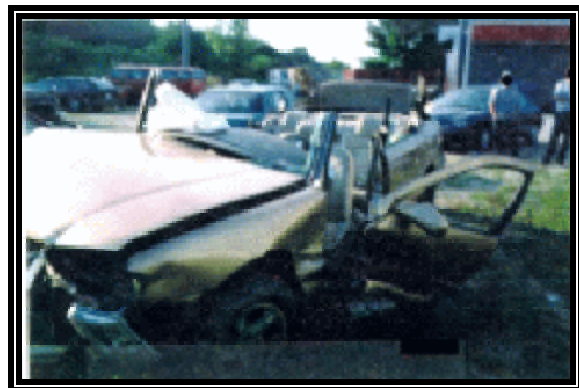
The CDC for the secondary impact to the ground with the left front area was 11-FLLE-1. Direct damage was noted on the lower left fender forward of the left front wheel (**Figure 5**). The fender was deformed in a rearward direction and buckled outward above the left front wheel. Damage to the fender was also noted aft of the left front wheel.

**Figure 5. Damage to the left fender**

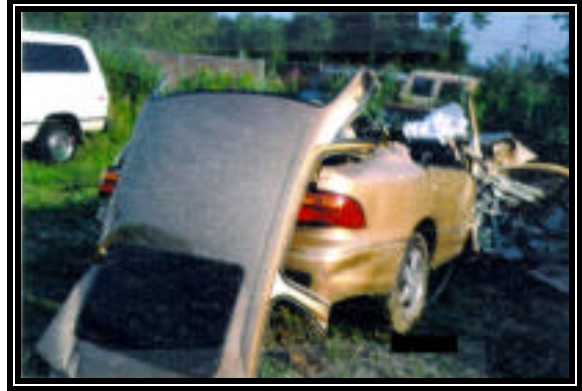
The CDC for the third impact to the culvert with the lower right rear area was 02-RBLW-1. Contact damage was noted approximately 5 cm (2") forward of the right rear bumper corner, and extended approximately 45 cm (18") longitudinally along the lower portion of the right rear quarter panel (**Figure 6**).

**Figure 6. Damage to the right rear area**

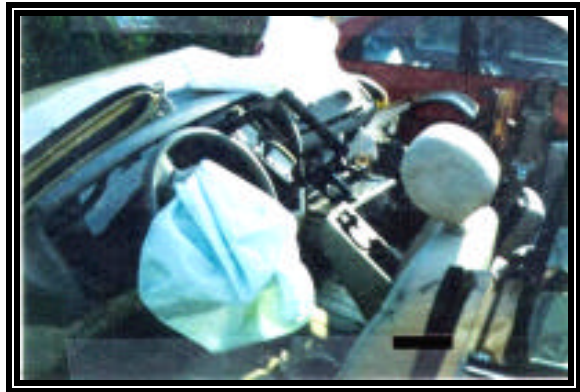
Interior damage for the 1998 Toyota Avalon was rated as moderate and attributed to exterior deformation and passenger compartment intrusion (**Figure 7**). The glove box door was open. Instrument panel molding in the front center and front right positions had separated from impact forces. Longitudinal intruded components included the entire instrument panel, right toe pan, and the right A-pillar. The front right seat back was noted to be in an almost fully reclined position and the adjustable head restraint appeared to be displaced rearward.

**Figure 7. Interior view**

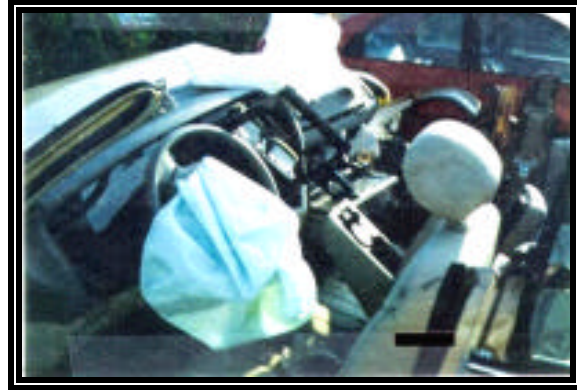
**Figure 7. Interior view**
