**REMOTE REDESIGNED AIR BAG RELATED ADULT DRIVER FATALITY  
INVESTIGATION  
SCI TECHNICAL SUMMARY REPORT**

**VERIDIAN CASE NO. CA99-064**

**RABSS VEHICLE - 1998 MERCURY MOUNTAINEER**

**CRASH DATE - JULY 1998**

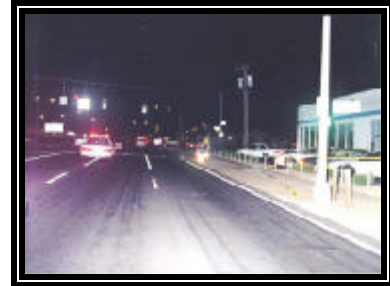
The 70-year-old male driver of the 1998 Mercury Mountaineer was operating the vehicle westbound in the outboard lane on approach to a 4-leg intersection (**Figure 1**). For unknown reasons, the driver lost control of the Mercury Mountaineer and it drifted to the right off of the roadway. The loss of control may have been due to a pre-crash medical episode however, it could not be confirmed. Based on the intersection configuration, lack of tire marks, and a witness statement, there was no attempted avoidance maneuver prior to impact. The 1998 Mercury Mountaineer was equipped with Firestone Wilderness AT tires on each wheel. Based on the on-scene photographs, all tires appeared to be inflated and intact post crash. Therefore, the tires do not appear to be a factor in the pre-crash loss of control.

**Figure 1. Westbound approach for the Mercury Mountaineer**

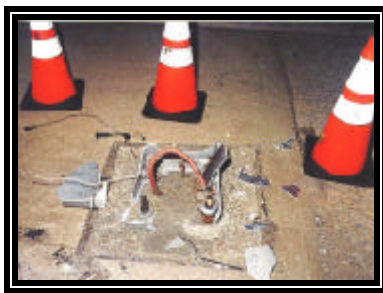
As the Mercury Mountaineer departed the roadway, the front right area impacted a luminaire with a frangible (breakaway) base (**Figure 2**) that was mounted approximately 0.6 m (2.0') from the curb (**Figure 3**). The principal direction of force was within the 12 o'clock sector. The luminaire was fractured at the base and was displaced upward. The mid-shaft area of the luminaire struck the windshield header and roof on the right side of the Mountaineer as the bottom was displaced upward and forward. The Mountaineer continued in a forward direction with no steering inputs and crossed the intersecting north/south roadway.

**Figure 2. Fractured base of luminaire from the first impact**

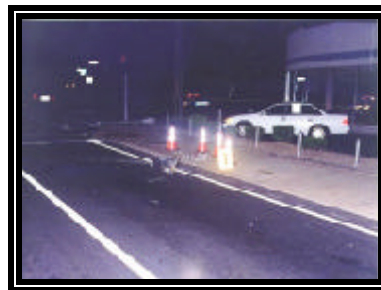
**Figure 3. View showing location of the fractured base with respect to the roadway**

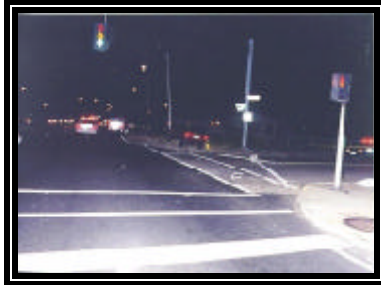
The luminaire came to rest across the north/south roadway (**Figure 4**). The Mountaineer over rode the northwest curb edge, as evidenced by tire marks on the curb edge. It traveled onto the northwest sidewalk and struck a second luminaire with the front left area (**Figure 5**). The principal direction of force was in the 12 o'clock sector. The impact with the second luminaire was sufficient to deploy the redesigned frontal air bag system in the Mountaineer. The concrete foundation of the luminaire was displaced forward in the loose soil which caused the luminaire to lean to the side. The Mountaineer rotated counterclockwise (CCW) around the luminaire approximately 10 degrees. As it rotated, it impacted a fire hydrant with the right rear area which stopped the rotation. The Mountaineer came to rest with the front left area against the luminaire and the right rear area against the fire hydrant (**Figure 6**).

**Figure 4. Intersection showing the fractured luminaire in the roadway**

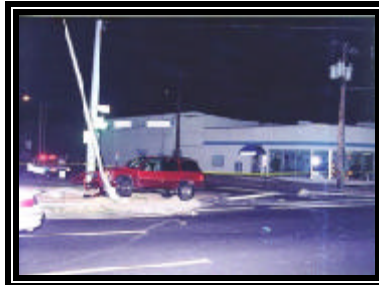
**Figure 5. Impact with the second luminaire**

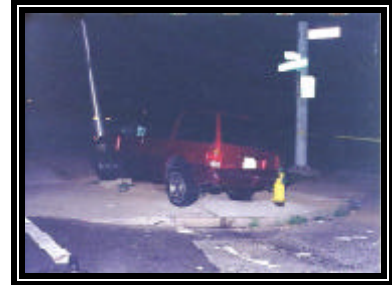
**Figure 6. Final rest position**

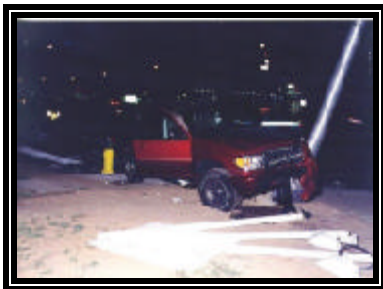
The Mercury Mountaineer sustained moderate damage as a result of the multiple impacts. Abrasions were noted on the front right aspect of the front grille guard. The bumper fascia, grille, and leading aspect of the hood on the right side were displaced rearward slightly from the rearward displacement of the grille guard (**Figure 7**). The Collision Deformation Classification (CDC) for the first event (initial luminaire impact) was 12-FREN-1. A depression was noted on the right windshield header and the windshield was cracked from the impact force on the right side. The CDC for the second event (shaft of luminaire striking windshield header) was 00-TYRN-2. The direct contact damage involved the front left corner of the Mountaineer. The front grille guard was crushed against the front right grille and headlamp. The grille guard had separated from the Mountaineer on the right side. The front bumper fascia was severed to the right of center, and the left and center aspects were separated from the Mountaineer. The hood was buckled on the left side. The maximum crush was estimated at approximately 10 cm (4") at the left bumper corner (**Figure 8**). The CDC for the third event (impact to second luminaire) was 12-FLEE-1. Abrasions were noted on the right rear quarter panel and the tail grille on the rear right tail light was displaced rearward from snagging on the fire hydrant. The rear right bumper corner sustained scratches and was displaced rearward approximately 3 cm (1") (**Figure 9**). The CDC for the fourth event (impact to the fire hydrant) was 03-RBEN-1.

**Figure 7. View showing the front right damage**

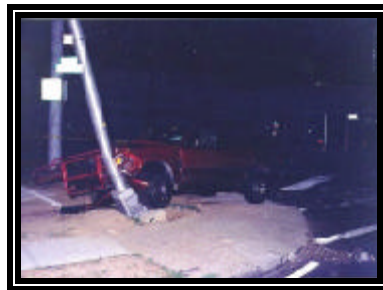
**Figure 8. View showing the front left damage**

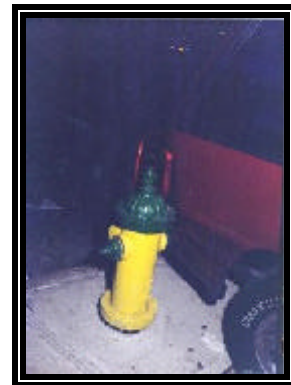
**Figure 9. Damage from the fire hydrant**

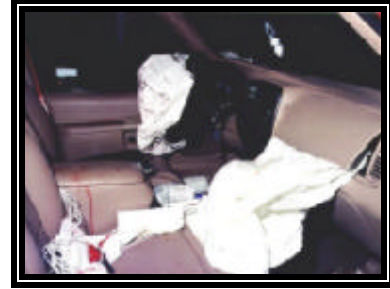
Interior damage was minor and attributed to occupant contact (**Figure 10**). There were no apparent intrusions. The knee bolster was displaced from occupant contact. The steering column appeared to be compressed based on comparison photographs of an exemplar vehicle. Blood was noted on the center arm rest and left aspect of the front right seat cushion.

**Figure 10. Interior view**
