**REMOTE REDESIGNED AIR BAG DEPLOYMENT INVESTIGATION  
SCI TECHNICAL SUMMARY REPORT**

**VERIDIAN CASE NO. CA99-065**

**RABSS VEHICLE - 1998 DODGE RAM PICKUP TRUCK**

**CRASH DATE - NOVEMBER 1998**

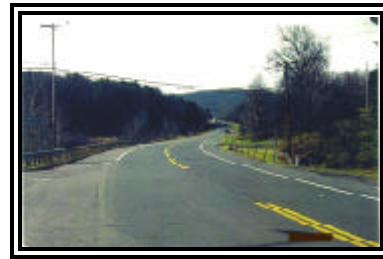
This two vehicle crash occurred during the nighttime hours of November 1998. At the time of the crash, it was dark and the roadway was unlighted. There were no adverse road conditions as the asphalt road surface was dry. The crash occurred on a straight and level portion of a 2-lane undivided highway that curved to the left approximately 0.40 km (.25 miles) north of the crash site. The roadside environment consisted of asphalt shoulders adjacent to the roadway, the east shoulder bordered by a guardrail that extended into the curve. Adjacent to the shoulders were grass and wooded areas. There were no traffic controls present at the scene. The posted speed limit was 89 km/h (55 mph) (**Figure 1**).

**Figure 1. View of crash site looking south**

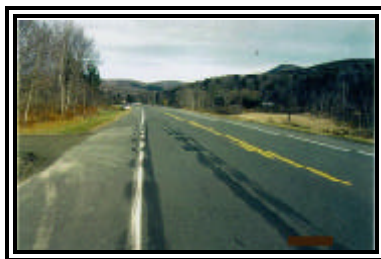
**Figure 2. Northbound approach for the tractor/semi-trailer prior to steering inputs showing skid marks from power unit and trailer**

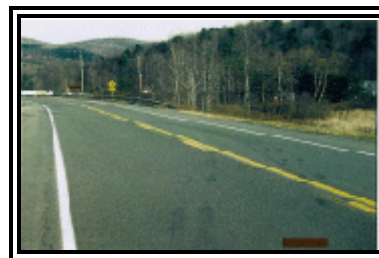
**Figure 3. Northbound approach for the tractor/semi-trailer showing skid marks from attempted avoidance maneuvers**

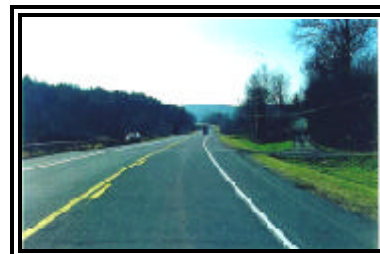
The 27-year-old male driver was operating the Dodge Ram pickup truck southbound and was exiting a curve to the right onto the straight portion of the roadway when he detected the oncoming tractor/semi-trailer traveling in the opposite direction in the same lane (**Figure 4**). The driver of the Dodge pickup truck realizing the impending harmful event, steered right and traveled onto the shoulder in an attempt to avoid the collision with the tractor/semi-trailer truck. The tractor/semi-trailer driver steered hard right immediately prior to the impact, while the trailer continued in a forward direction of travel.

**Figure 4. Southbound approach for the Dodge pickup truck**

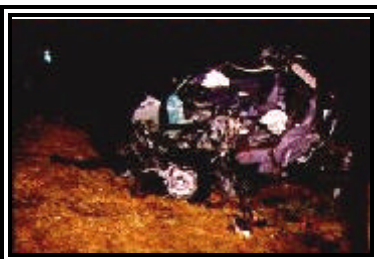
**Figure 5. On-scene photograph showing final rest position of the pickup truck**

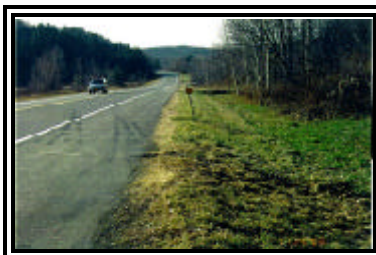
**Figure 6. Point of impact and final rest position for the pickup truck**

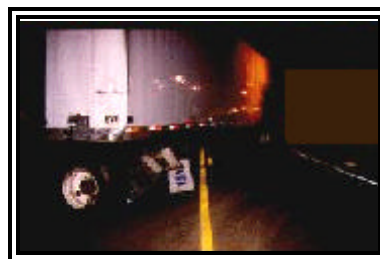
The front left area of the Dodge pickup truck impacted the left leading drive axle of the power unit. As the tractor/semi-trailer engaged the Dodge pickup truck, the forward momentum of the tractor/semi-trailer arrested the forward momentum of the pickup truck. The principal direction of force was in the 11 o'clock sector for the pickup truck. The left leading drive axle and leading left corner of the trailer penetrated the frontal plane of the pickup truck outboard of the left frame rail and continued down the left side to the rear axle. The left A-pillar impacted the front left corner of the trailer which caused severe rearward and lateral displacement of the sheet metal and severe damage to the left side of the greenhouse area (**Figure 5**). The momentum of the tractor/semi-trailer and clockwise (CW) yaw of the power unit redirected the pickup truck rearward while it rotated approximately 90 degrees in a counterclockwise (CCW) direction to final rest on the west road side facing east (**Figure 6**). The tractor/semi-trailer power unit traveled across the centerline in a CW yaw, and came to rest against the east guide rail in a jackknife position (**Figure 7**).

**Figure 7. On-scene photograph showing final rest position of the tractor/semi-trailer truck**

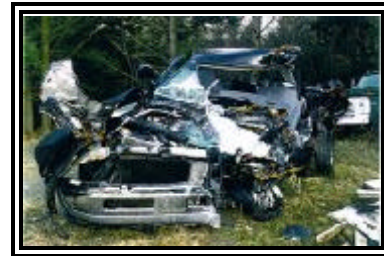
The 1998 Dodge Ram Pickup truck sustained severe left side damage as a result of the impact with the tractor/semi-trailer. The direct contact damage began approximately 44 cm to the left of the center of the bumper and extended approximately 46 cm (18") to the left front bumper corner. The direct damage continued down the left side of the vehicle approximately 398 cm (157") rearward, ending approximately at the rear axle (**Figure 8**). The dimensions were estimated by comparing the damage of the subject vehicle to an exemplar vehicle. The Collision Deformation Classification (CDC) for this impact was 11-FLAE-9 incremented by 60 due to front end-shift of approximately 20 cm (8"). The direct contact damage extended vertically from the left front wheel up the entire side of the vehicle from the impact with the rear of the power unit. Direct contact damage was noted by longitudinal scratches on the hood from the under ride with the corner of the trailer. Direct contact damage was also noted by damage to the left A-pillar and roof from the impact with the corner of the trailer. The hood was displaced forward and to the right. The front axle, left A-pillar, left B-pillar, and rear bed of the pickup truck were all displaced rearward. The left front wheel rim was bent from contact with the leading drive axle of the power unit, and the left front tire was deflated. The pickup truck bed was displaced upward and rearward from impact forces. The cab was shifted laterally to the right approximately 30 cm (12"). The height of the direct contact damage surpassed the level of the beltline producing induced buckling to the roof and separation of the left front A-pillar at the bottom of the windshield. The left side door tempered glazing had disintegrated from impact forces. The windshield was fractured and bond separation noted along the header and left side areas. The maximum crush was along the left side of the pickup truck outboard of the frame rail and extended from the front left bumper corner to the left rear wheel (**Figure 9**).

**Figure 8. Frontal view of exterior damage to the Dodge pickup truck**

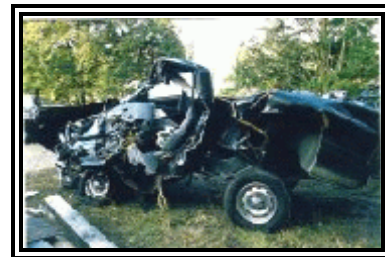
**Figure 9. Left side damage to the Dodge pickup truck**

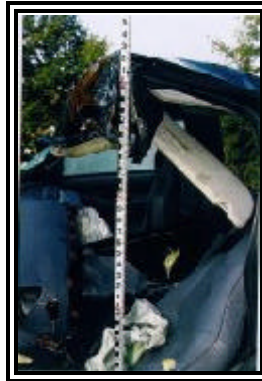
Interior damage to the Dodge Ram pickup truck was severe and was attributed to longitudinal component intrusion, the most severe being on the left side of the vehicle (**Figure 10**). Left front intrusions included the left A-pillar, upper and lower instrument panel and toepan, left door, windshield header and B-pillar. The steering column was displaced rearward and downward coming to rest on top of the driver's thighs. The steering wheel rim was severely deformed with the top portion bent rearward and the sides bowed out from component intrusion. The bottom of the steering wheel rim was bent forward due to occupant contact. The driver's side instrument panel fascia and gauges were displaced (**Figure 11**). The driver's seat back was displaced rearward and to the left. The webbing on the driver's 3-point lap and shoulder restraint system was cut by rescue personnel. The center armrest was deformed. The passenger seat back was displaced slightly to the left. Right front intrusions included the right A-pillar, upper and lower instrument panel, toepan, windshield header, and right side roof area.

**Figure 10. Interior view from the left side**

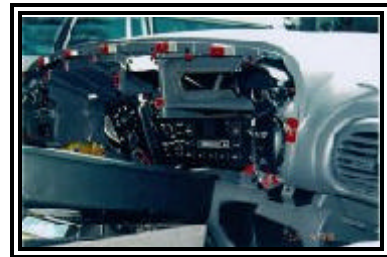
**Figure 11. Instrument panel showing deformation and front right passenger's air bag cut off switch**

The redesigned front right passenger's air bag deployed from the right mid-instrument panel area with a single cover flap design hinged at the top aspect. No contact evidence was noted on the air bag or cover flap. A cutoff switch for the passenger air bag was located in the center mid-instrument panel area, but the position of the switch could not be determined from the available photographs.

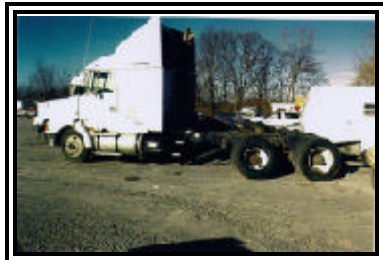
The 1997 Volvo tractor/semi-trailer sustained moderate damage to the left rear of the power unit, and minor damage to the left front corner of the trailer. Direct contact damage began just forward of the left drive axles of the power unit and extended to the left front corner of the trailer (**Figure 12**). Both rear axles of the power unit were displaced counterclockwise (CCW) approximately 15 degrees from contact with the Dodge pickup truck (**Figure 13**). The Truck Deformation Classification (TDC) for this impact was 11-LWEW-2. The left rear drive axle rim was deformed by contact with the left front wheel of the Dodge pickup truck. Damage to the trailer was attributed to the left A-pillar and windshield header of the Dodge pickup truck as evidenced by paint transfers and deformation to the front left corner (**Figure 14**).

**Figure 12. Damage to the power unit of the tractor/semi-trailer**

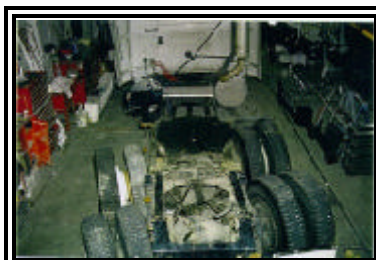
**Figure 13. Counterclockwise displacement of drive axles**

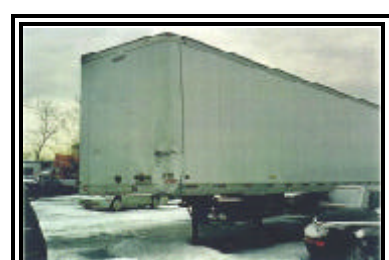
**Figure 14. Damage to front left corner of the trailer**
