**REMOTE REDESIGNED AIR BAG ADULT DRIVER FATALITY INVESTIGATION  
SCI TECHNICAL SUMMARY REPORT**

**VERIDIAN CASE NO. CA99-068**

**RABSS VEHICLE - 1998 PONTIAC SUNFIRE COUPE**

**CRASH DATE - AUGUST 1998**

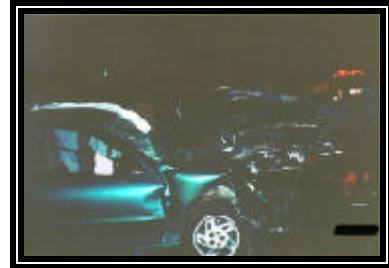
**Figure 1. On-scene photograph showing vehicle final rest positions**

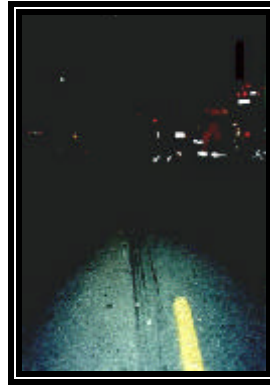
The 62-year-old female driver of the 1998 Pontiac Sunfire was operating the vehicle eastbound on a two-lane state roadway. The vehicle crossed the centerline for an unknown reason and traveled into the westbound lane prior to entering the intersection and into the path of the Dodge pickup truck. The driver of the pickup truck realized the impending harmful event, applied the brakes and attempted to steer left. Approximately 9m (30') of pre-impact skid marks from the pickup truck's left front tire were noted in the on-scene photographs (**Figure 2**).

**Figure 2. Skid mark from Dodge pickup truck**

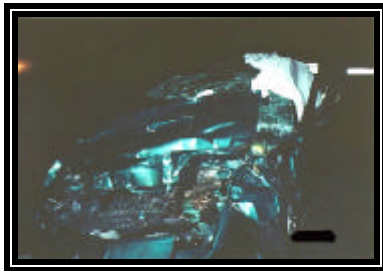
The 1998 Pontiac Sunfire sustained moderately severe frontal damage as a result of the impact with the Dodge pickup truck. On-scene photographs provided the basis for exterior damage of the vehicle. The Collision Deformation Classification (CDC) for the impact with the pickup truck was 12-FDEW-3. Direct contact damage involved the entire frontal width of the vehicle (**Figure 3**). The front bumper fascia had become displaced from the vehicle and the bumper reinforcement beam was displaced rearward. The hood was displaced rearward and buckled at the designed fold points. Scratches were noted on the hood from underriding the pickup truck. Both front fenders were buckled and displaced rearward, which restricted both front wheels (**Figure 4**). Six crush measurements were estimated at the level of the bumper reinforcement beam and were as follows: C1: 50cm (20"), C2: 50cm (20"), C3: 45cm (18"), C4: 45cm (18"), C5: 40cm (16"), C6: 35cm (14").

**Figure 3. Frontal damage to the Pontiac Sunfire**

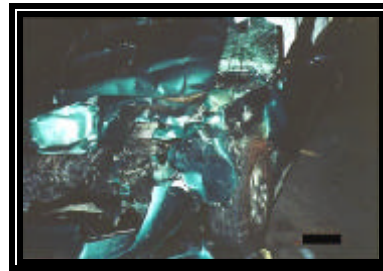
**Figure 4. Close-up of front left damage to the Pontiac Sunfire**

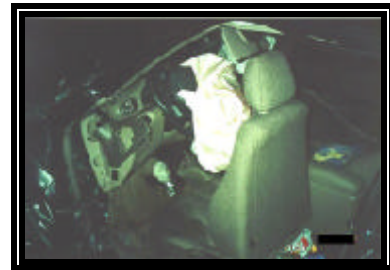
The interior of the Chevrolet Cavalier sustained moderate damage that was associated with exterior deformation and driver contact (**Figure 5**). The left instrument panel intruded into the driver's compartment due to rearward displacement of the left A-pillar. The left toe pan displaced approximately 10-12" rearward to a near vertical position. The unrestrained driver initiated a forward trajectory and loaded the steering assembly through the redesigned air bag. Her loading force deformed the upper and lower aspects of the steering wheel rim and probably compressed the energy absorbing steering column. This was evident by the close proximity of the steering wheel rim to the instrument panel. The driver's knees contacted and deformed the plastic knee bolster directly below and to the left of the steering column. Scuff marks identified both knee strikes to the bolster panel.

**Figure 5. Interior view of the Pontiac Sunfire**

The driver's knees impacted the knee bolster. The left knee scuffed and deformed the left side of the bolster while the right knee scuffed and deformed the bolster at the base of the steering column. This contact, in combination with the intrusion of the left toe pan produced unspecified bilateral open wounds of the lower extremities.

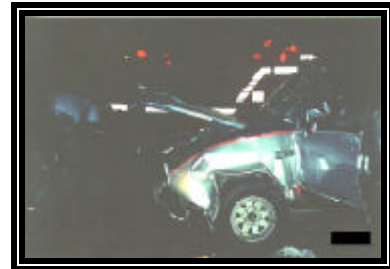
The 1989 Dodge pickup truck sustained moderate frontal damage as a result of the impact with the Sunfire. On-scene photographs provided the basis for exterior damage of the vehicle (Figure 6). The Collision Deformation Classification (CDC) for the impact with the Sunfire was 12-FDEW-2. The direct contact damage involved the entire frontal width of the vehicle. The direct contact damage extended vertically from the bumper to the face of the hood. The front bumper was displaced rearward and downward from the override to the Sunfire. The left front wheel was restricted from the rearward displacement of the left fender. Six crush measurements were estimated at the level of the bumper reinforcement beam and were as follows: C1: 40 cm (16"), C2: 40 cm (16"), C3: 35 cm (14"), C4: 30 cm (12"), C5: 25 cm (10"), C6: 20 cm (8").

**Figure 6. Exterior damage to the Dodge pickup truck**
