## REMOTE SCHOOL BUS INVESTIGATION

CASE NUMBER - IN99-077

LOCATION - TEXAS

VEHICLE - 1993 INTERNATIONAL 3700 WITH BLUEBIRD BODY

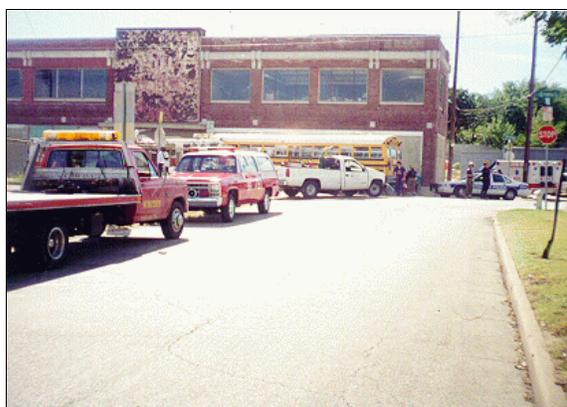
**Figure 1:** Case vehicle's westbound approach on east leg of four-leg, offset-cross intersection; Note: both vehicles at final rest (i.e., other vehicle is white Chevrolet pickup) and regulatory **STOP** sign at upper right of photograph (case photo #01)

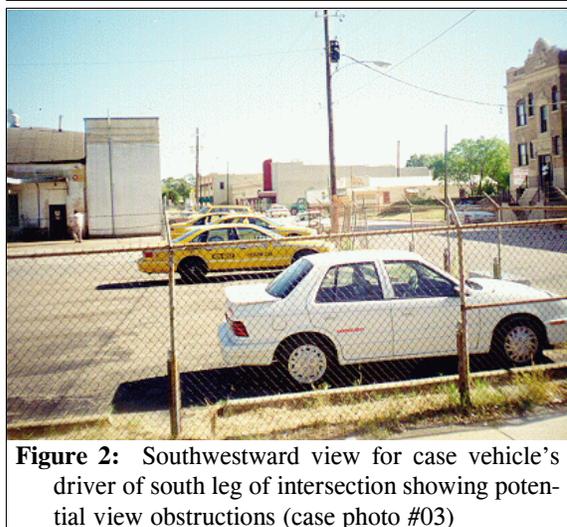
**Figure 2:** Southwestward view for case vehicle's driver of south leg of intersection showing potential view obstructions (case photo #03)

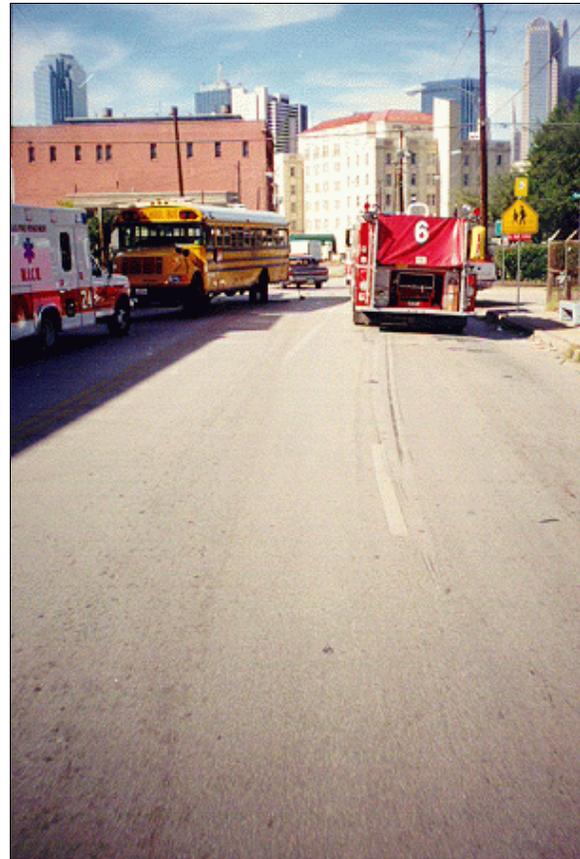
**Figure 3:** Chevrolet pickup's northward travel path from inside to outside northbound travel lanes; Note: case vehicle present but pickup not seen in photograph (case photo #04)

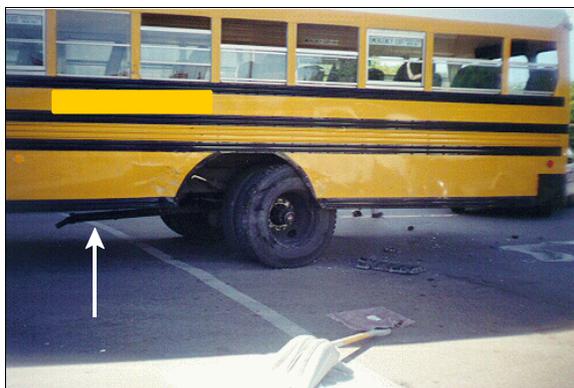
Direct damage to the case vehicle included sheet metal crush forward, around, and aft of the left rear wheel well (**Figure 4**). In addition, the left rear dual wheels were knocked off their mounts and shoved to the rear; the left rear springs were broken at their forward connection; and the drive shaft was broken at a universal joint (**Figure 5**).

**Figure 4:** Damage to case vehicle's left rear wheel well and axle: Note: rearward displacement of left rear dual tires and disconnected drive shaft (case photo #10)

Indirect damage consisted of the rear axle being angled, with the left rear dual wheels displaced rearward and the right rear dual wheels shoved forward. The investigating officer did not take any interior photographs of the case vehicle. There was no report of passenger compartment integrity loss or any indications of intrusion. The front right accordion door and the back emergency door remained closed and operational. Of the 12 left side windows, 6 were completely open, 3 were partially open, and 3 were closed. Of the 12 right side windows, 6 were completely open, 2 were partially open, and four were completely closed. The case vehicle (school bus) is not a NASS CDS-applicable vehicle and, therefore, the Collision Deformation Classification (CDC) is not applicable. The Truck Deformation Classification (TDC) is also not relevant. The case vehicle was towed due to disabling damage.

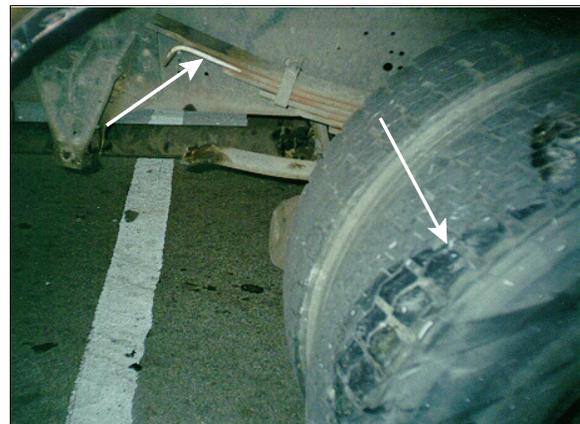
**Figure 5:** Forward end of case vehicle's broken left rear leaf springs; Note: Chevrolet pickup's contact marks on top leaf spring and on outside left rear dual tire (case photo #12)

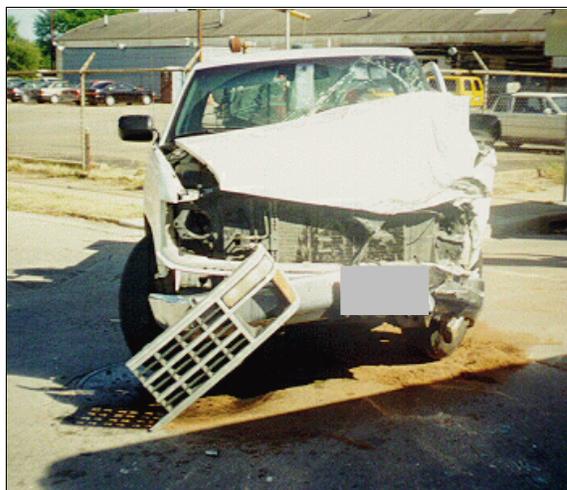
**Figure 6:** Chevrolet pickup's damaged front; Note: primary damage to front left corner and leftward shift of hood and right fender (case photo #15)

The Chevrolet pickup sustained direct contact damage to the left half of the front plane, with the left half of the front bumper displaced rearward (**Figures 6 and 7** above). In addition, the front grille was shattered, the radiator frame was bent, the female hood latch mechanism was pulled to the left, both headlamp assemblies were shattered, the left half of the hood was displaced rearward, and the left fender was shoved rearward. Induced damage included the left front wheel pushed into the lower “A”-pillar (**Figure 7** above); the front of the left rocker panel shoved upward; the upper left “A”-pillar shoved rearward; the left half of the windshield cracked; the left roof rail deformed; the left front door panel bowed outward; the left front door, the right front door, and the backlite glazings shattered (kernelized); the left “B”-pillar bent rearward; and the left rear roof rail buckled.

Based on available police photographs, a CDC for the Chevrolet pickup was estimated as: **12-FYEW-3 (10)** [maximum crush was approximated at 80 centimeters (31.5 inches)]. The WinSMASH reconstruction program, barrier algorithm, was used on the Chevrolet pickup's highest severity impact. The Total, Longitudinal, and Lateral Delta Vs are, respectively: 32.9 km.p.h. (20.4 m.p.h.), -32.4 km.p.h. (-20.1 m.p.h.), and -5.7 km.p.h. (-3.5 m.p.h.). This reconstruction is considered a borderline reconstruction, but this estimate appears to be reasonable. The Chevrolet pickup was towed due to disabling damage.

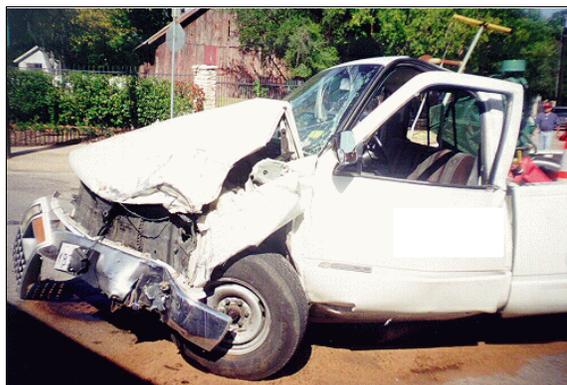
**Figure 7:** Chevrolet pickup's frontal damage viewed from left; Note: position of left front tire and induced damage to the left "A"-pillar (case photo #16)
