# INDIANA UNIVERSITY

## ON-SITE AIR BAG INVESTIGATION

CASE NUMBER - IN99-078  
LOCATION - TEXAS  
VEHICLE - 1995 FORD MUSTANG  
CRASH DATE - December, 1998

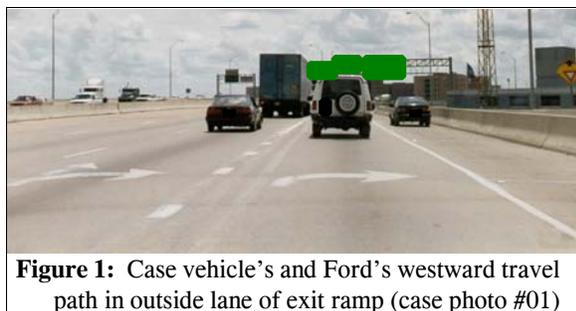
**Figure 1:** Case vehicle's and Ford's westward travel path in outside lane of exit ramp (case photo #01)

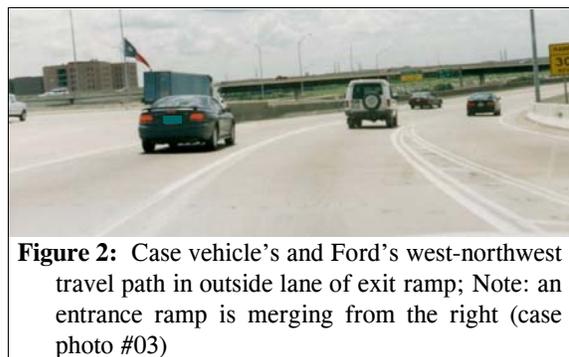
**Figure 2:** Case vehicle's and Ford's west-northwest travel path in outside lane of exit ramp; Note: an entrance ramp is merging from the right (case photo #03)

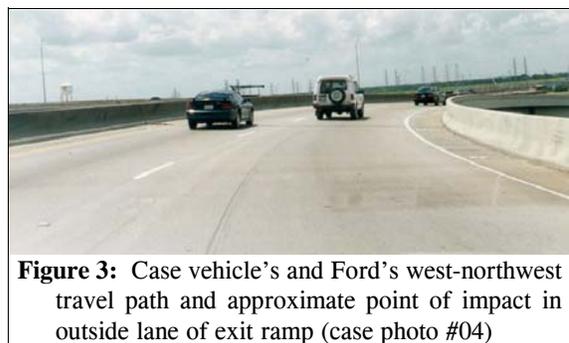
The case vehicle had been traveling in the outside through lane of a three-lane westbound roadway which was part of a divided, six-lane, state freeway, when the case vehicle entered an associated exit ramp in an Interchange area (**Figure 1**). The case vehicle was traveling west-northwest in the outside lane of the two-lane, exit ramp (**Figure 2**), intending on merging into the northbound roadway of an Interstate trafficway. The Ford pickup had also entered the exit ramp and was traveling ahead of the case vehicle in the outside lane when the Ford pickup unexplainably came to a complete stop. The case vehicle's driver braked, attempting to avoid the crash. The crash occurred in the Interchange area in the outside lane of the exit ramp (**Figure 3**); see **CRASH DIAGRAM** below.

**Figure 3:** Case vehicle's and Ford's west-northwest travel path and approximate point of impact in outside lane of exit ramp (case photo #04)

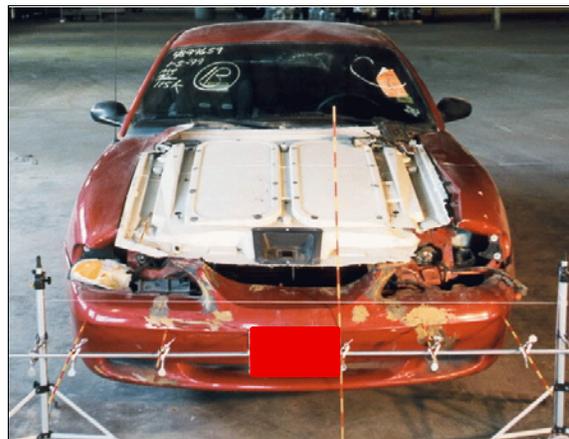
**Figure 4:** Elevated view of case vehicle's front under-ride damage with contour gauge at bumper level; Note: exposed inner hood structure and damaged headlight and turn signal assemblies (case photo #05)

The front (**Figure 4**) of the case vehicle impacted, and subsequently underrode (**Figure 5**) the back of the Ford pickup, causing the case vehicle's driver and front right passenger supplemental restraints (air bags) to deploy. The case vehicle came to rest heading west-northwest in the outside lane of the interchange ramp. The driver of the Ford pickup drove from the scene without rendering assistance or exchanging information.

The case vehicle’s contact with the Ford pickup involved the entire front end (**Figures 4 and 5** above). Based on the damage pattern on the case vehicle, the case vehicle’s front bumper underrode the Ford pickup’s back bumper, and the majority of the case vehicle’s damage occurred above the bumper as a result of the underride type impact (**Figures 6 and 7**).

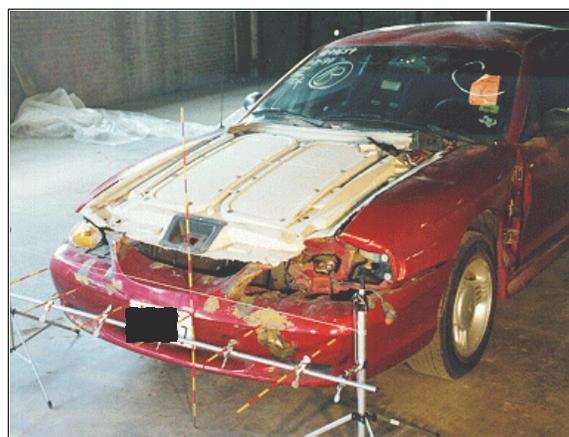
**Figure 5:** Case vehicle's frontal damage viewed from left of center showing under-ride damage pattern; Note: contour gauge at bumper level (case photo #07)

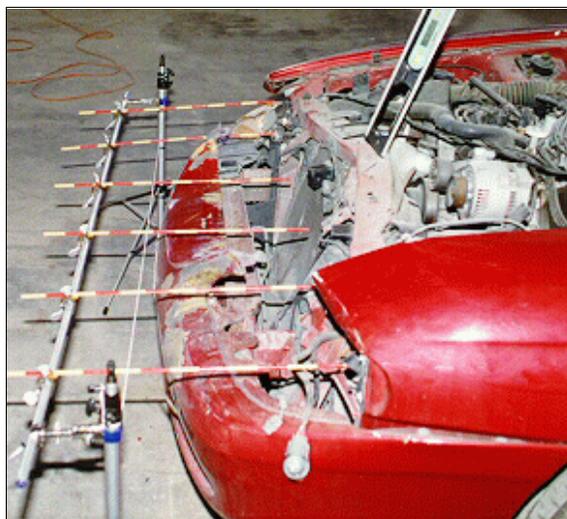
Direct damage began at the front left bumper corner and extended, a measured distance of 154 centimeters (60.6 inches), from bumper corner to bumper corner. The most severe crush occurred above bumper to the center (i.e., radiator area) of the case vehicle (**Figure 7**). Actual maximum deformation occurred above the bumper at C<sub>1</sub> and was 38 centimeters (15.0 inches). Maximum residual crush also occurred above the bumper and was 24 centimeters (9.4 inches) at C<sub>3</sub> and C<sub>4</sub>. Maximum average residual crush was 13 centimeters (5.1 inches) at C<sub>3</sub> and C<sub>4</sub>. The case vehicle’s wheelbase was unaltered from the crash. The case vehicle’s front bumper fascia, grille, hood, radiator, right and left headlight and turn signal assemblies, and both the right and left fenders were directly damaged and crushed rearward. The fiberglass hood had been partially torn away, exposing the inner hood structure, and was not available to be viewed. None of the case vehicle’s tires were physically restricted or deflated. Both the right and left fenders sustained induced damage as well and the left fender was pushed rearwards partially obstructing the opening of the driver’s door.

**Figure 6:** Reference line view from left of case vehicle’s front underride damage; Note: contour gauge shows above bumper damage (case photo #09)

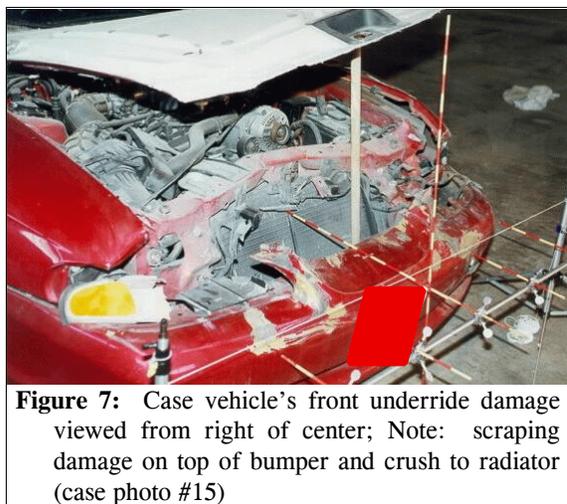
**Figure 7:** Case vehicle’s front underride damage viewed from right of center; Note: scraping damage on top of bumper and crush to radiator (case photo #15)

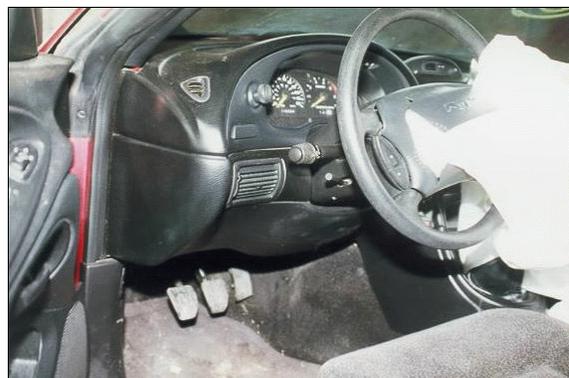
Inspection of the case vehicle’s interior revealed contact evidence on the driver’s knee bolster to the left side of the steering wheel (**Figure 8** below). In addition, the rearview mirror

**Figure 8:** Case vehicle's driver seating area showing deployed driver air bag and contact evidence on driver's knee bolster, left of the steering column (case photo #20)

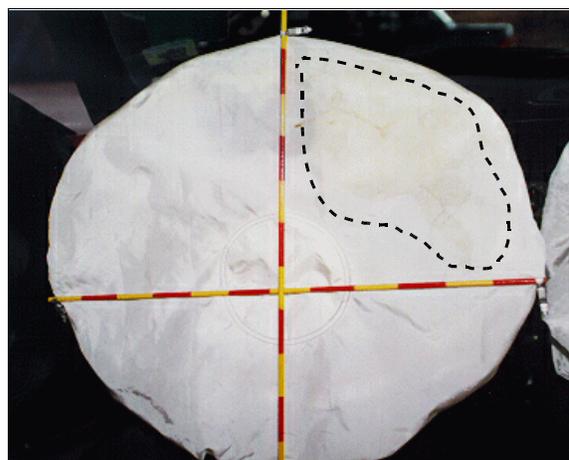
**Figure 9:** Case vehicle's deployed driver air bag with highlighted fluid stain of unknown origin (case photo #23)

driver's air bag was round with a diameter of 63 centimeters (24.8 inches). There was no contact (i.e., skin or blood) evidence readily apparent on the driver's air bag; although, there was an unknown fluid stain, measuring 21 x 23 centimeters (8.3 x 9.1 inches), located on the right upper quadrant of the air bag's fabric (**Figure 9** above).

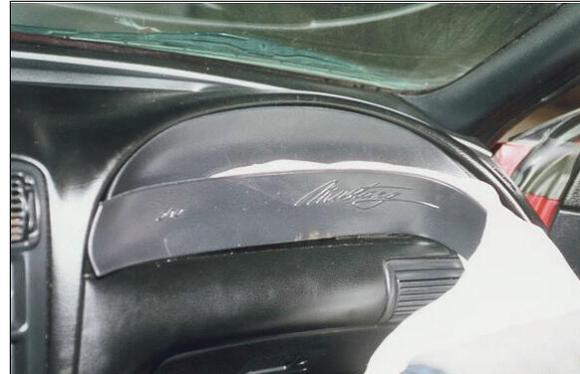
The front right passenger's air bag module was located in the middle of the instrument panel. There were two asymmetrical modular cover flaps made of a thick vinyl over a thick cardboard type frame (**Figure 10**). The upper flap was shaped like a quarter-moon and the flap's dimensions were 48 centimeters (18.9 inches) at the lower horizontal seam and 7.5 centimeters (3.0 inches) at the middle ordinate. The lower flap was trapezoidal and the flap's dimensions were: 48 centimeters (18.9 inches) at the top horizontal seam, 51 centimeters (20.1 inches) at the bottom horizontal seam, and 7.5 centimeters (3.0 inches) vertically between the seams. The profile of the case vehicle's instrument panel resulted in a 5 centimeter (2.0 inch) setback of the leading edge of the cover flap relative to the protruding right instrument panel.

**Figure 10:** Case vehicle front right passenger air bag module's irregularly shaped cover flaps (case photo #36)

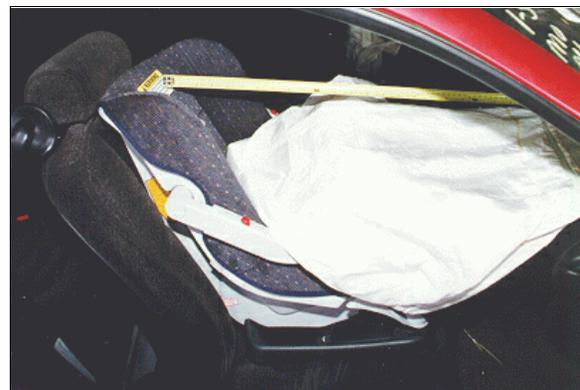
**Figure 11:** Case vehicle's outstretched, untethered, front right passenger air bag; Note: air bag's rearward excursion is capable of touching the seat back of this convertible, forward facing configured, child safety seat (case photo #34)

As mention above, the case vehicle's front right passenger air bag was designed without any tethers. Because of the untethered bag's rearward excursion [73 centimeters (28.4 inches ) from instrument panel–**Figure 11** above], the front right passenger was contacted across the lower half of her face (**Figure 15**), primarily to the right side. As a result, her head was accelerated upward and her torso rearward into the back of her child safety seat. Based on previously investigated SCI crashes, the facial injury pattern sustained by the case vehicle's front right child passenger is a strong indication that the forward facing child safety seat remained upright (vertical) and did not tip forward. At final rest the front right passenger remained in the child safety seat, slumped to the side (unknown), with her arms still over the top of the safety seat's shield.

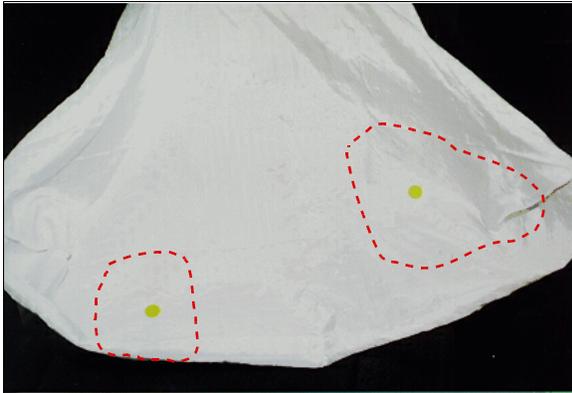
with the child safety seat located on the top surface of the air bag towards the front right edge (Figure 12).

**Figure 12:** Skin transfer (left) and blue cloth transfer (right) on top surface of the case vehicle's front right passenger air bag (case photo #28)

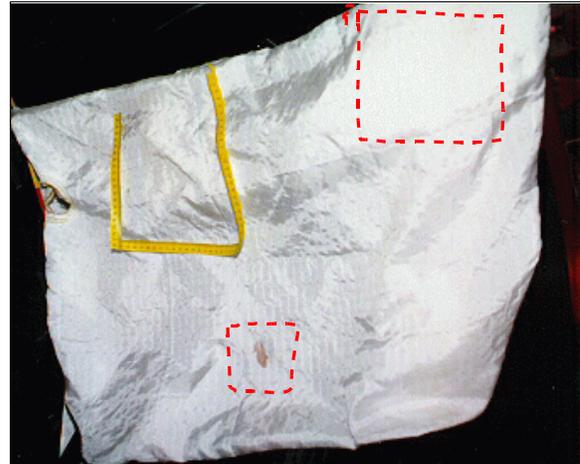
**Figure 13:** Front surface of case vehicle's front right passenger air bag showing two skin transfers along top and a blood smear toward bottom center portion of air bag (case photo #27)

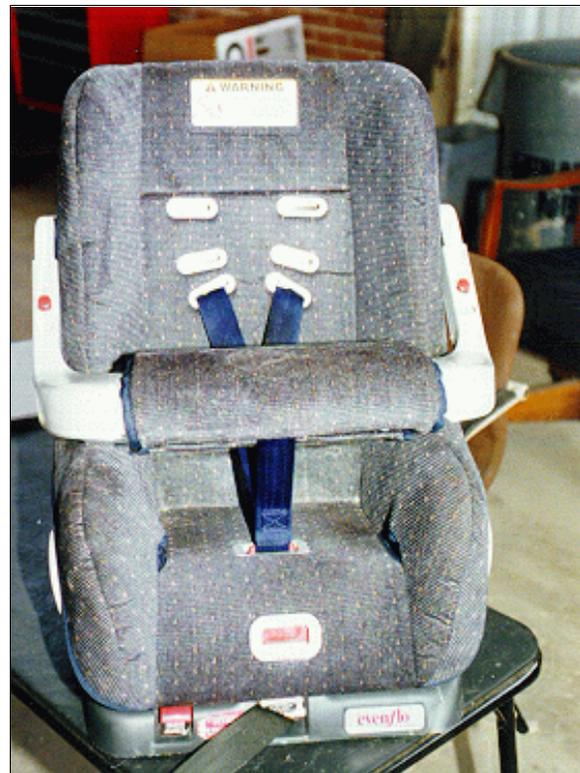
The front right passenger was seated in a convertible child safety seat that was used in its forward facing configuration (Figure 14). The child safety seat was manufactured by Evenflo, on July 20, 1998, and was identified by Model name "Ultara I" and Model number **235115 P1**. The convertible seat was designed with a three-point harness connected to a pullover shield which buckled between the toddler's legs. The seat was also equipped with a three position recline mechanism and a three position pullover shield. The child seat was in the upright position, and the shield was in the middle position.

**Figure 14:** Front of case vehicle's undamaged Evenflo "Ultara I" convertible child safety seat; Note: harness straps improperly located when seat used in forward facing mode (case photo #40)

The NHTSA recommends that a child have a weight of 9 kilograms (20 pounds) or greater and be one year of age to be placed in a forward facing child safety seat. Thus, this child should have been in a rear facing child safety seat because the child was less than one year old. The convertible child safety seat which contained this child was not designed to handle a child over 9 kilograms (20 pounds) in a rear facing configuration. Therefore, the ideal situation would have this child in a rear facing seat that was designed to handle a child of this weight and the child seat secured in the back seat of this vehicle. In essence, the child seat used in this crash could not properly provide the needed occupant protection.

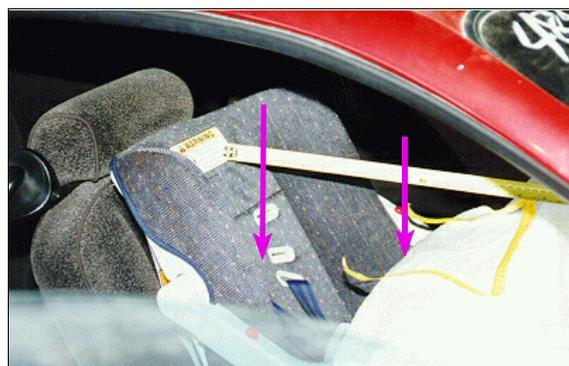
**Figure 15:** Angled close-up of case vehicle's forward facing child safety seat secured in front right seating position showing close proximity [8 cm (3.1 in)]-between arrows] of skin transfer (i.e., taped area) on front portion of air bag in relation to center of safety seat's back (case photo #35)
