ON-SITE REDESIGNED AIR BAG INVESTIGATION

CASE NUMBER - IN99-090

VEHICLE - 1999 CHEVROLET SILVERADO 1500

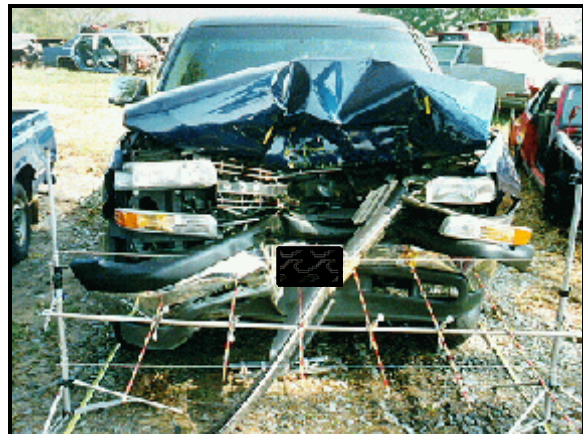
The front (**Figures 2 and 3**) of the case vehicle impacted a concrete railroad bridge support (**Figure 4**), causing the case vehicle's driver supplemental restraint (air bag) to deploy. The front right passenger supplemental restraint (air bag) did not deploy because the activation switch was in the "off" position. The case vehicle most likely rebounded slightly backwards prior to coming to rest heading southward.

Figure 2: Case vehicle's front center damage; Note: yellow tape defines direct damage

The case vehicle's contact with the railroad bridge support involved the front center of the front bumper. Direct damage began 40.7 centimeters (16.0 inches) inward from the front left bumper corner and extended a measured distance of 90 centimeters (35.4 inches) along the front bumper. Maximum crush was measured as 59 centimeters (23.2 inches) at C₃. The wheelbase on the case vehicle's left side was shortened only 2 centimeters (0.8 inches) while the right side was shortened 5 centimeters (2.0 inches). The case vehicle's front bumper, bumper fascia, grille, hood, and radiator were directly damaged and crushed rearward. The case vehicle's left front tire was physically restricted, and the front of the tire was rotated inward (Figure 3 above) from the crash. Both the right and left headlight and turn signal assemblies sustained induced damage, as did both the right and left fenders. Remote buckling was also found on the left portion of the case vehicle's extended cab (Figure 6) behind the driver's door and in front of the regular truck bed.

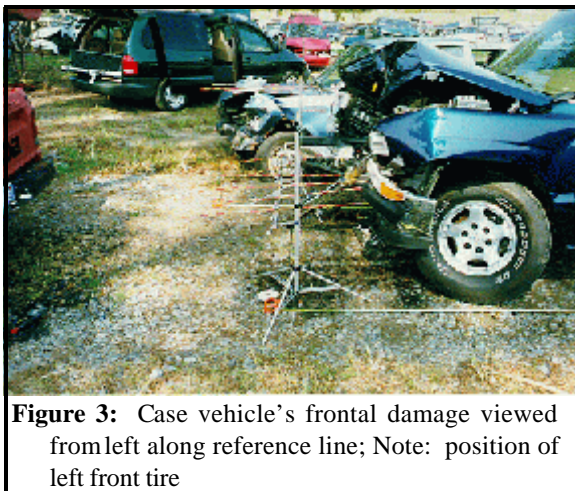
Figure 3: Case vehicle's frontal damage viewed from left along reference line; Note: position of left front tire

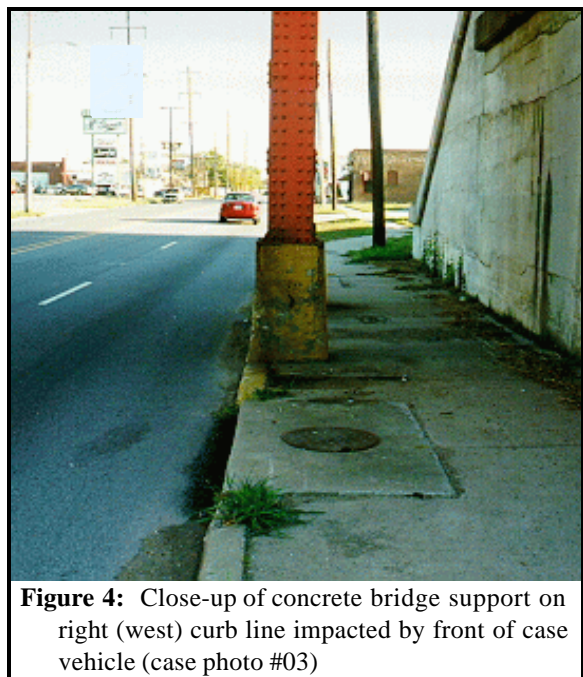
Figure 4: Close-up of concrete bridge support on right (west) curb line impacted by front of case vehicle (case photo #03)

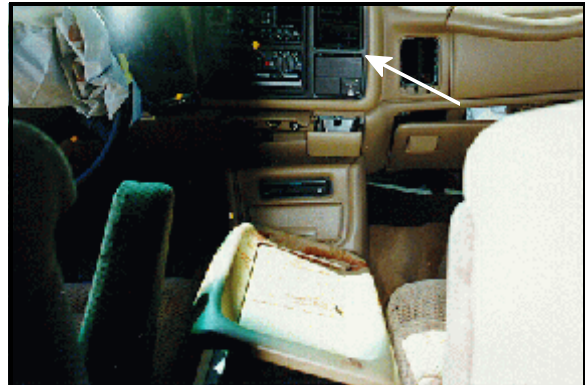
was controlled by an activation switch that was located in the center instrument panel. The driver's air bag deployed as a result of the case vehicle's impact with the bridge support. The front right passenger's air bag did not deploy because the activation switch was in the "off" position (Figure 5).

Figure 5: Case vehicle's center instrument panel showing passenger air bag activation switch (arrow) in "off" position; Note: distorted center console's cover (case photo #23)

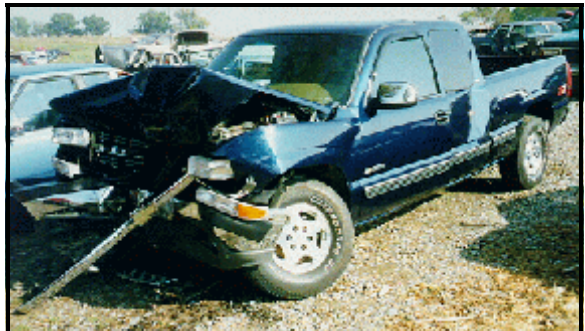
Figure 6: Case vehicle's frontal damage viewed from left of front; Note: induced damage to left fender and left side of extended cab (case photo #08)

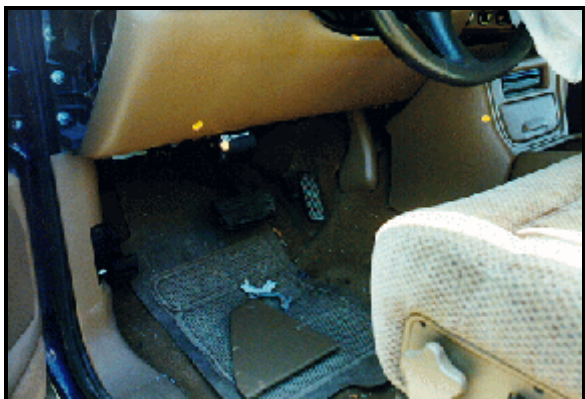
Figure 7: Evidence of occupant contact on case vehicle's left knee bolster and center instrument panel (case photo #19)

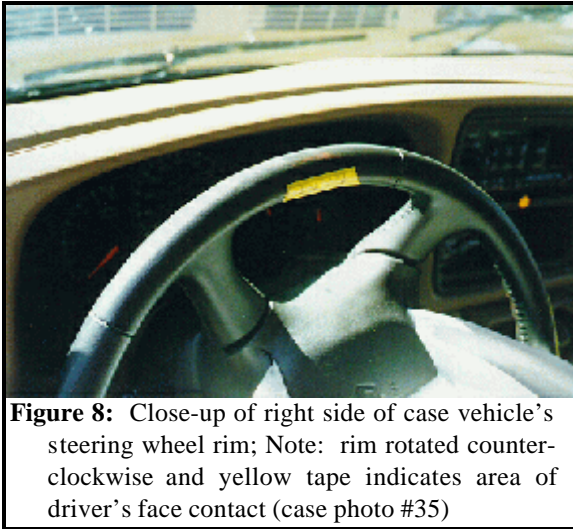
Figure 8: Close-up of right side of case vehicle's steering wheel rim; Note: rim rotated counter-clockwise and yellow tape indicates area of driver's face contact (case photo #35)

above) caused him to load and compress [approximately 5 centimeters (2.0 inches)] the steering column against the left instrument panel (**Figure 11** above) and strike the left side of his face against the steering wheel rim (through the compressed air bag’s fabric--**Figures 8 and 9** above). Because the case vehicle’s final rest position was only slightly backward of maximum engagement, coupled with the driver’s rightward pre-crash posture, the driver rebound backward and rightward toward the left portion of the case vehicle’s center console. The posterior right part of the driver’s right leg struck and uplifted (i.e., tilted toward the right side of the vehicle) the center console’s cover (**Figures 11 and 12** above). Although the case vehicle’s driver does not recall his exact final rest position, he was most likely leaning to the right against the center console with his back straddling the space between the front bucket seats and his head near the front right seat back.

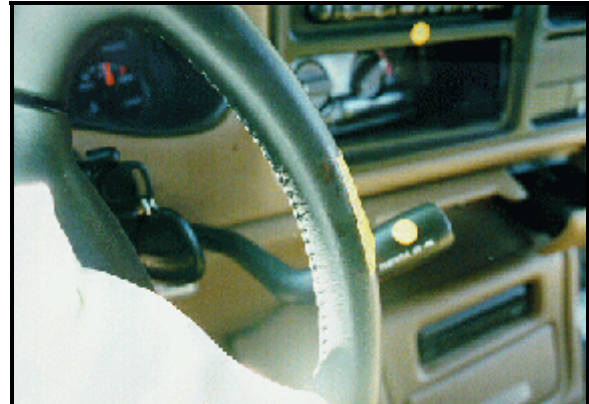
Figure 9: Close-up of lower right portion of case vehicle's steering wheel rim showing blood spots; Note: behind rim, transmission selector lever is jammed against instrument panel (case photo #37)

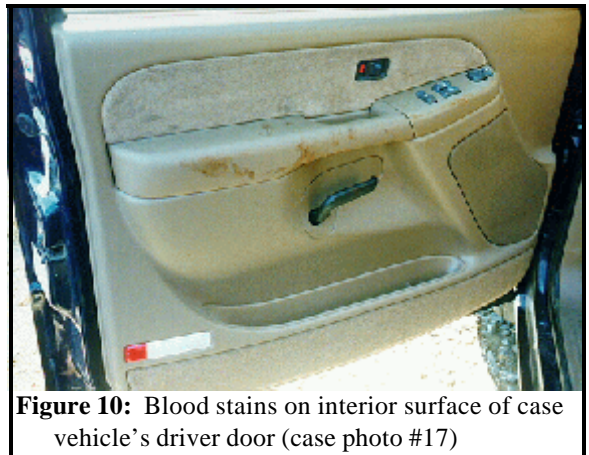
Figure 10: Blood stains on interior surface of case vehicle's driver door (case photo #17)

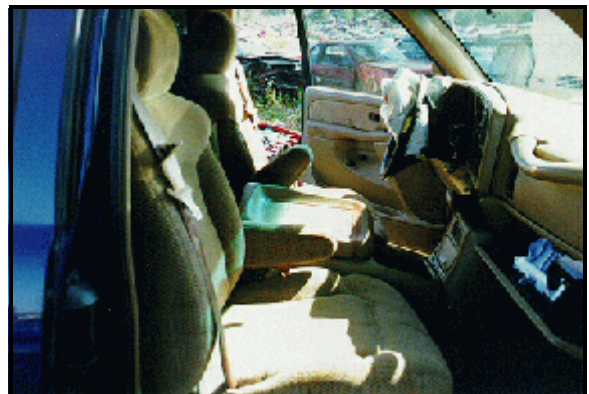
Figure 11: Case vehicle's front seating area showing steering column compressed against instrument panel and distorted center console cover (case photo #26)

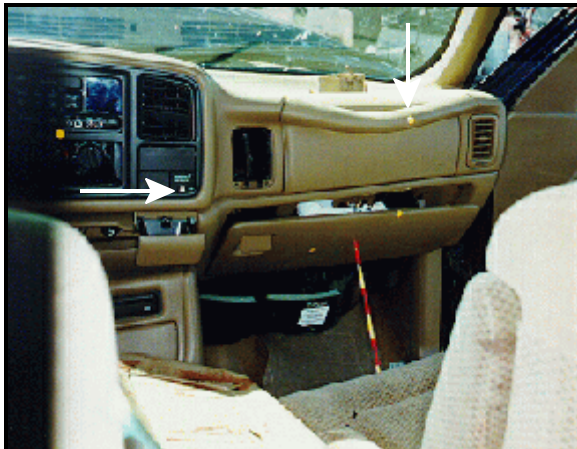
Figure 13: Case vehicle's front right seating area showing suspected occupant contacts to glove box door and oblong hand rail atop of front right air bag module; Note: arrows highlight rail contact and air bag cutoff switch (case photo #25)

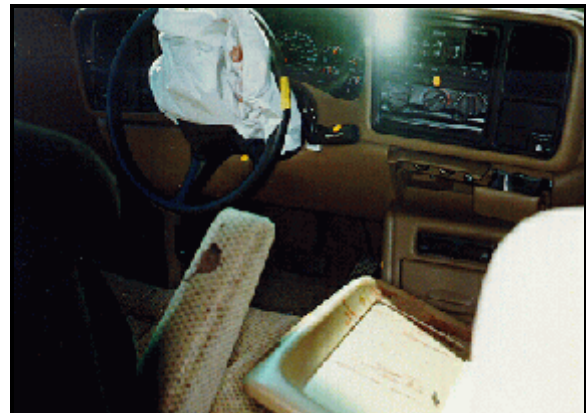
Figure 12: Case vehicle's driver seating area showing compressed steering wheel, driver's blood stained right armrest, and distorted center console cover (case photo #22)

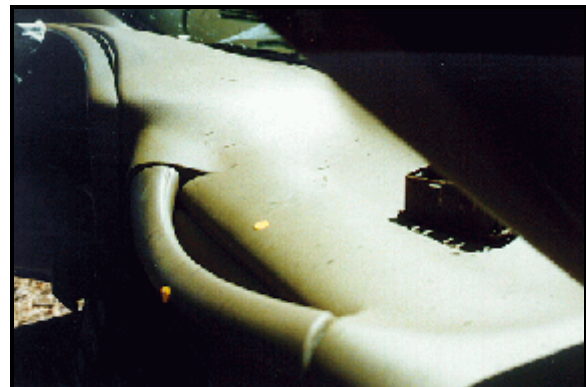
Figure 14: Close-up of contact evidence on oblong hand rail atop of case vehicle's front right air bag module (case photo #27)

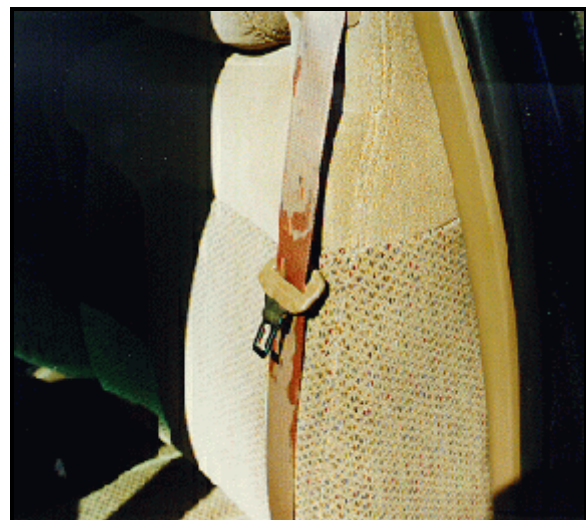
Figure 15: Case vehicle's driver safety belt showing blood stains on torso portion of webbing (case photo #29)

The case vehicle's driver [198 centimeters and 100 kilograms (78 inches, 220 pounds)] was restrained by his available, active, three-point, lap-and-shoulder, safety belt system. There was no self-reported evidence of belt pattern bruising and/or abrasions to the driver's body. Inspection of the driver's seat belt webbing indicated fabric waffling, but the "D"-ring and latch plate showed no clear evidence of loading. There were, however, several blood-stained areas on the torso portion of the webbing (**Figure 15** above).

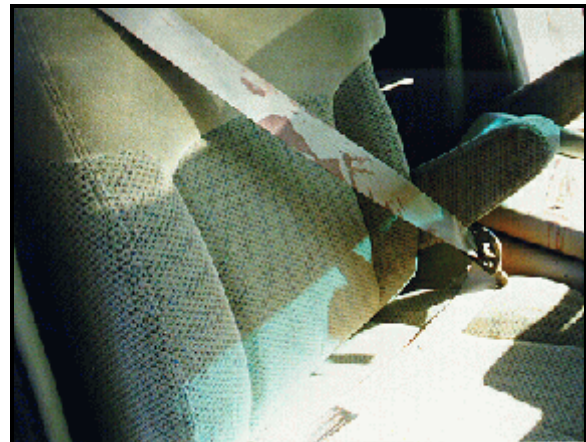
Figure 16: Case vehicle's front right safety belt showing blood stains on torso portion of webbing (case photo #31)

The case vehicle's front right passenger [180 centimeters and 59 kilograms (71 inches, 130 pounds)] was restrained by her available, active, three-point, lap-and-shoulder, safety belt system. The front right passenger reported a contusion across her lower abdomen. Inspection of the front right seat belt webbing indicated fabric waffling and a diagonal crimp near where the inboard connection would have been made. The front right "D"-ring and latch plate showed no evidence of loading but, similar to the driver's safety belt, there were several blood-stained areas on the fabric (**Figure 16** above).

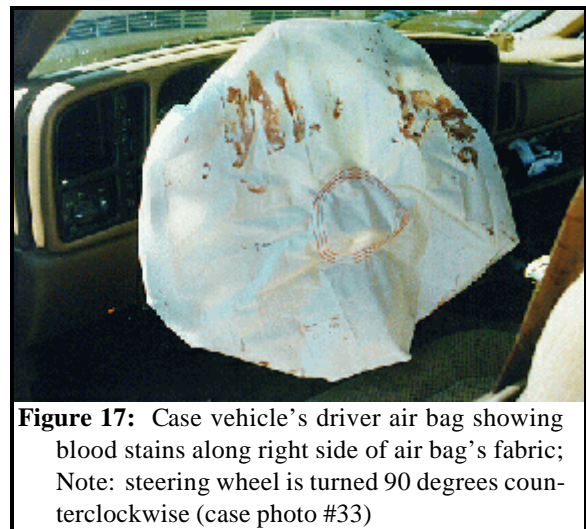
the air bag module's cover flaps and air bag revealed that the cover flaps opened at the designated tear points, and there was no evidence of damage during the deployment to the air bag or the cover flaps. The front right passenger's air bag was located in the middle of the instrument panel. Again, it did not deploy because the activation switch was in the "off" position (**Figure 10** above). The driver's air bag was designed with two tethers, each 10 centimeters (3.9 inches) wide, and two vent ports, approximately 3 centimeters (1.2 inches) in diameter, located at the 11 and 1 o'clock positions. The deployed driver's air bag was elliptical, with a height of approximately 60 centimeters (23.6 inches) and a width of approximately 54 centimeters (21.3 inches). There were scattered, copious blood stains on the right half of the air bag's fabric (**Figure 17**), and there were two body fluid stains at the top of the bag.

Figure 17: Case vehicle's driver air bag showing blood stains along right side of air bag's fabric; Note: steering wheel is turned 90 degrees counterclockwise (case photo #33)
