INDIANA UNIVERSITY

TRANSPORTATION RESEARCH CENTER

REMOTE AIR BAG DEPLOYMENT REPORT

CASE NUMBER - IN99-102
LOCATION - OKLAHOMA
VEHICLE - 1998 FORD CROWN VICTORIA LX
CRASH DATE - October 1998

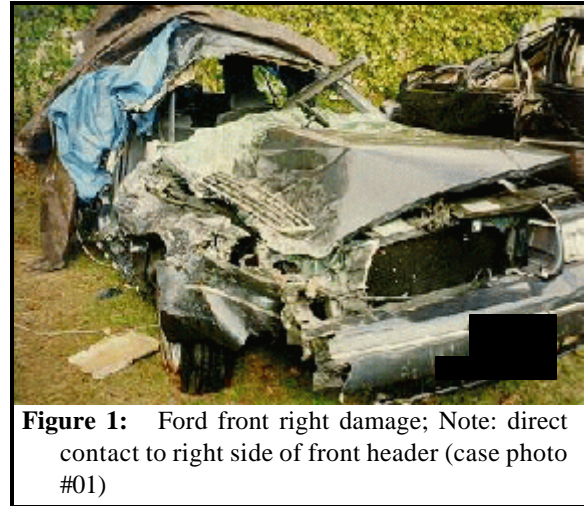
Figure 1: Ford front right damage; Note: direct contact to right side of front header (case photo #01)

Direct damage to the Ford began at its front right and extended to its front windshield header's right side and the right upper A-pillar (**Figure 1**). The front right quarter of the front bumper fascia and reinforcement bar were pushed rearward against the right front tire, the front right headlamp assembly was shattered, the front right grille was missing, the front right plane of the right front fender was pushed rearward, the top of the hood's right side near the seam and the top of the right front fender were depressed downward, the right front wheel was pushed into the lower A-pillar, the upper A-pillar was pushed rearward, as was the right side of the front header, and the right side of the windshield was contacted (in the storage lot, the windshield glazing positioned atop the rear of the front hood does not lend itself to estimates of its immediate post-impact condition). Visible induced damage includes a tenting of the right forward portion of the roof and missing right rocker panel cover. The Ford's right front door is missing, but it is suspected that may be the result of extrication efforts (the upper A-pillar was snapped near the top of the instrument panel). Missing backlight glazing may also be indirect damage from the front roof damage or from extrication efforts. Possible further induced damage along the case vehicle's right side and roof was obscured by a tarpaulin. A CDC for the only event (third of seven) of this crash sequence involving the case vehicle was estimated from insurance photographs: **12-FZAW-7 (010)**.

The WinSMASH reconstruction program barrier algorithm, with a CDC-only estimated crush profile from available photographs, was used to estimate the Barrier Equivalent Speed (BES). This WinSMASH run provided a borderline reconstruction and the results appear high. The BES was estimated as 82.6 km.p.h. (51.3 m.p.h.) for the Ford. This was a severe crash (40-55 km.p.h. [25 to 34 m.p.h.]) for the Ford.

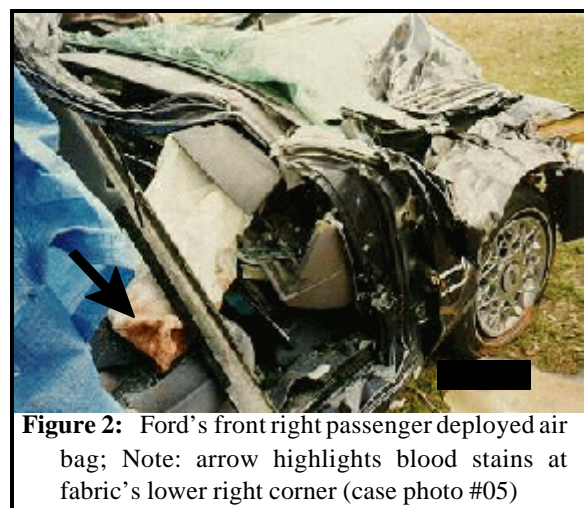
Insurance company photographs verify the deployment of the case vehicle's front right passenger air bag (**Figure 2**). None of the available photographs

Figure 2: Ford's front right passenger deployed air bag; Note: arrow highlights blood stains at fabric's lower right corner (case photo #05)

provide much of a view for any other seat position in the Ford. The front right passenger air bag module appears to have been located in a mid-mount location on the right side of the instrument panel and was equipped with a single cover flap that opened along its tear points. The shape of the passenger’s air bag fabric is estimated to have been rectangular. It is not known if that air bag was equipped with tethers or vent ports. Blood stains can be seen on the air bag fabric’s front right and along its right side (**Figure 3**).

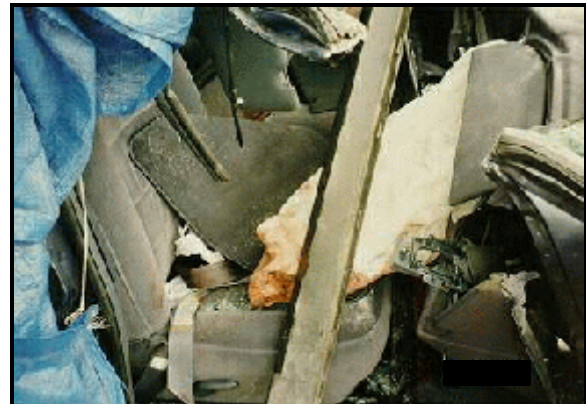
Figure 3: Ford’s front right passenger seating area; Note: blood-stained air bag, cut safety belt, air bag module cover, and open glove compartment (case photo #06)

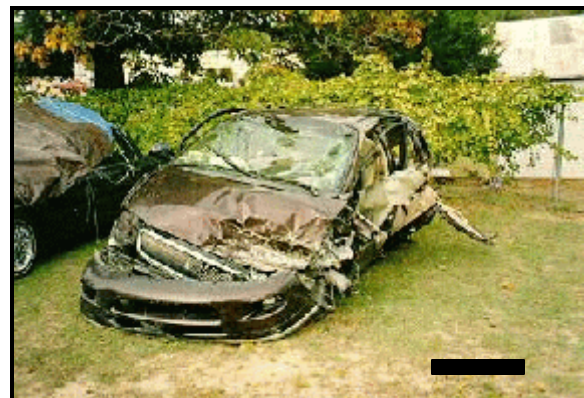
Direct damage to the Chrysler involved all planes except the back plane. Event #1 was the right side of the Chrysler contacting the east guardrail (**Figure 6**). Resultant direct damage included lateral crush to the right front fender, the right front door, the right rear door, and the right rear quarterpanel. Event #2 was a complex rollover sequence. After reaching a 45 degree counterclockwise yaw in the median, the Chrysler rolled right three quarter-rolls about its longitudinal axis while completing a full 360 counterclockwise rotation (**Figure 5**). Resultant direct damage included lateral crush to the left front fender, the left front door, the left rear door, and the left back quarterpanel. Event #3 was the front left plane of the Chrysler, while on its left (driver's) side and heading north, impacting the front right area of the southbound Ford in a non-horizontal crash configuration (**Figures 1 and 4**). Resultant direct damage included rearward displacement of the front left bumper corner fascia and reinforcement bar, the front left headlamp

Figure 4: Chrysler's non-horizontal front damage;
Note: left side damage from sliding on pavement
(case photo #08)

assembly, the front left grille, and the front left hood edge, with the front left fender's sheet metal peeled rearward, the left front tire and wheel pushed rearward into the lower A-pillar, the forward edge of the left front door shoved rearward, the left front door's sheet metal creased with a lateral indentation, and the left rear sliding door's forward edge dislodged from the B-pillar and its top half (surrounding the glazing) bent outward. Event #4 was a second rollover, to the right as the Chrysler separated from the Ford. Event #5 was another non-horizontal impact, this time with a bridge rail that was contacted by the Chrysler's right and undercarriage surfaces (**Figures 5 and 6**). Resultant direct damage was the lateral creasing of the right front door, and unknown damage, if any, to the undercarriage. Event #6 consisted of the four tires and wheels, plus the undercarriage, striking the ground after dropping approximately 4.6 meters (15 feet) off the bridge rail (**Figures 5 and 6**). Possible direct damage to the tires, wheels, and undercarriage is unknown (no obvious damage is visible in available photographs). Event #7 was the Chrysler striking a fence (**Figure 5**). Resultant direct damage was paint transfer, sheet metal scratching, and minimal denting to the left back quarterpanel. Indirect damage to the Chrysler included the front right bumper corner detached from the reinforcement bar, missing front right headlamp assembly, splintered windshield glazing, disintegrated glazing (LF, LR, LR2, Backlight, RR2, RR, and RF), displaced right rear taillight assembly, and sheet metal waffling to the back tailgate. The estimated vehicle-to-vehicle CDC (Event #3) for the Chrysler was **00-FYMW-4**. No WinSMASH reconstruction program was run because of the non-horizontal collision between the two involved vehicles. A visual crash severity estimate from available photographs of the Chrysler was moderate (24-40 km.p.h. [15 to 25 m.p.h.]). The Chrysler's driver (75-year-old male; race, ethnicity, height, and weight not known) was reportedly restrained by his available, manual, three-point, lap-and-shoulder safety belt system. Police assessed his injuries as fatal, with involvement of the head, trunk (external), trunk (internal), arm, and leg. He was transported from the crash scene by ambulance to a medical facility. His specific injuries, treatment status (if any), and time of death are not known.
