NIST Technical Note XXXX

**Motorcoach Flammability Project
Final Report: Tire Fires - Passenger
Compartment Penetration, Tenability,
Mitigation, and Material Performance**

Erik L. Johnsson
Jiann C. Yang

November 2010

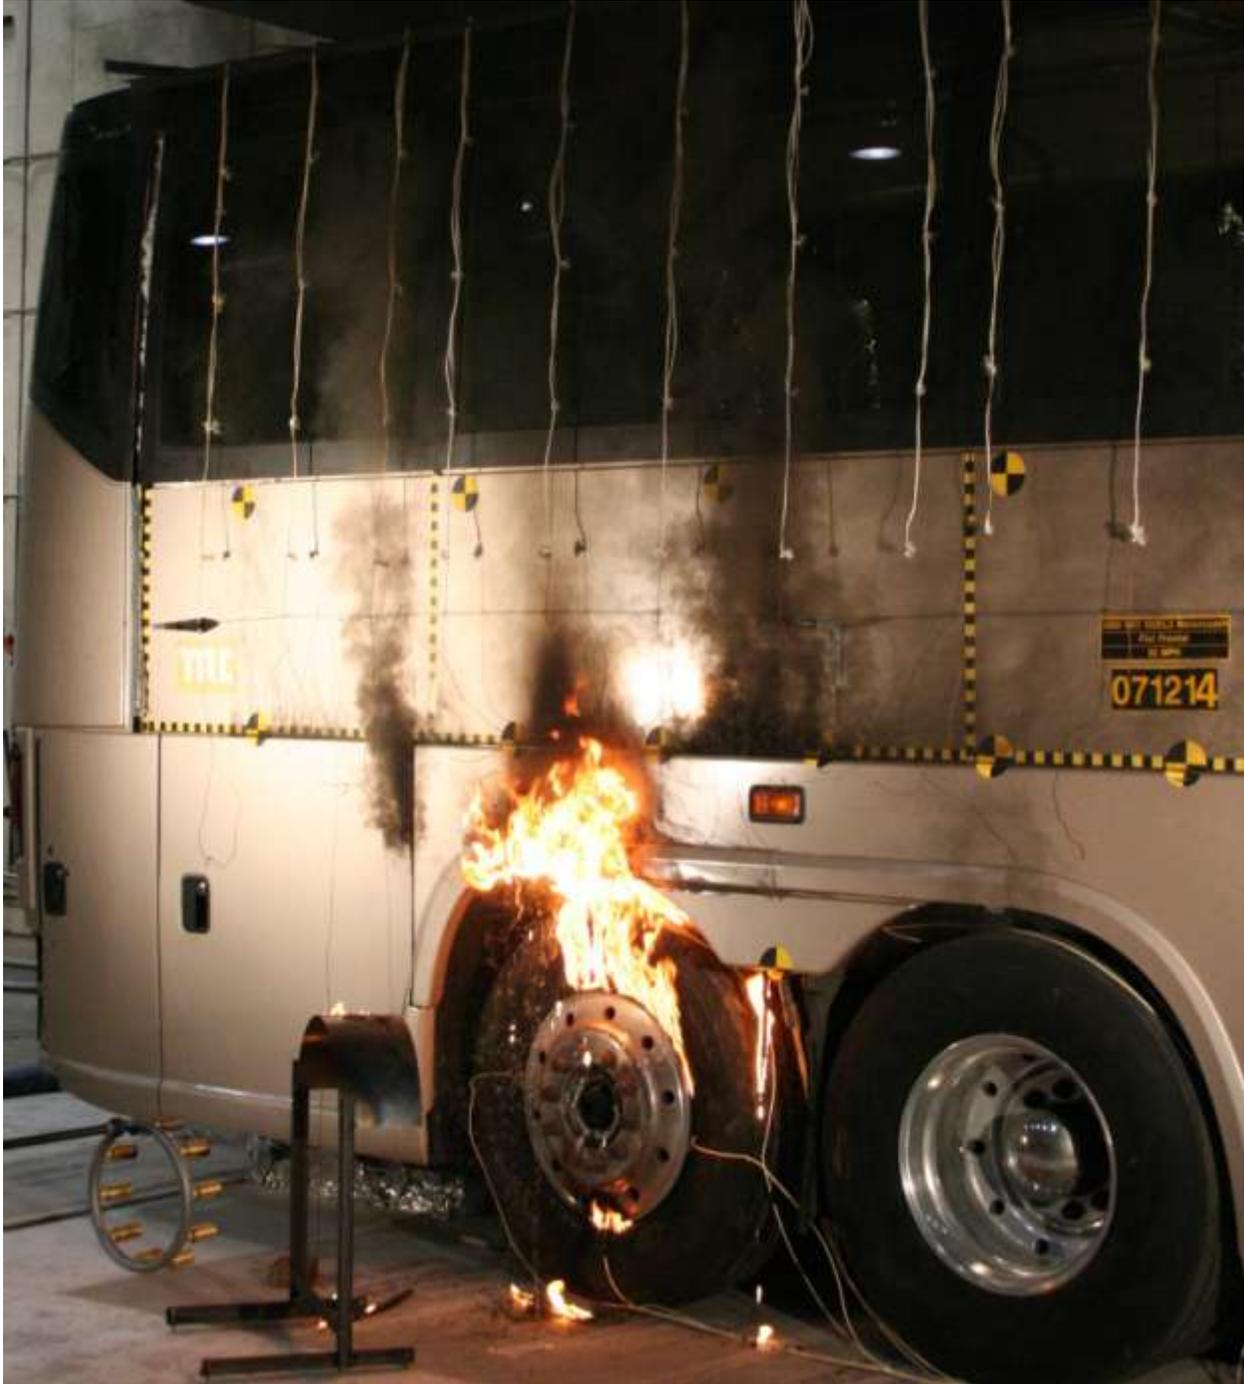
Figure 32 Tag axle wheel heating penetration experiment about 1 min after the burner was removed. The fender is already burning and the exterior panel is just igniting.

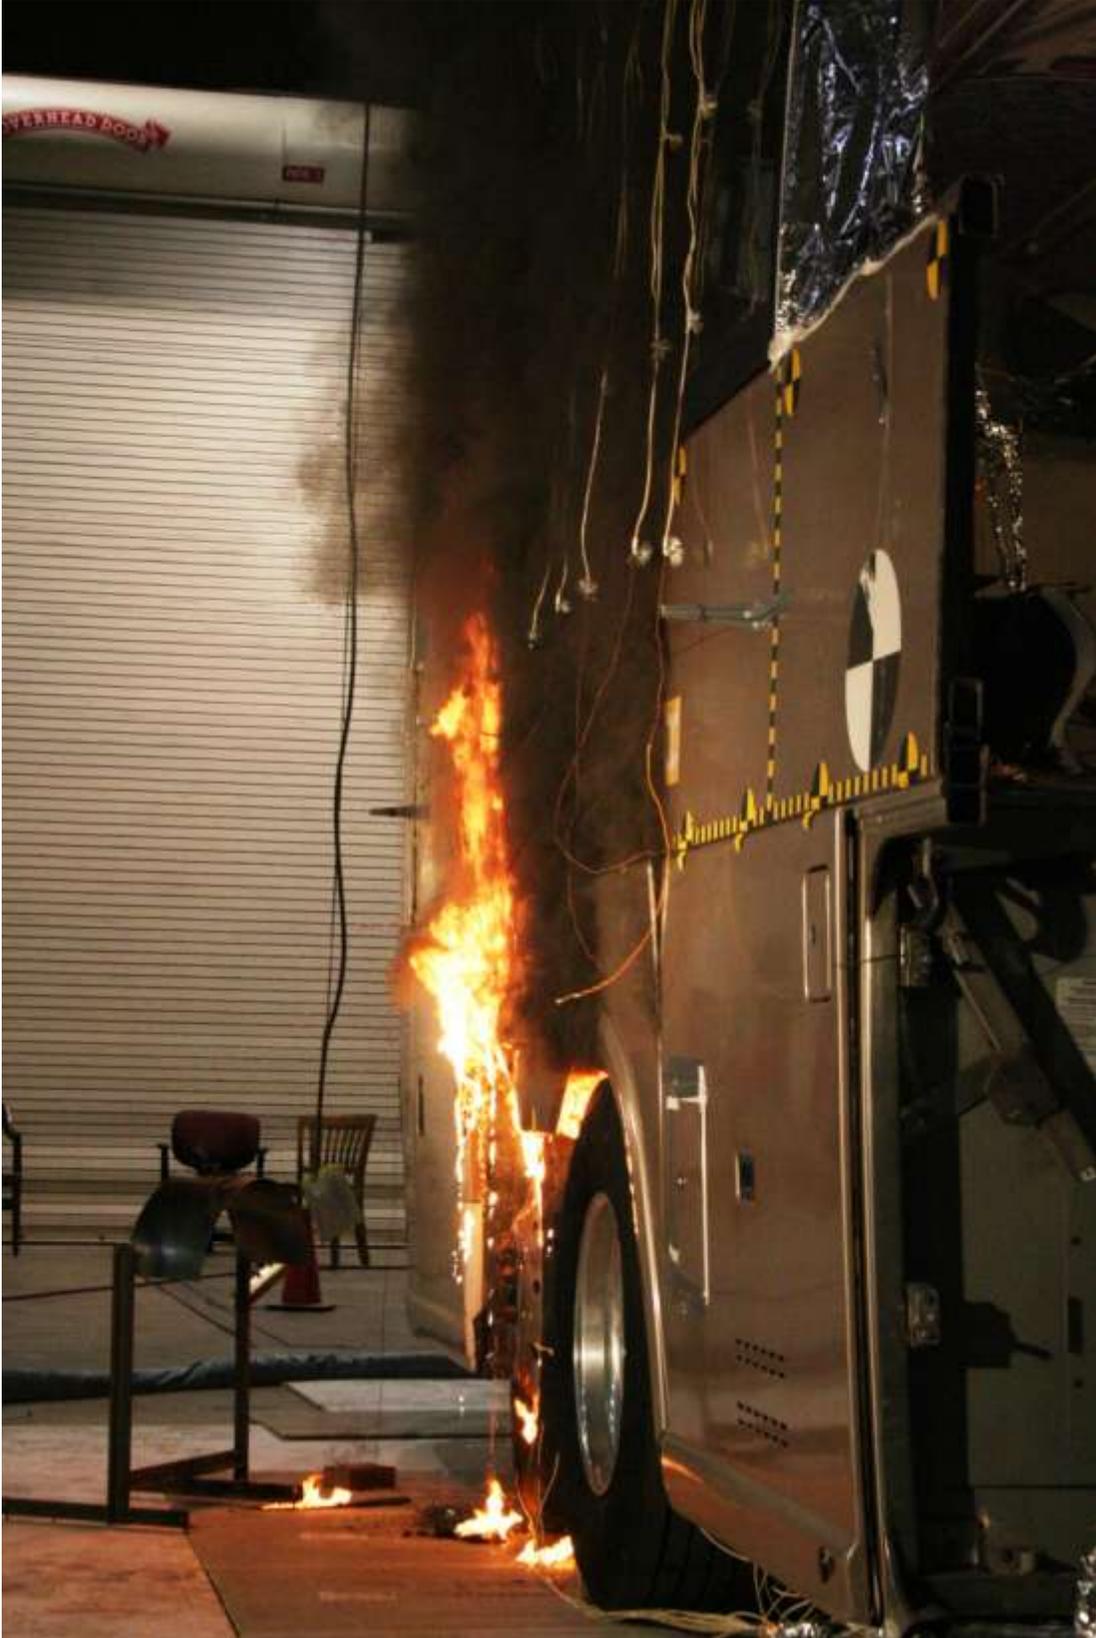
Figure 33 Tag axle wheel heating penetration experiment about 2 min after the burner was removed. The exterior panel is burning up to the windows.

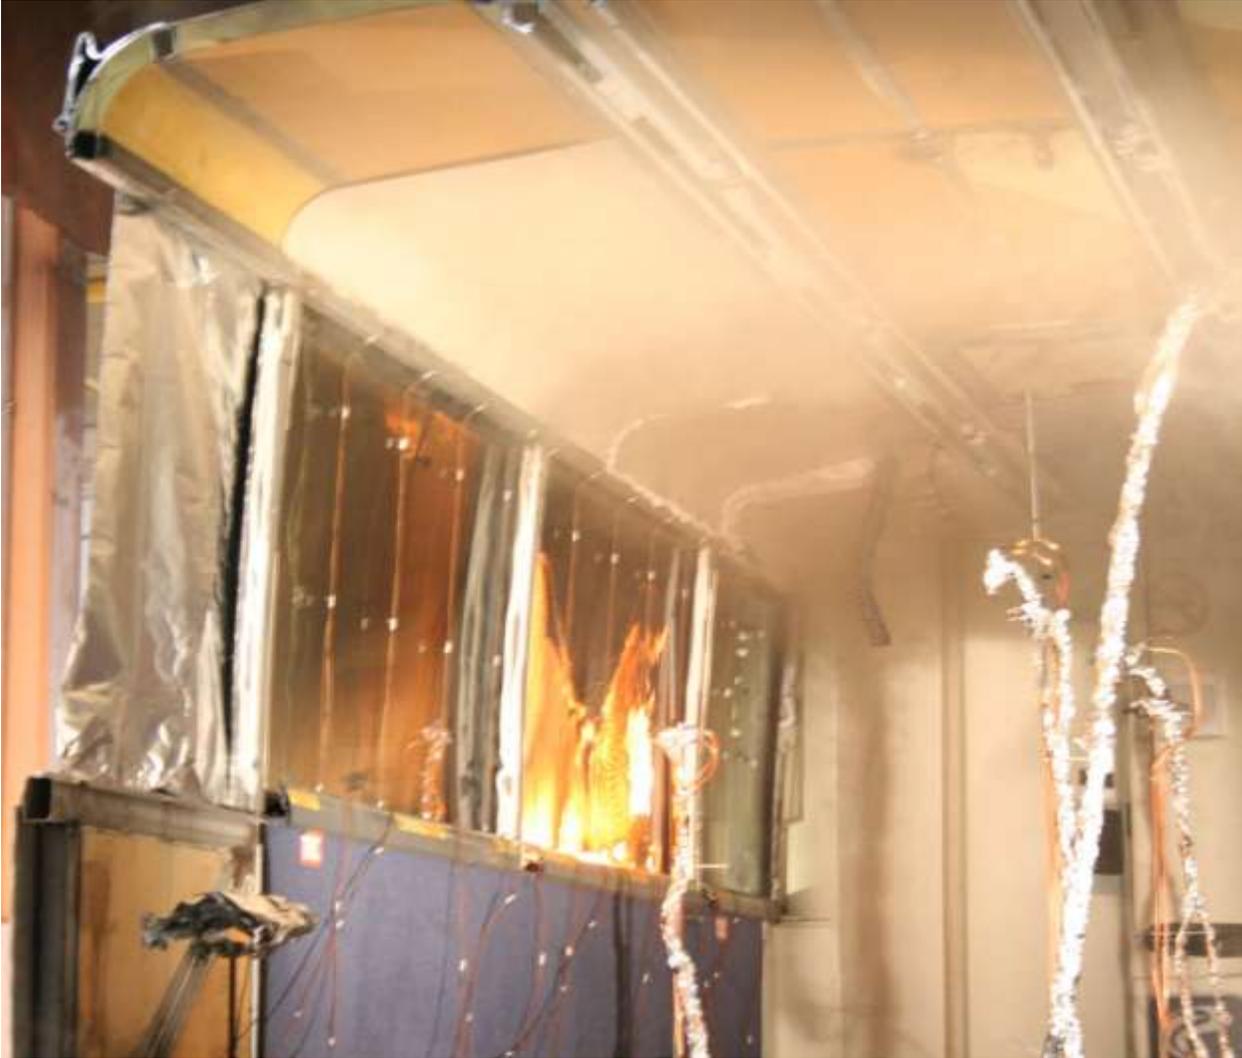
Figure 35 Tag axle wheel heating penetration experiment at fire penetration, about 4 min 40 s after burner removal.

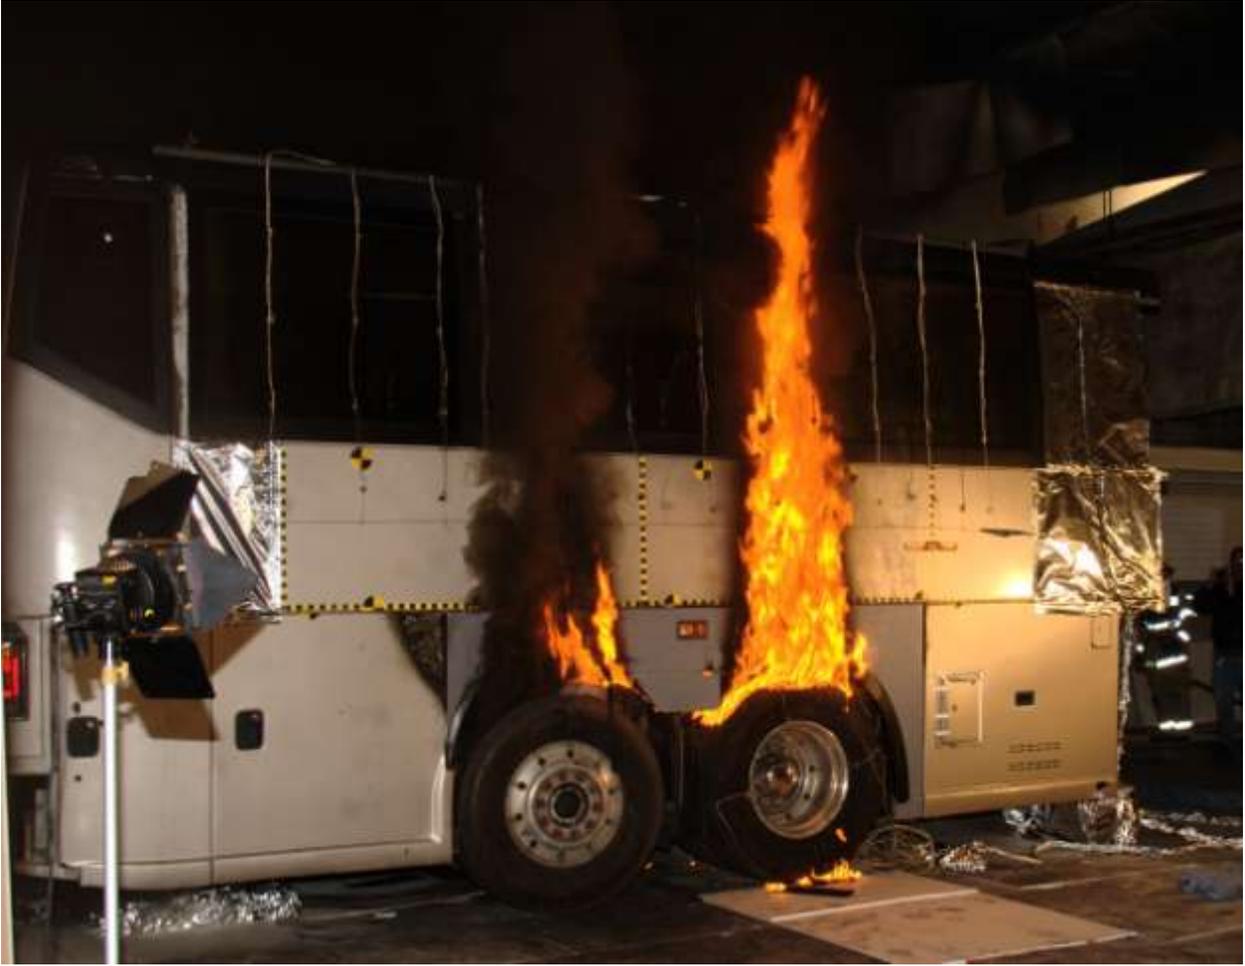
Figure 39 Drive axle wheel heating penetration experiment showing fire spreading from the drive axle to the tag axle area of the fender.

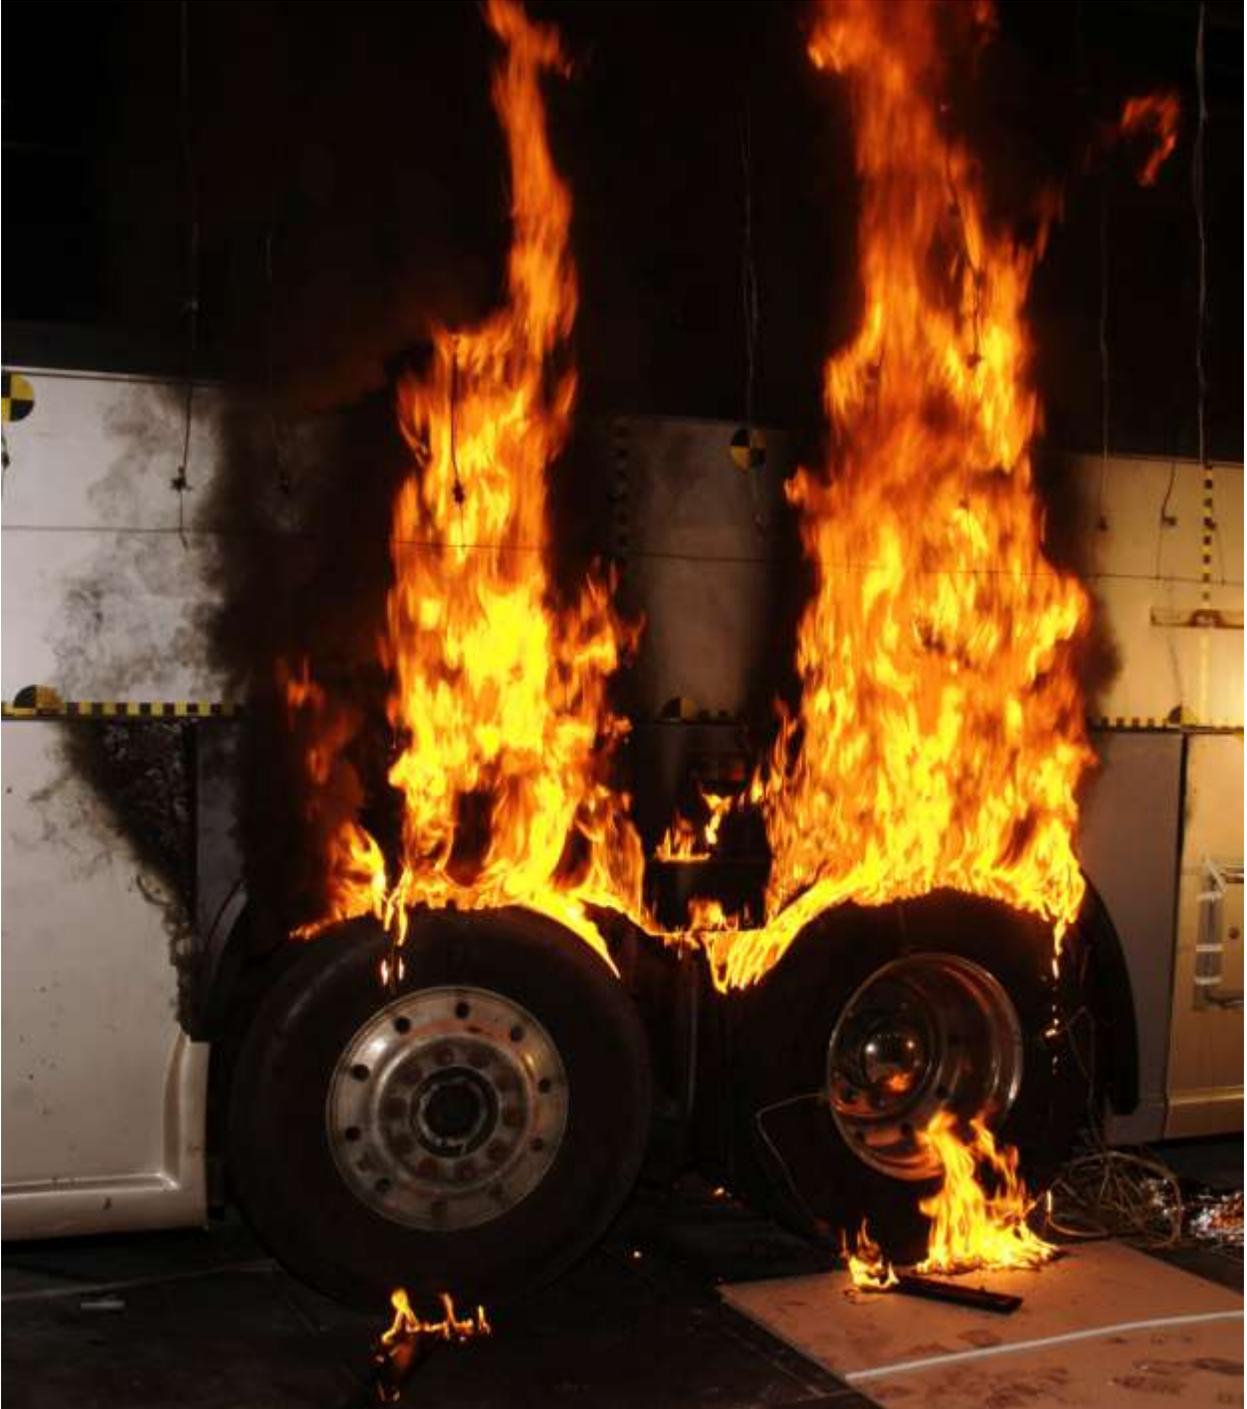
Figure 41 Drive axle wheel heating penetration experiment showing large fire plumes on each tire.

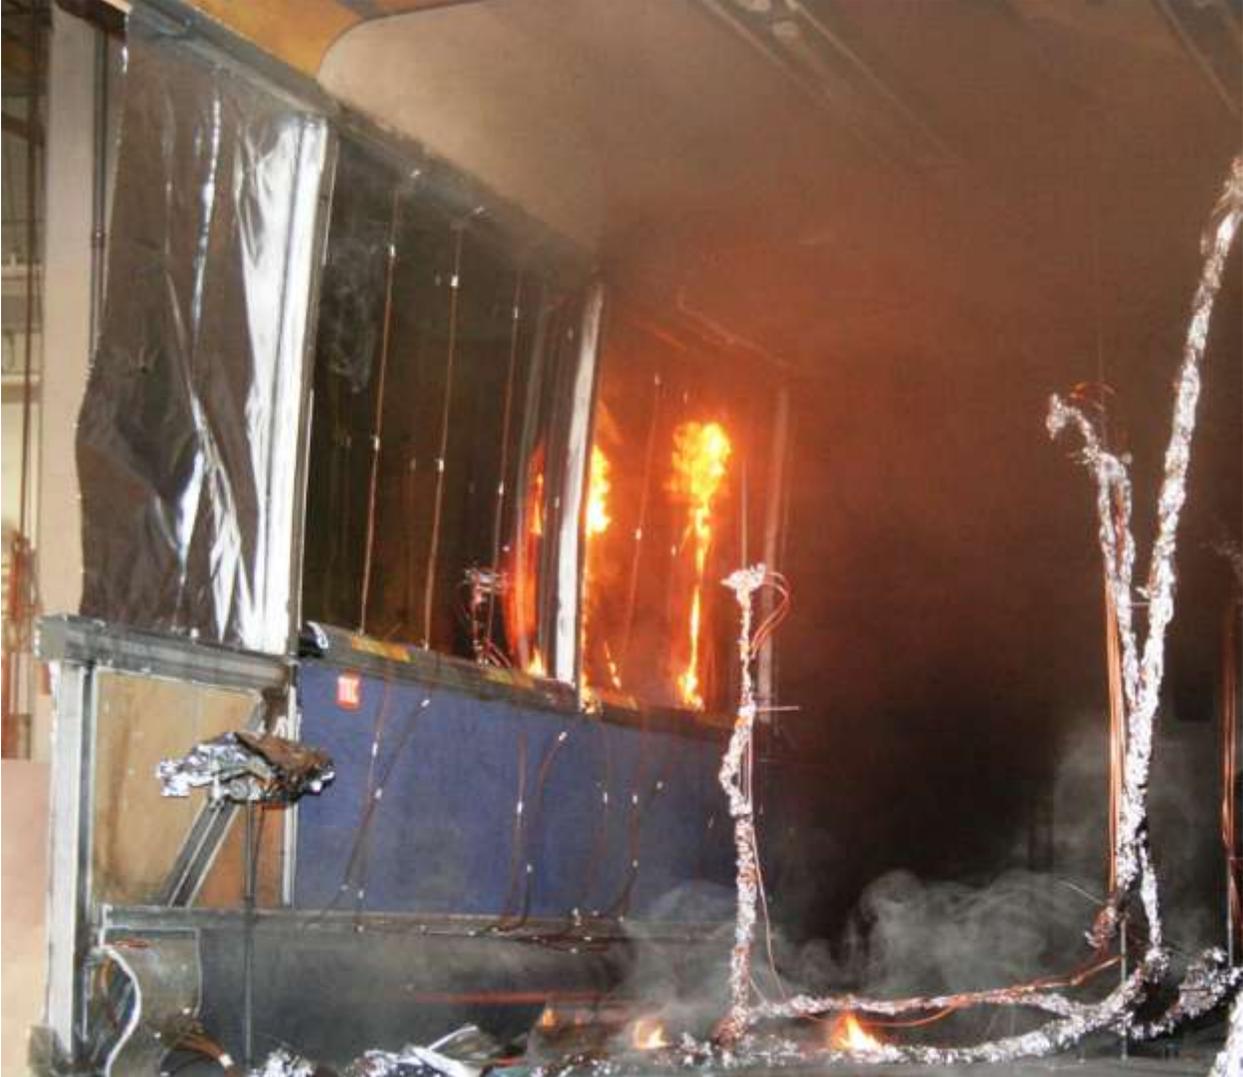
Figure 44 Drive axle wheel heating penetration experiment at fire penetration, about 6 min 3 s after burner removal. Window breakage occurred on the more rearward window while the burning tire was fairly centered on post 3 between windows.

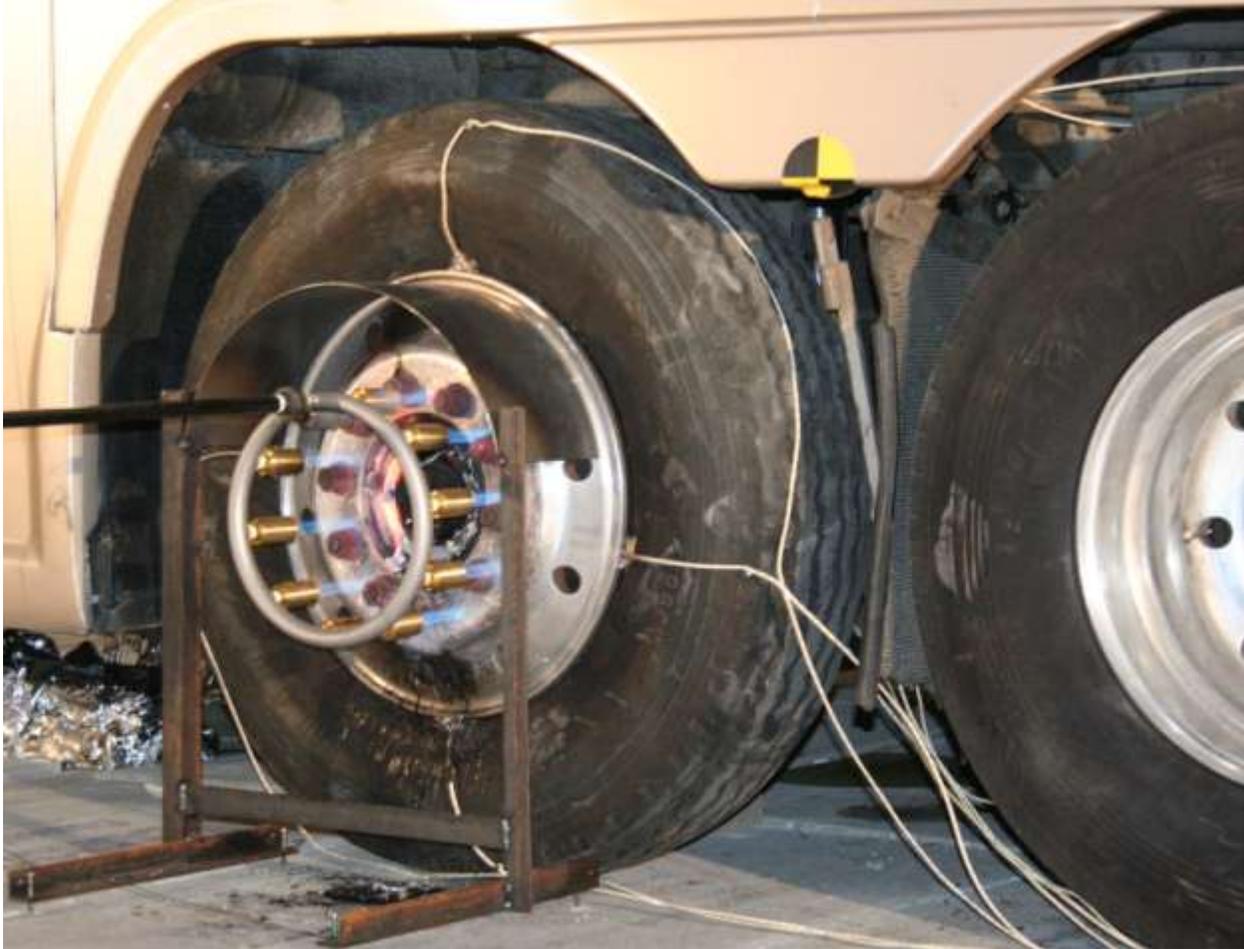
Figure 103 Tag axle wheel heating penetration experiment showing burner, shield, melted hub, and early thermal damage to tire.

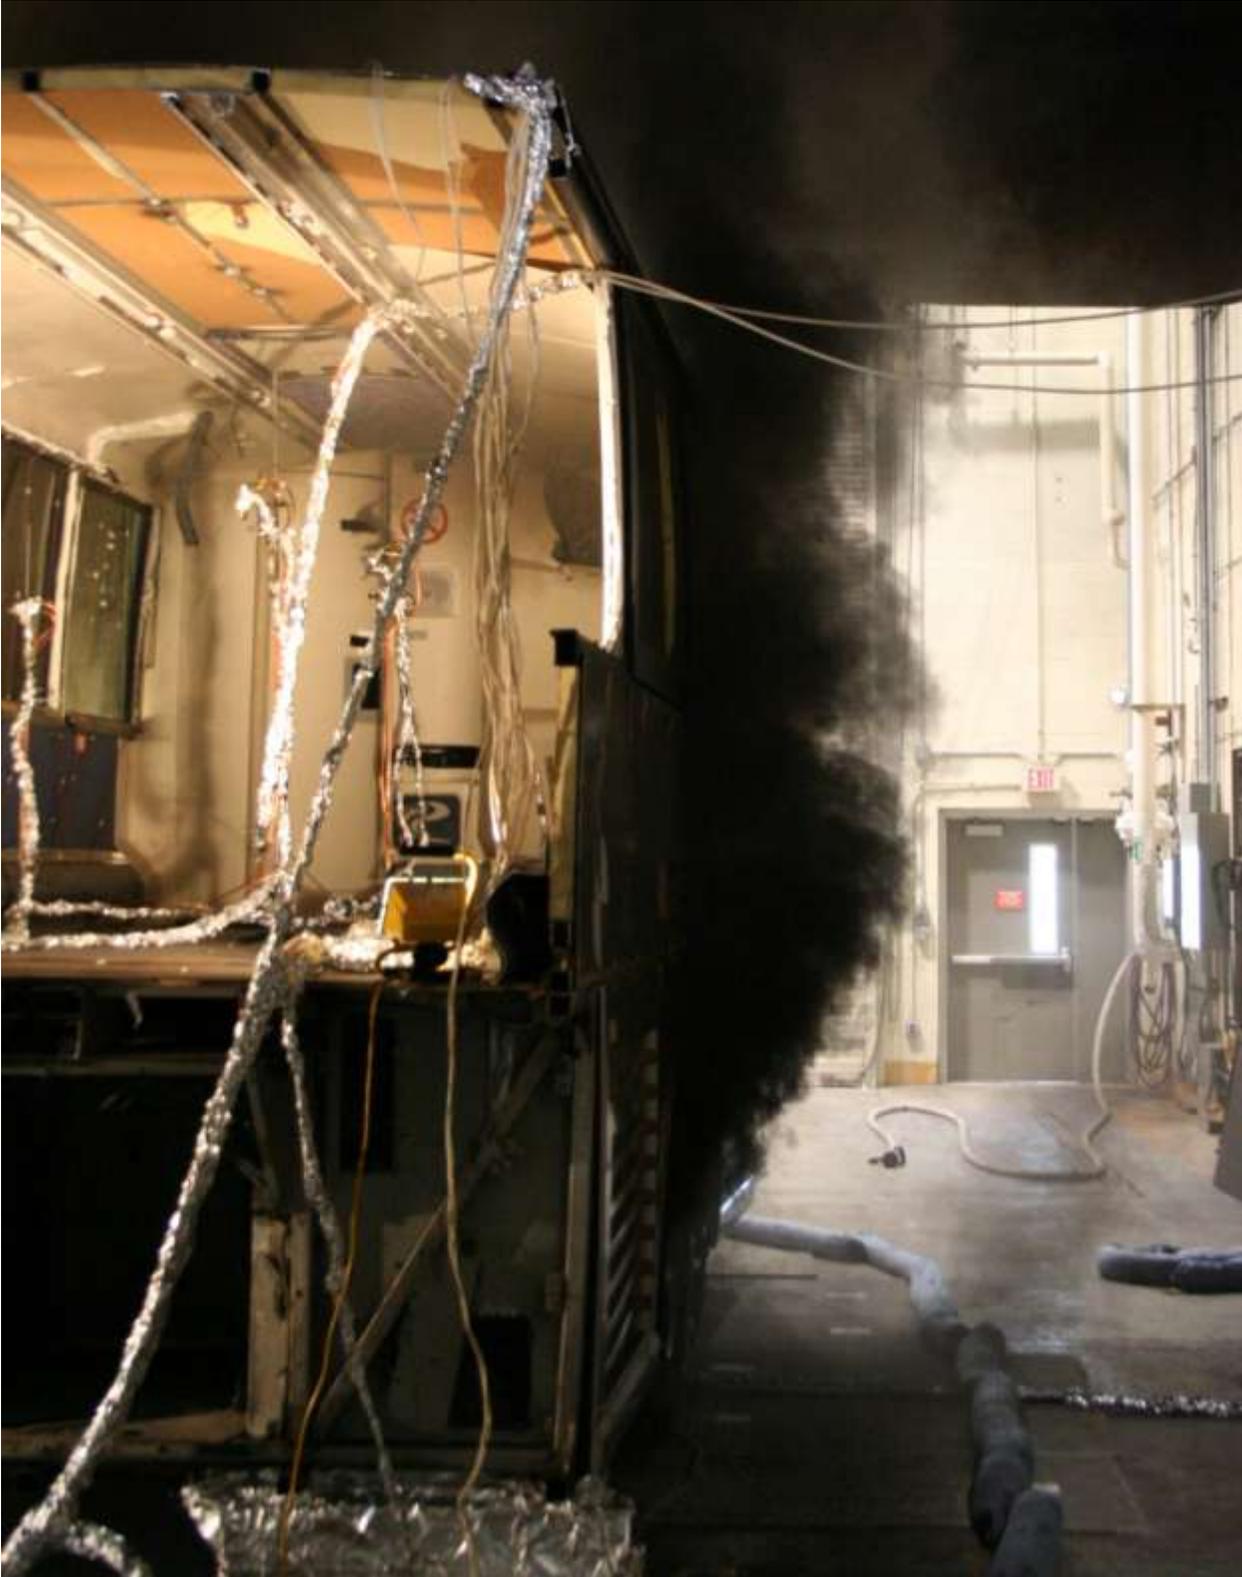
Figure 104 Tag axle wheel heating penetration experiment about 2.5 minutes after the burner was removed showing the large quantity of black smoke on the far (driver's) side of the motorcoach.

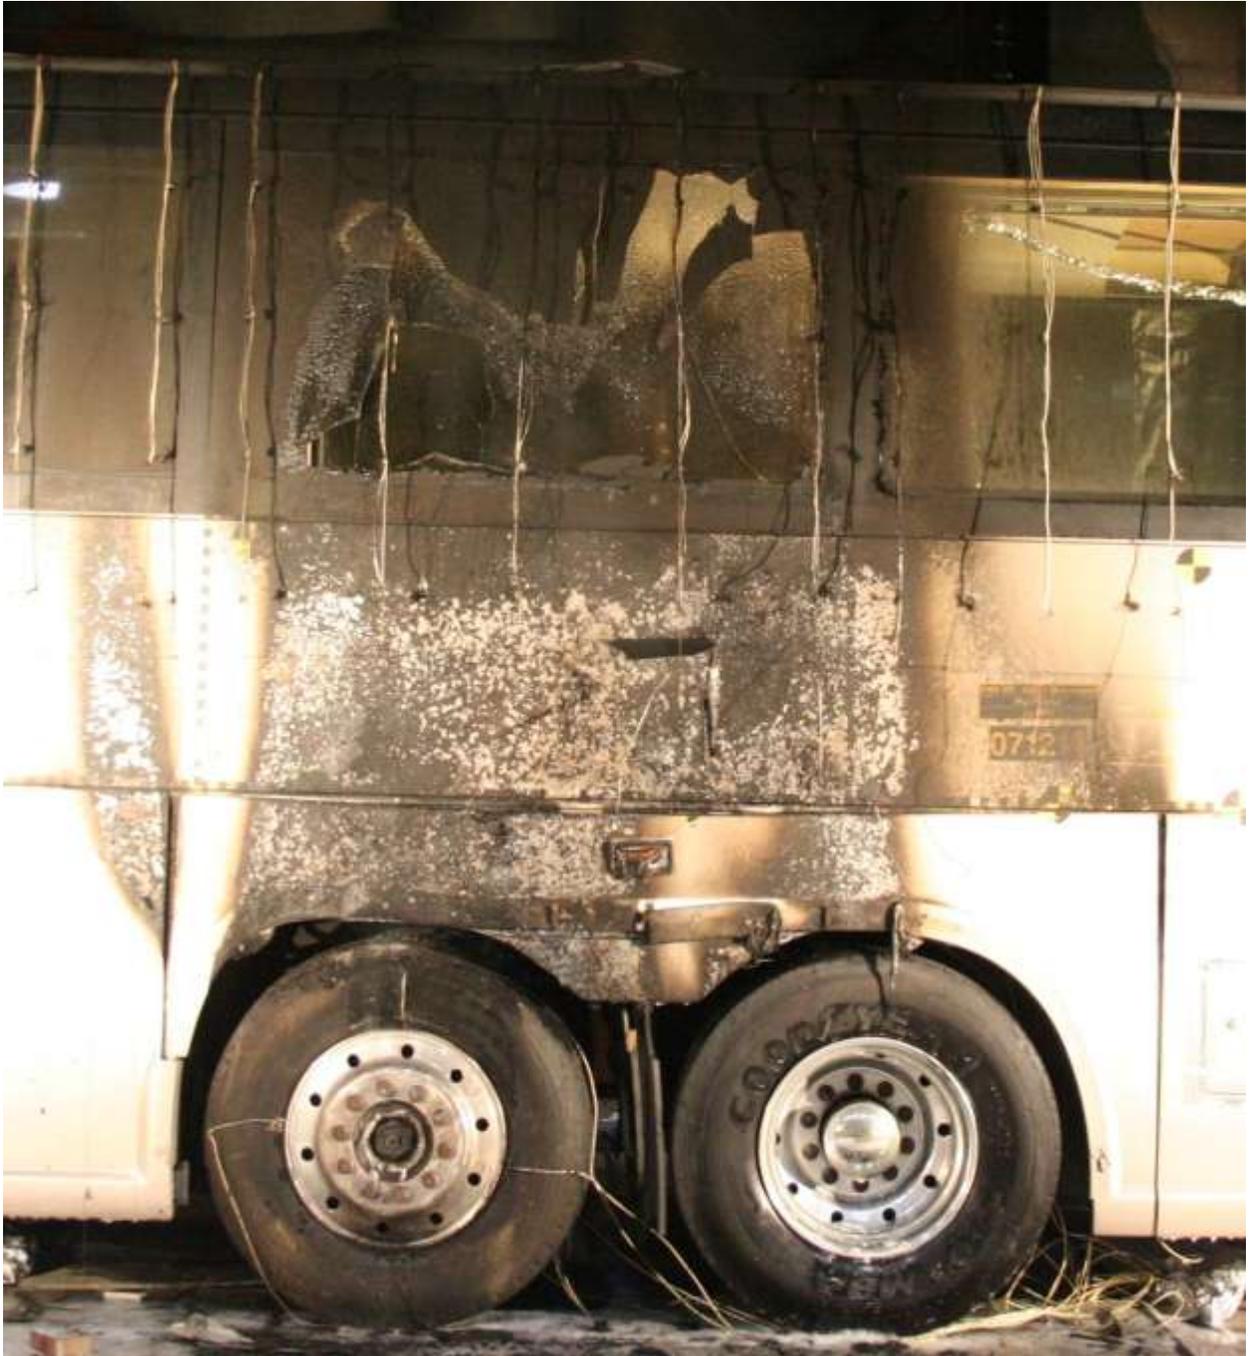
Figure 105 Exterior fire damage due to tag axle wheel heating penetration experiment

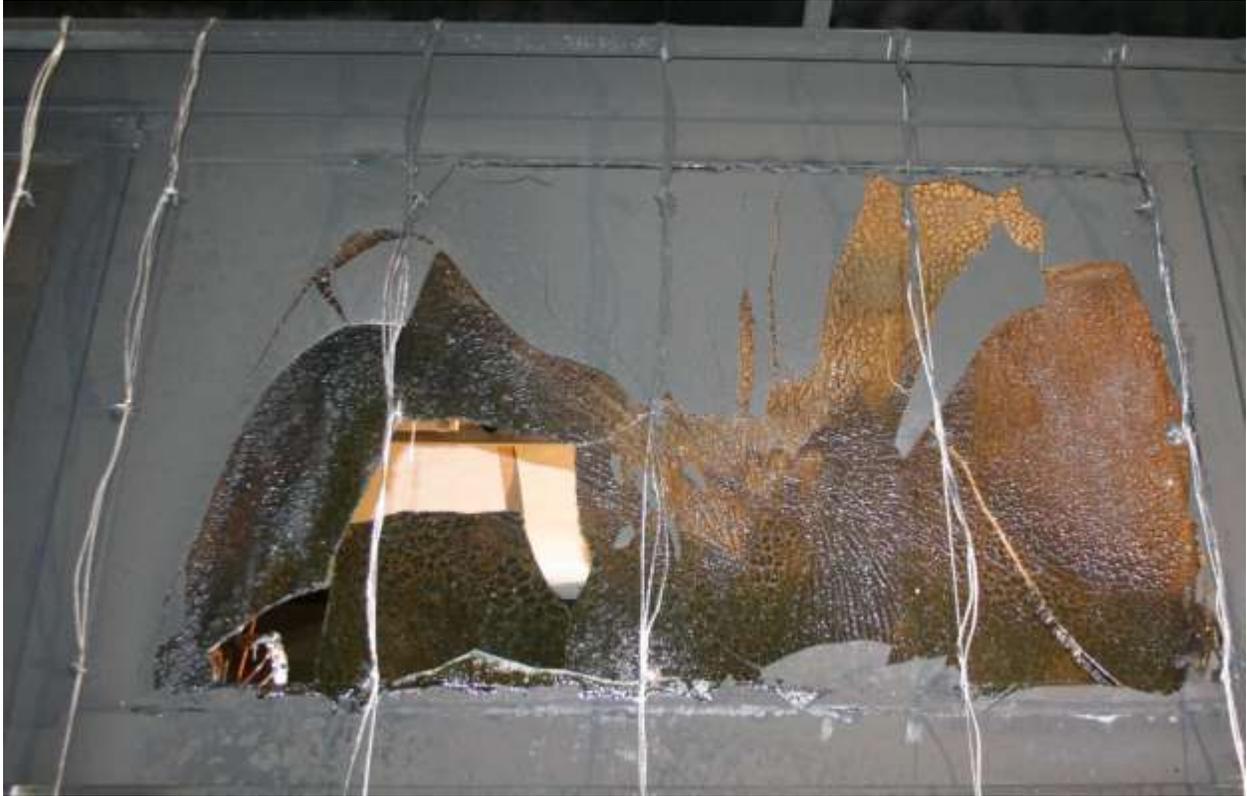
Figure 106 Exterior view of window damage after tag axle wheel heating penetration experiment.

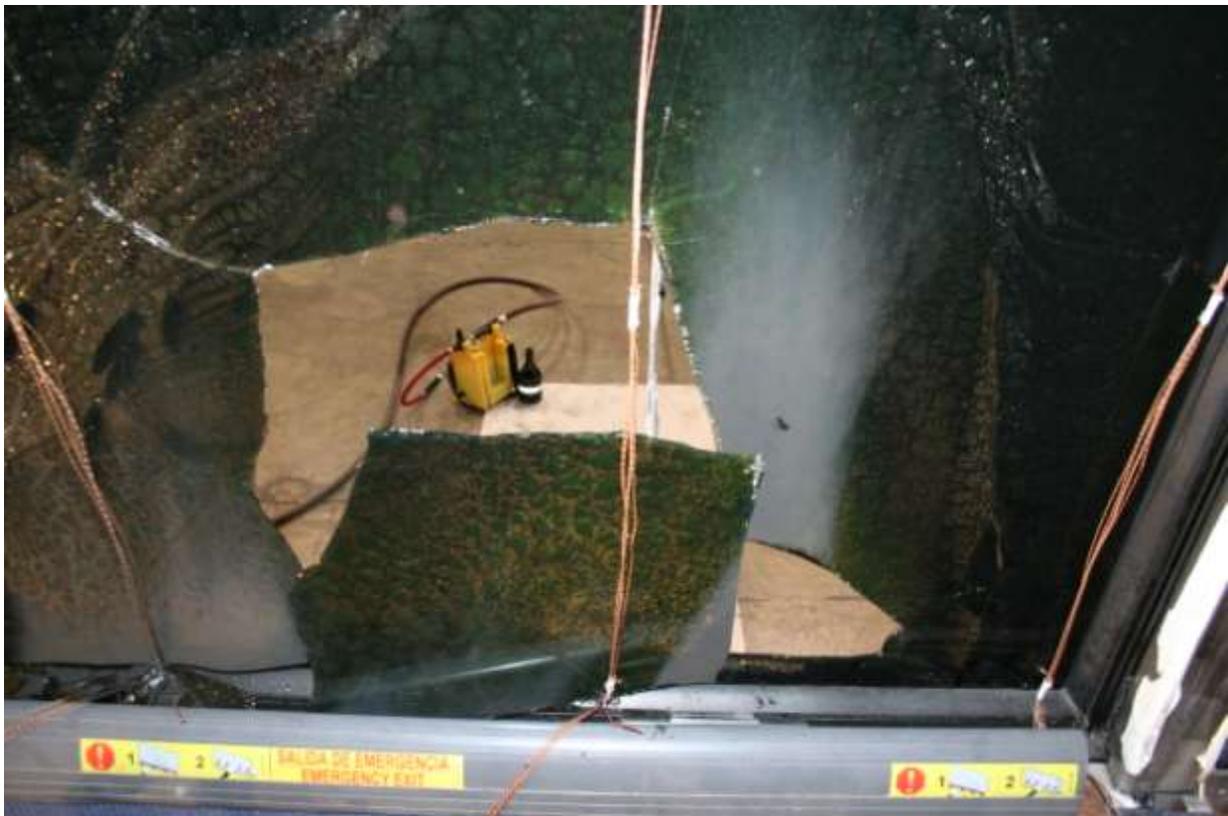
Figure 107 Interior view of window damage after tag axle wheel heating penetration experiment.

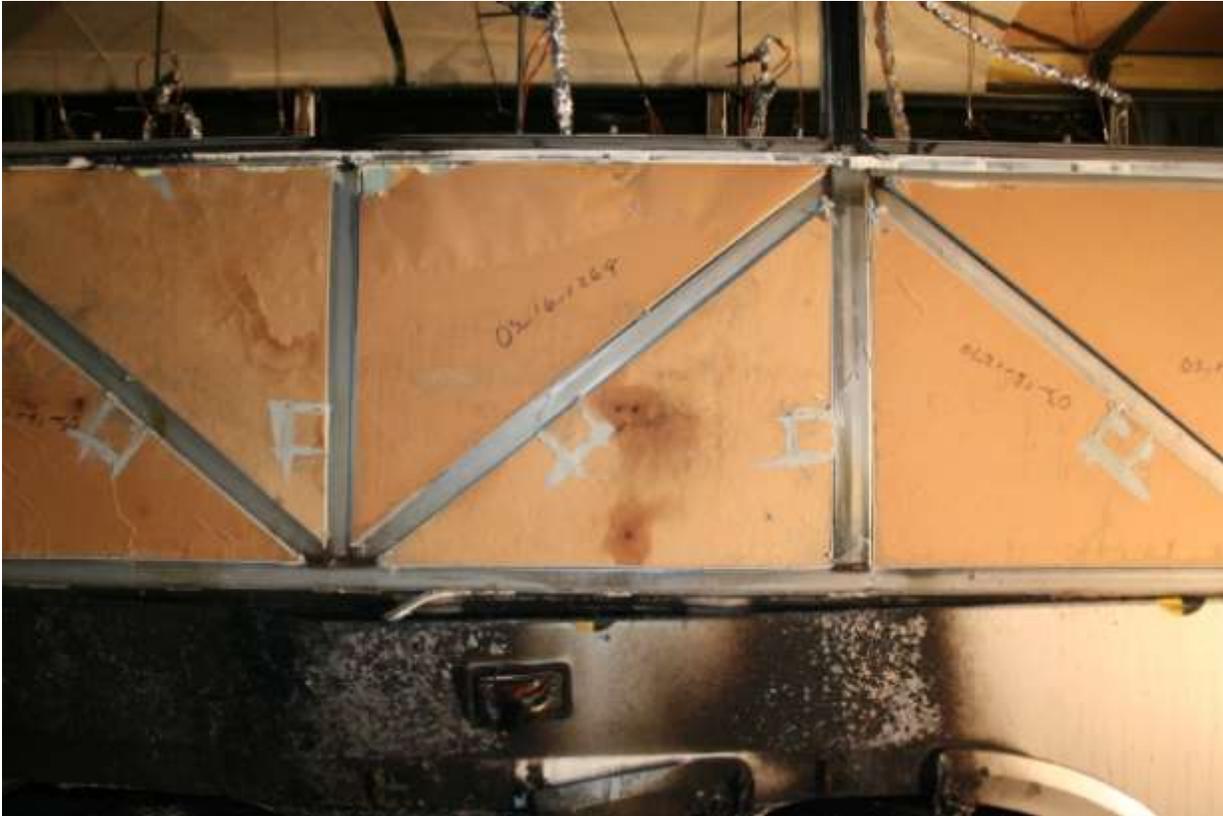
Figure 108 Damage to wall behind exterior panel after tag axle wheel heating penetration experiment.

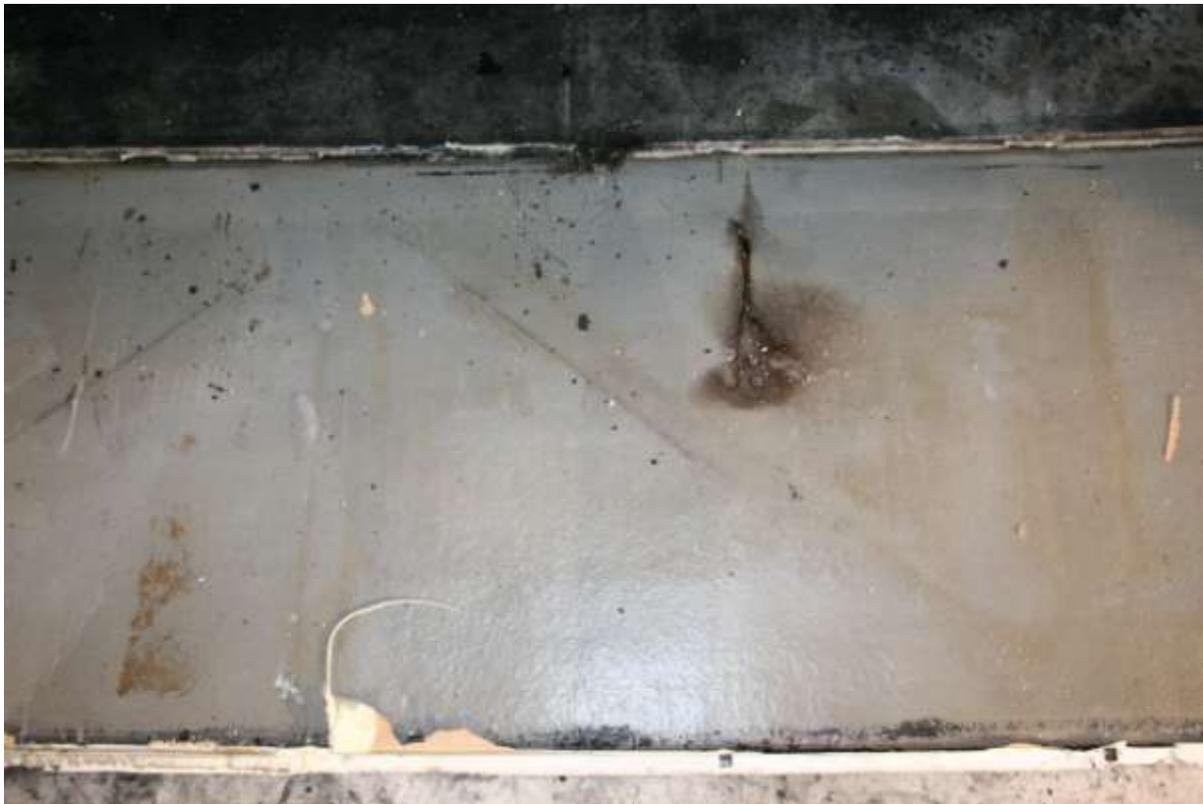
Figure 109 Damage to back side of exterior panel showing little penetration of fire through the GRP.

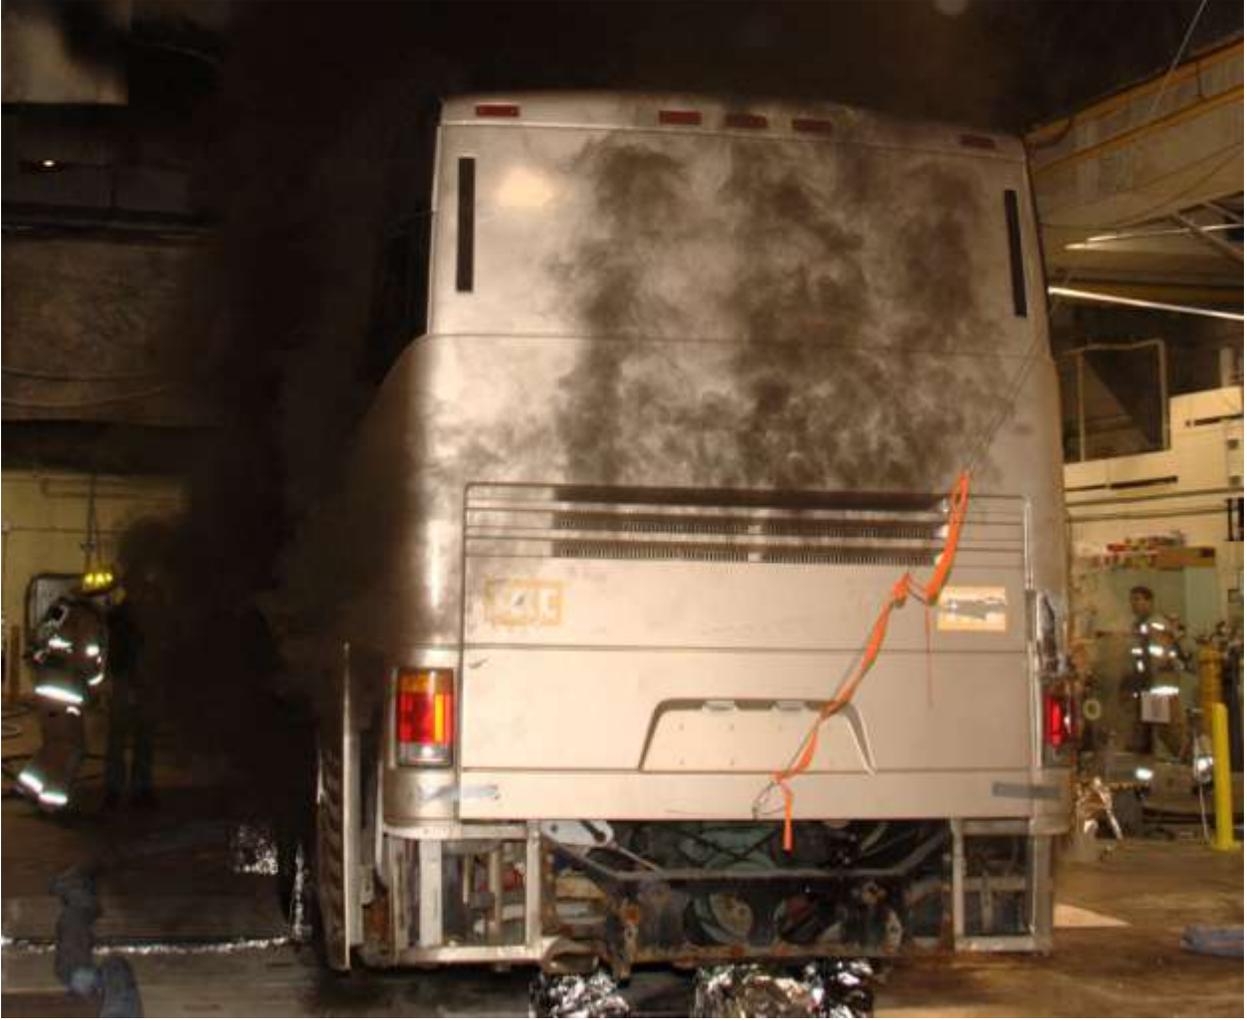
Figure 113 Drive axle wheel heating penetration experiment showing smoke coming from the external air vents.

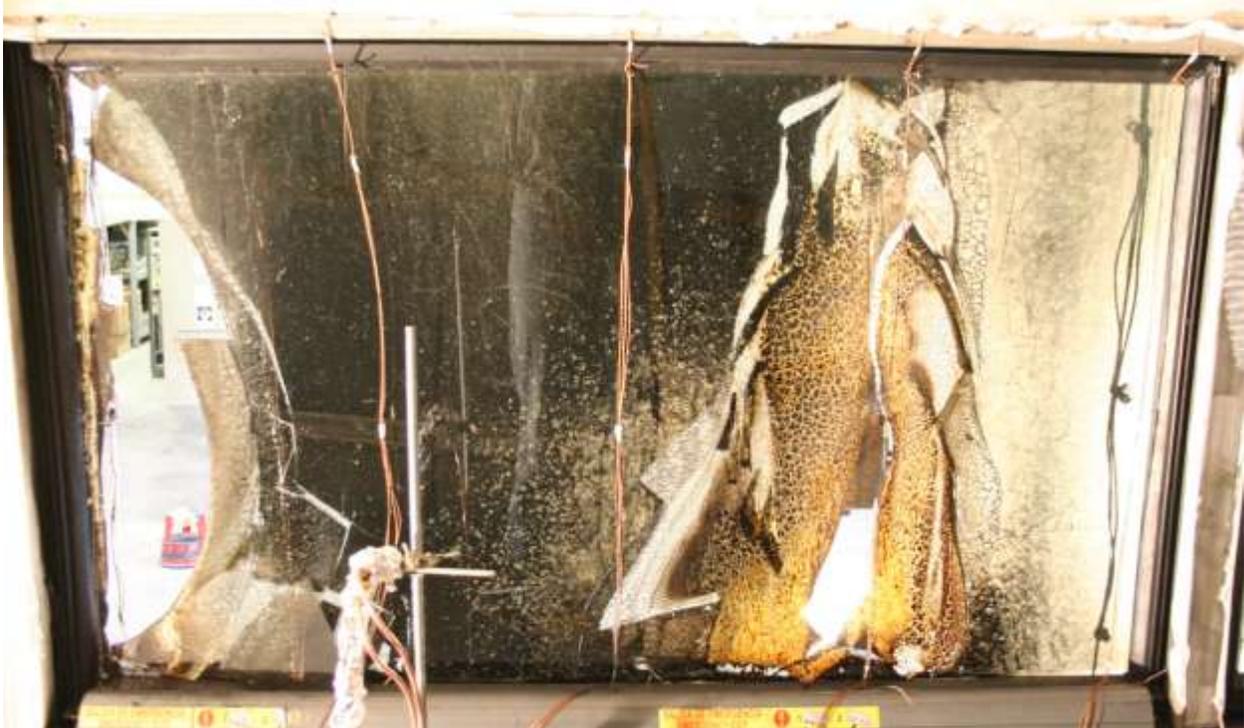
Figure 117 Interior view of damage to the window over the tag axle after the drive axle wheel heating penetration experiment fire.

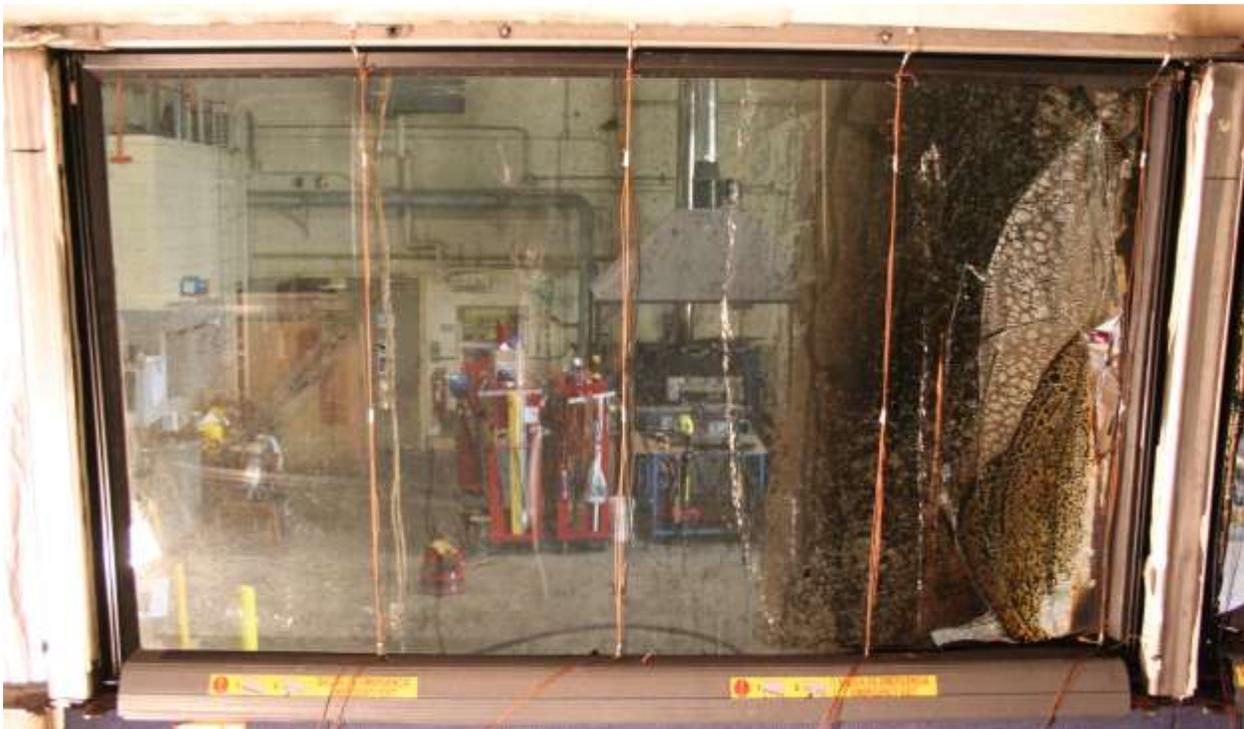
Figure 118 Interior view of damage to the window over the drive axle after the drive axle wheel heating penetration experiment fire.

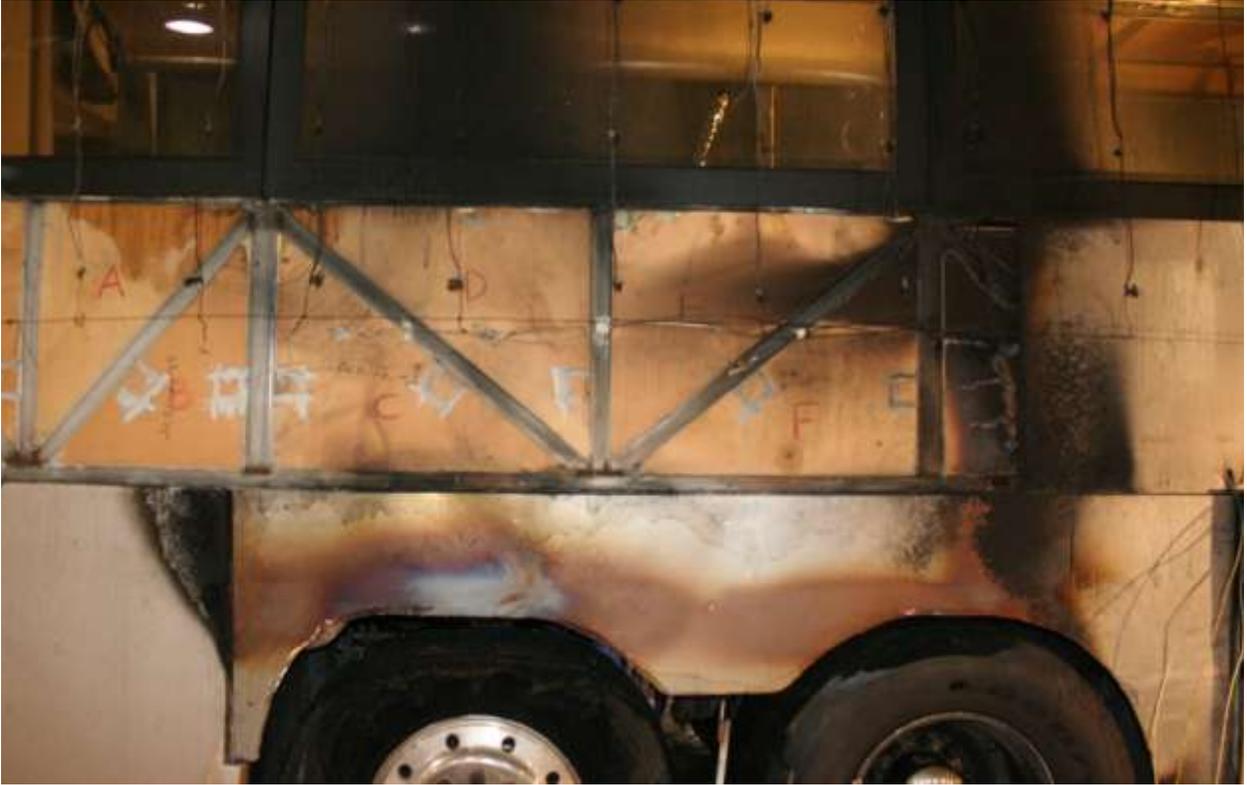
Figure 120 Steel exterior panel fire-hardening experiment paper-covered wall foam damage from fire.
